FIELD CHANGE ORDER

Number DEQNA-R001

Applicability: Any Micro-PDP11 or Micro-VAX LSI-Bus systems which are attached to Ethernet using the DEQNA at revision level "D" or earlier will need the "Required" FCO. Replace all M7504 (DEQNA) modules below Rev "E1/E2" with reworked devices. Purge all units from the shelf stock in the Field Logistics Stockrooms and SR# 17 which have not been ECO'ed (M7504-MK005) and return for rework to rev "E1/E2." This FCO implements ECO M7504-MK005.

Problem/Symptoms: Undetected Data Corruptions can occur and/or a device "lock-up" can be seen when the DEQNA is busy with a transmit pre-fill operation and a receive message comes in. The DEQNA will appear to be hung and requires a device or system reset to clear the "lock-up."

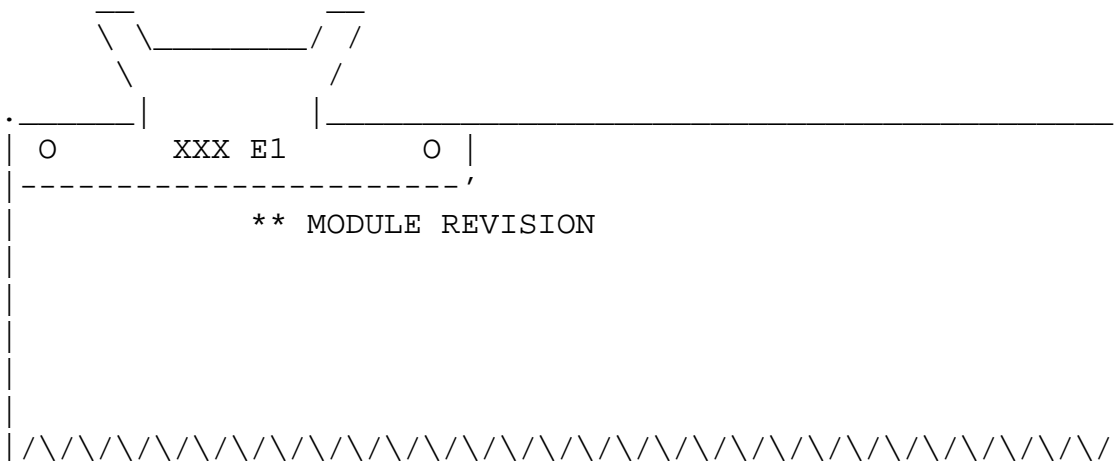
SIDE 2 (BOTTOM)

THIS PICTORIAL IS DESIGNED TO AID IN EASY DETECTION OF A REV. E1 OR HIGHER DEQNA UPGRADED MODULE (M7504). THE MODULE REVISION IS STAMPED ON THE BOTTOM OF THE PLASTIC HANDLE VISIBLE ON SIDE TWO (BOTTOM SIDE) AS REFERENCED BELOW. ADDITIONALLY, IF YOUR APPLICATION SOFTWARE IS DEPENDENT UPON THE DEQNA M7504 PHYSICAL ETHERNET ADDRESS, IT MAY BE NECESSARY TO EXCHANGE THE CHIP ON THE "OLD" MODULE WITH THE CHIP ON THE "NEW" MODULE. THE SOCKETED CHIP IS LABELED AS "ENET ADDR" (365A1) AS IDENTIFIED IN THE SECOND PICTORIAL.

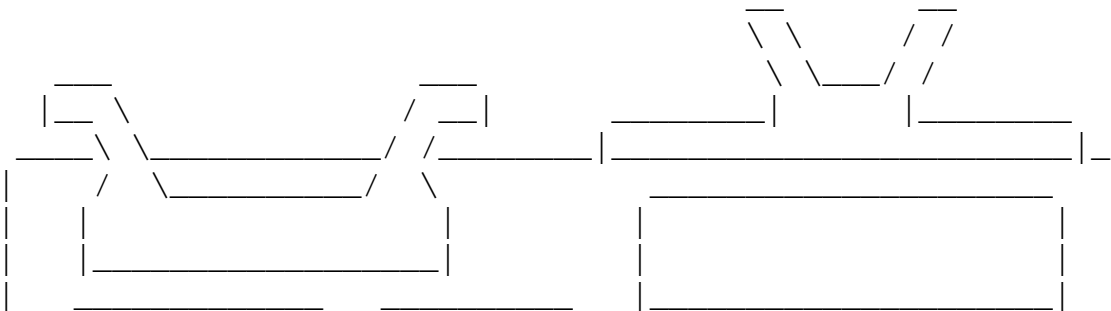
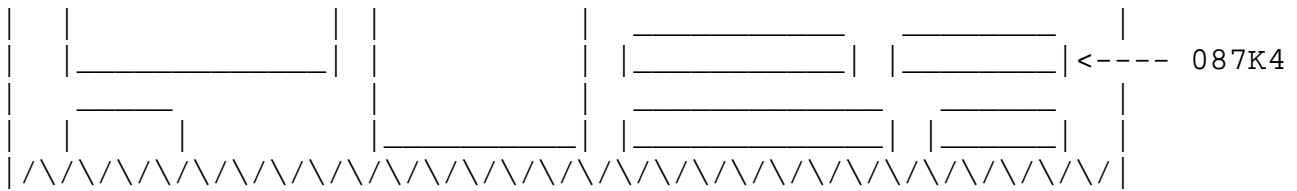
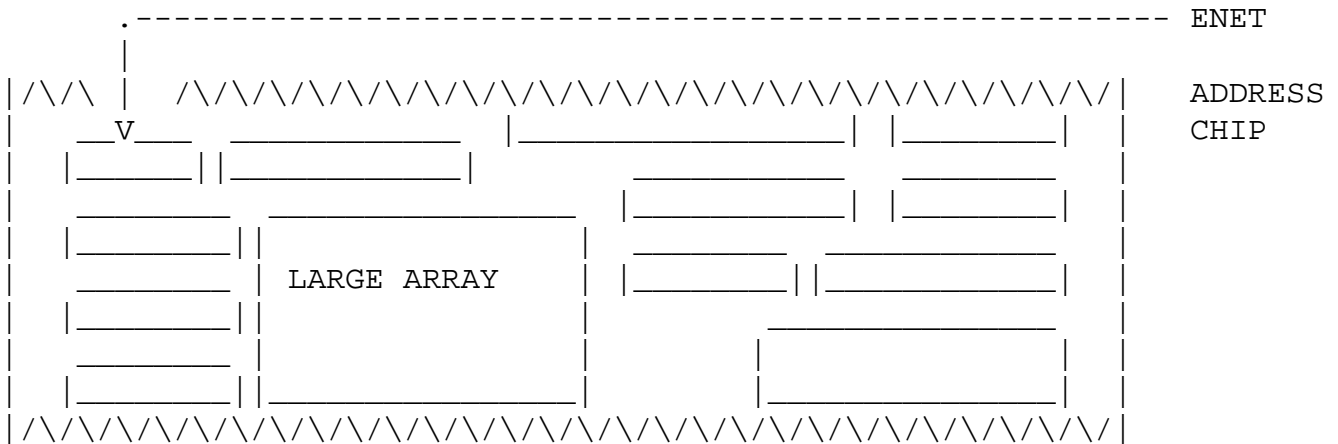
PICTORIAL REPRESENTATION  
OF MODIFIED DEQNA  
- M7504 -

THIS PICTORIAL IS DESIGNED TO AID IN EASY DETECTION OF A REV E1 OR E2 DEQNA REWORKED MODULE (M7504). THE IDENTIFYING FEATURE WHICH WILL ALLOW EASY DETECTION OF THE E1 OR E2 M7504 MODULE IS THE 087K4 LABELED COMPONENT IN THE UPPER RIGHT HAND CORNER OF THE MODULE AS SHOWN BELOW. ADDITIONALLY, IF YOUR APPLICATION SOFTWARE IS DEPENDENT ON THE DEQNA M7504 PHYSICAL ETHERNET ADDRESS, IT MAY BE NECESSARY TO EXCHANGE THE CHIP ON THE "OLD" MODULE WITH THE CHIP ON THE "NEW" MODULE. THE CHIP IS CLEARLY LABELED AS "ENET ADDR" AND IS IDENTIFIED IN THE SECOND PICTORIAL.

2. Remove the M7504 module to be upgraded from the LSI-Bus system.
3. Check to see if the M7504 is at Rev "E1/E2" or higher by verifying that the quick check chip (P/N 23-087K4-00) is present in location E11 (see diagram below in step 5).

5. Assure that all applicable jumpers and switches on the new M7504 are configured in the same manner as the module being removed. BE SURE TO EXCHANGE THE ADDRESS ROM IN LOCATION E42 (THE 16 PIN DIP, AS SHOWN ON THE NEXT PAGE) FROM THE OLD MODULE TO THE NEW MODULE TO GUARANTEE THE DEQNA ADDRESS REMAINS THE SAME (this will assure that software being down-line-loaded is still addressing the correct node address).
