FIELD CHANGE ORDER

NUMBER: FT810-0001

APPLICABILITY:

FCO FT810-0001

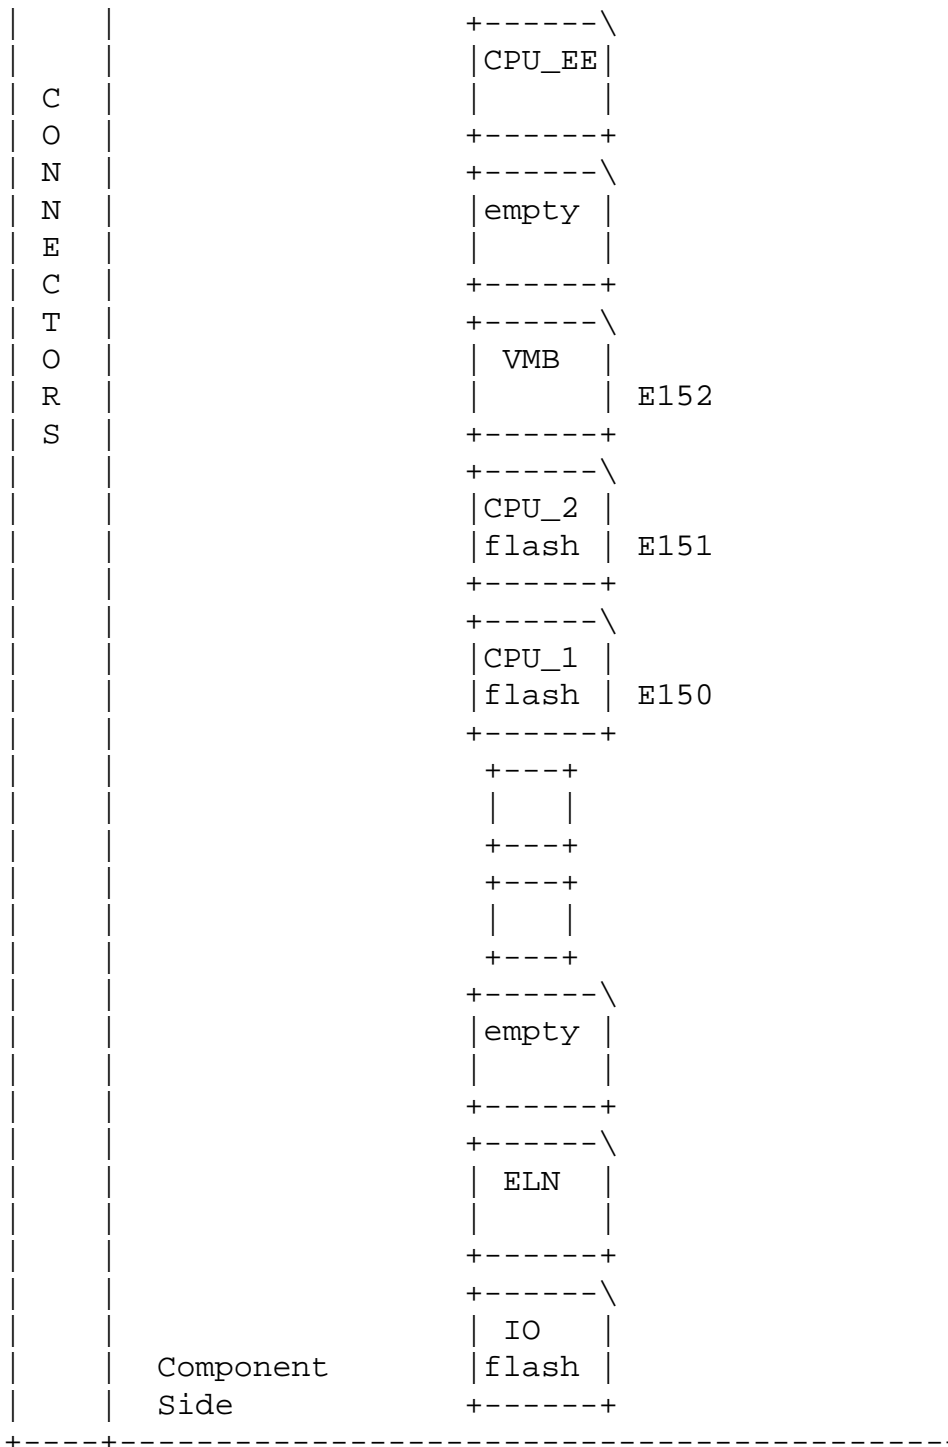
FT810-0001

1.3 Refer to the sketch for the location of ROMs.
(Attachment #1)

4.4 Place new part number 23-0006Z4-00 (V1.1 VMB) gently "on" the socket orienting the pin 1 designator, (single dot depression on slanted upper surface, see Attachment#1), facing toward the module handle. Verify that the beveled corner is oriented toward the corner of the module where the battery pack is mounted.

4.7 Place new part number 23-0037Z4-00 (V1.4 CPU_1) gently "on" the socket orienting the pin 1 designator, (single dot depression on slanted upper surface, see Attachment#1), facing toward the module handle. Verify that the beveled corner is oriented toward the corner of the module where the battery pack is mounted.

4.10 Place new part number 23-0036Z4-00 (V1.4 CPU_2) gently "on" the socket orienting the pin 1 designator, (single dot depression on slanted upper surface, see Attachment#1), facing toward the module handle. Verify that the beveled corner is oriented toward the corner of the module where the battery pack is mounted.
