FCO Application

Field Change Order Number: LX5XX-XX-0001

Field Change Order Name: Prioris LX5000 RTC

Applicability: Prioris LX Models FR944WW / LX5150, FR945WW / LX5200

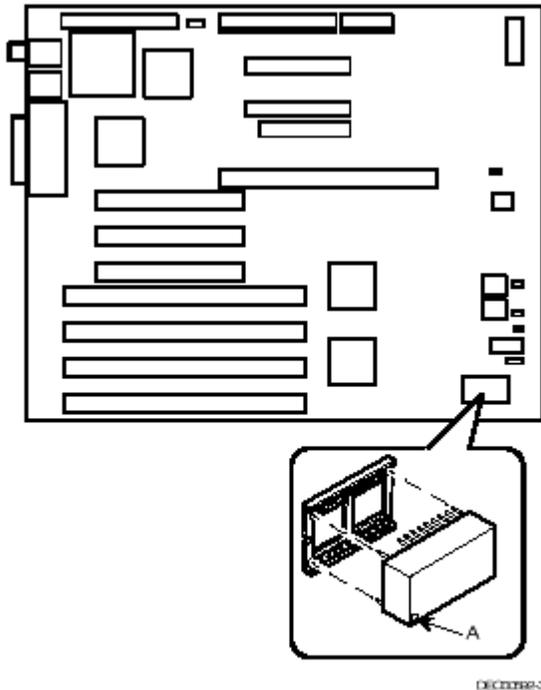
Figure 3-15. Installing the Server Battery

CAUTION: Make sure pin 1 on the battery is correctly aligned with the pin 1 location on the socket (A, Figure 3-15). The pin 1 location on the battery is designated by a (white) dot in the lower left corner of the battery. Incorrect installation may cause faulty server operation.

- return to the main menu and exit.
2. Power off your server.
3. Unlock and remove the left side panel.
4. Remove the RTC chip (ref. to Fig 3.15 below)
5. Install the new RTC chip (ref. to Fig 3.15 below).

- The RTC assembly supplied in the FCO kit can be identified by the small surface mount resistor and green ECO wire on the bottom of the RTC chip between pins 15 and 24.
