Field Change Order Number: 00-AS800 F001
Field Change Order Name: ASR800 Combo Slot –12v issue
Customer Document Number: EK-COR64-CL

Subject: AlphaServer 800 64-bit PCI slot restrictions

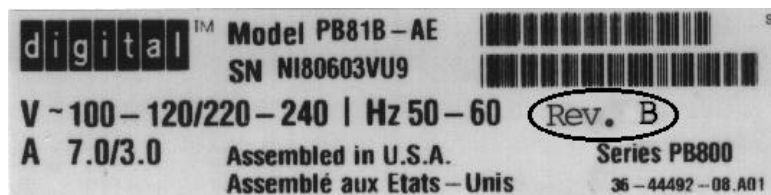
Digital has redesigned the system module to correct the problem and our manufacturing plants are now shipping only AlphaServer 800 systems that have this design change implemented. You can quickly determine if your system is affected by reading the revision of the system on the model number label on the back of the system enclosure. The systems that have had this problem corrected are marked with a Revision B or later. An example of the Revision B system label is shown in Figure 1 (see oval; the location of the revision text may vary). Any system that does not have a revision letter on the label is considered a Revision A and is affected by this problem.

- The 54-24803-01 variation with revisions beginning with letters Axx through Jxx have this condition. Revisions beginning with letter Kxx or later have been corrected. (The 'xx' field is a two digit number and a non-critical part of the revision information).

- The 54-24803-02 variation with a revision of Axx have this condition. Revisions beginning with letter Bxx or later have been corrected.

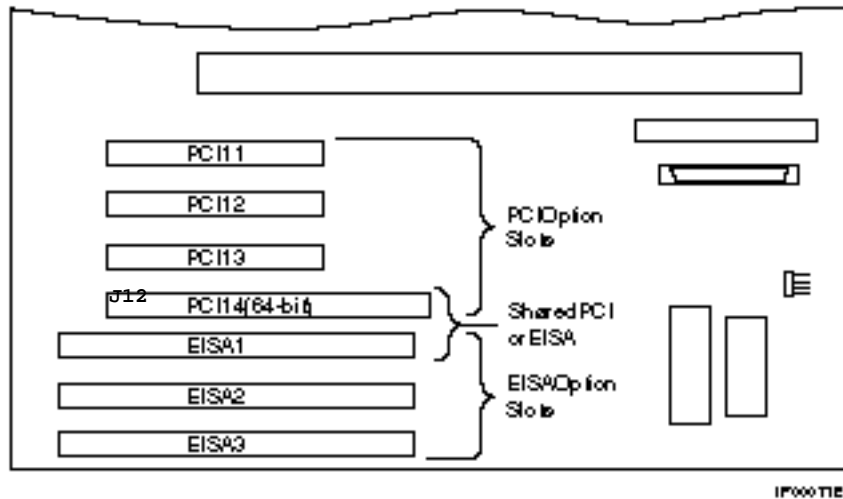
Digital has determined that a condition exists in the AlphaServer 800 system module which affects the 64-bit PCI option slot #14 (J12) that may cause electrical damage to some 32-bit and 64-bit PCI option modules, or other devices that are installed into that slot. The 64-bit PCI connector pin that should be providing the option module with -12 volts is actually supplying +12 volts. Only options that require -12 volts are susceptible to damage in this slot and most options do not use this connector pin. To date, Digital has not received any reports of such damage. This condition does not pose a product safety hazard, and all other PCI and EISA option slots in the AlphaServer 800 are unaffected.

We suggest that as a precautionary measure, customers apply a piece of non-conductive tape across the top of the 64-bit PCI slot to inhibit installation of option modules. The affected 64-bit PCI slot can be identified by the legend “J12” marked adjacent to the 64-bit PCI connector on either variation of the system module. See Figure 2 below.
