## FCO Application

**Field Change Order Number:** DS-ZXHX6-XX-F001

**Applicability:** Prioris ZX6 and HX6 Models;

**Problem Statement: The problem is with a lot of Power Harness cables from the Power Supply to the SCSI Backplane on the HX6 and ZX6 systems.**

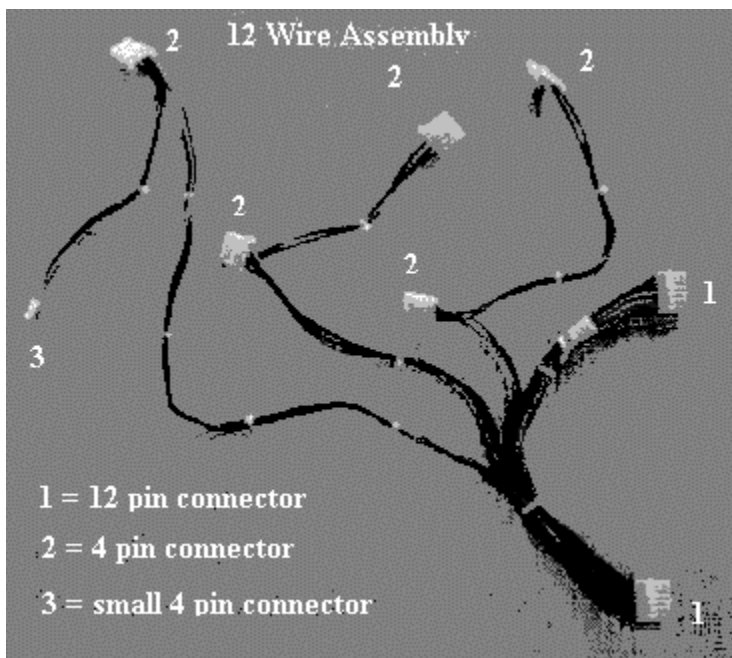
- 4) Unlock and remove the server side panels.
- 5) Locate the 12-wire cable assembly (P/N 70-31894-01) that is connected to the power supplies, SCSI backplane, diskette drive, and any optional drives (e.g. CD-ROM drive, tape drive, etc.). See item 7 below in Figure 13-3.
