FIELD CHANGE ORDER

Number: 85XBA-R005

Applicability: Retrofit all VAX 85X0s to Revision Level "D1". This FCO incorporated the following ECOs: 851BA-Y-LK004 and 855BA-Y-LK005; New Part Revision "D1".

Machine shuts down prematurely because of error in Temp Sensor-3 Location. Change Temp Sensor-3 with Air Flow Sensor-1.

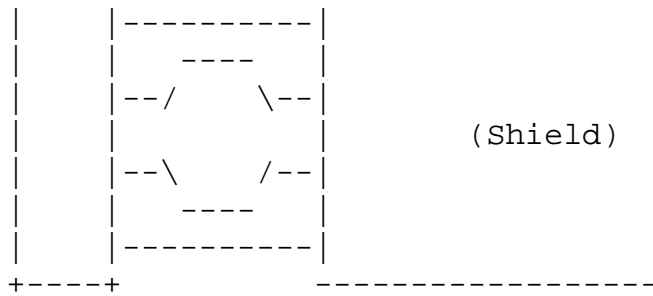
Some of the brackets have extra long threaded studs which will get in the way of the air flow sensor cable when it is installed. To eliminate chafing of the cable by the threaded stud, tie wraps should be installed on the wires using the following procedure.

Holding the connector that plugs into the air flow sensor you will notice four wires going into the plug. Separate the wires so that with the connector held flat the two inboard wires are next to the two outboard wires; as shown in the diagram below below.

Now take a tie wrap and install it around one two wire group, drawing it snug, but loose enough that it will slide on the wires. Now do the same for the other wire pair. This should leave you with a space near where the wires connect to the connector block that the threaded stud can fit through.

Next plug the connector into its receptacle on the air flow sensor and feed the stud through the space you created in the cable. Take special care to insure that the tie wraps and not the wires are pressing against the side of the stud. Reposition the tie wraps if necessary.
