DIGITAL	FCO	LEVEL OF URGENCY	PAGE 1 OF 7
		[I]

FIELD CHANGE ORDER	NUMBER: DSRZA-I001
--------------------	--------------------

PROB/SYMPT: The composite link has problems with error recovery, especially in the route-through configuration, and will cause the system to hang.

FCO DSRZA-I001

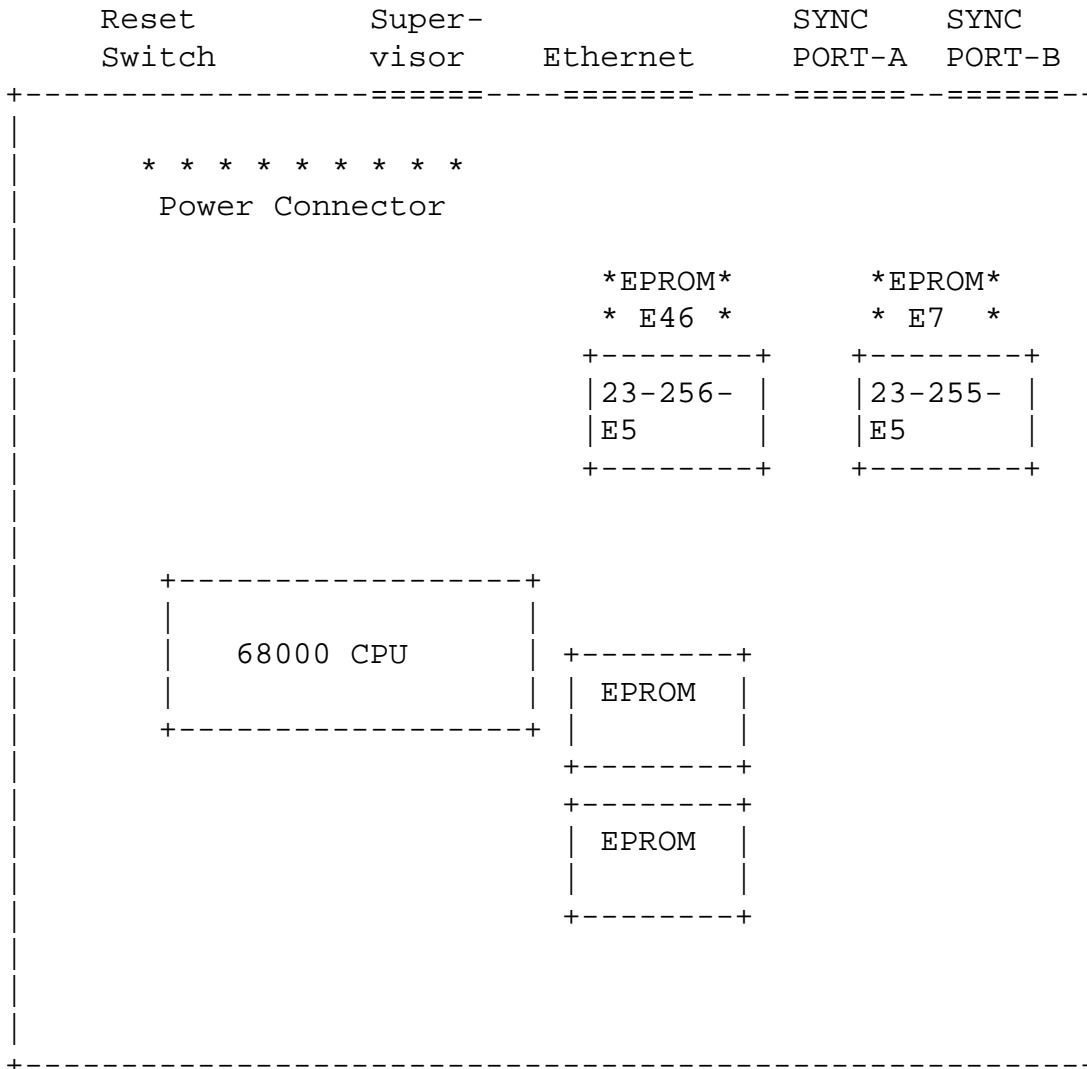
FIGURE 1

MUXserver 100, DSRZA-** Module
 54-16341-01

NOTE: Depending on Rev/Vintage of MUXserver, E numbers and original PROM numbers may not agree with table.

Find IC location E7 on the Muxserver layout diagram, locate old PROM on the module and remove that PROM (23-255E5-00). Carefully insert the new PROM "23-320E5-00" into IC location E7.

7. Locate the new PROM which has "23-321E5-00" printed on it. Find IC location E46 on the Muxserver layout diagram, locate old PROM on the module and remove that PROM (23-256E5-00). Carefully insert the new PROM "23-321E5-00" into IC location E46.

REPLACE EPROMS :
 E7 : 23-225E5-00 with 23-320E5-00
 E46: 23-256E5-00 with 23-321E5-00

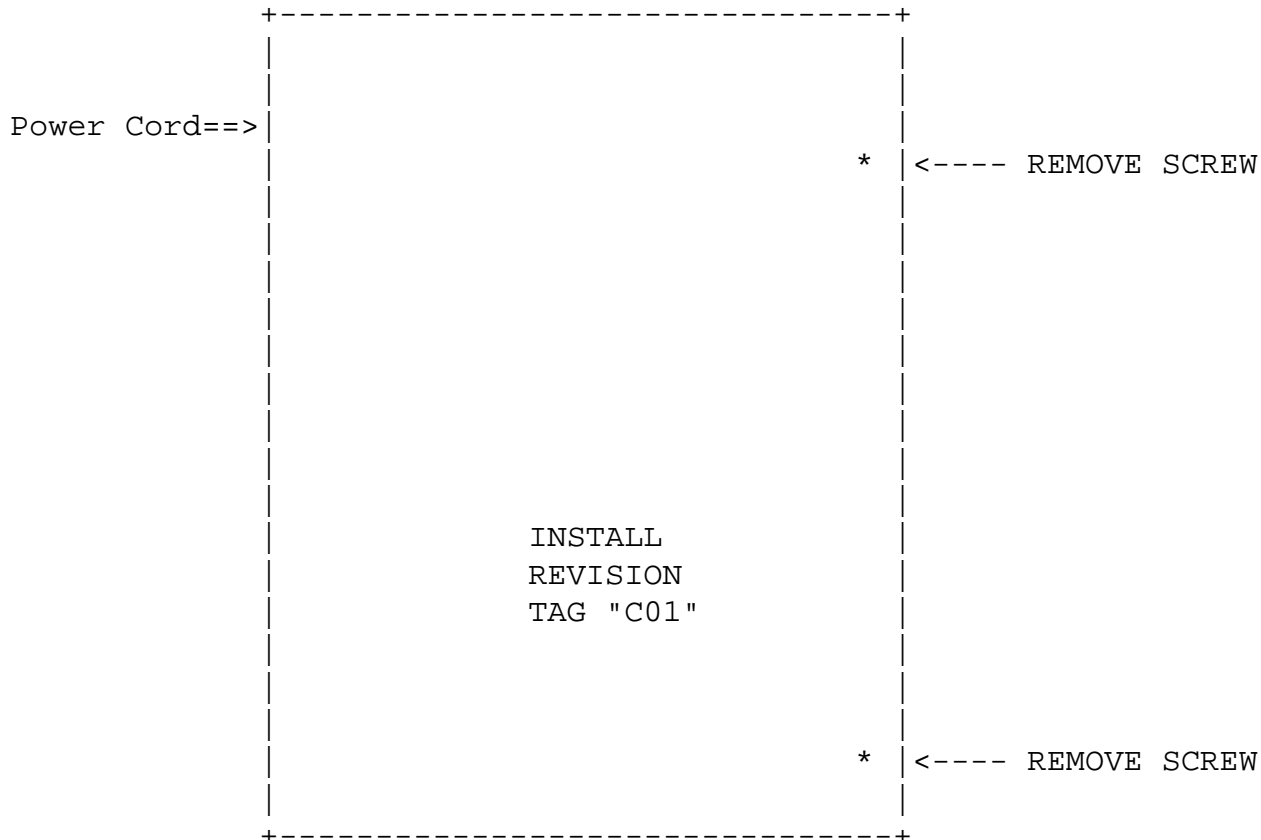
FIGURE 2

(Bottom View DSRZA-BA/BB)

9. Take the revision tag that is included in the EQ kit, part no. 36-291631-03, and cut off the section that states "REV C01" and install it as shown in figure 2. The Muxserver firmware update is now complete.

NOTE: 1. Remove the two screws as indicated.

NOTE: 2. Install the revision tag where indicated.
