PrintServer 17/600 Printer

Maintenance Advisory

EK-PRT17-MA. A01

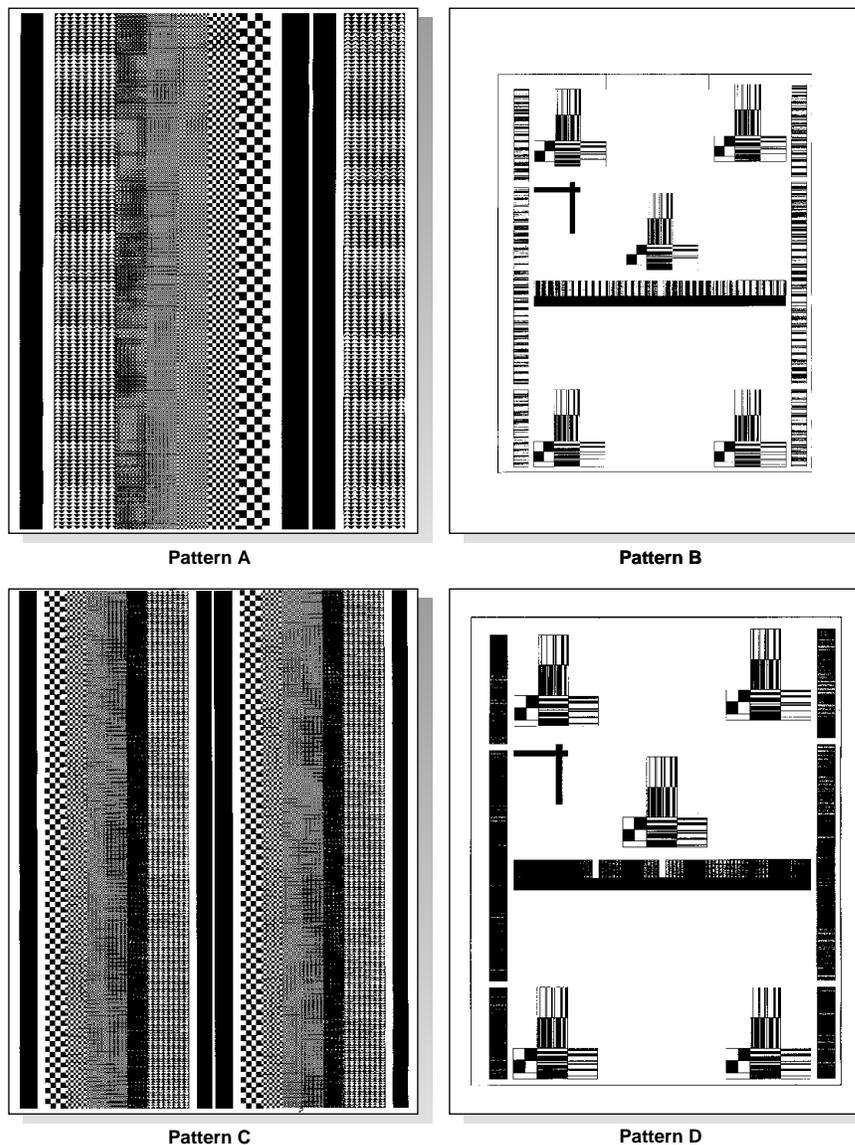
Figure 2-1 New V2.1 Controller Board Test Patterns

- Patterns A and B are printed at 400 dpi. Compare the B and D test test patterns. Notice how the B pattern is smaller on the page than pattern D. This only happens at 400 dpi.
- Patterns C and D are printed at 600 dpi. Compare the C and the A test patterns. Notice how the C test pattern is horizontally compressed. This compression effect increases as the density (dots-per-inch) increases.
