FIELD CHANGE ORDER

NUMBER: FT810-0001

APPLICABILITY:

FCO FT810-0001

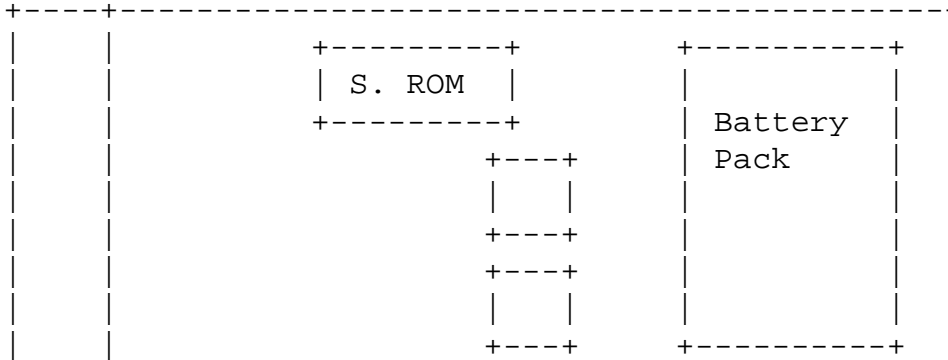
Module

Handle Side

- 1.1.1 23-006Z4-00 replaces 23-007Z4-00 (part of the V1.3 upgrade)
VMB FLASH
23-006Z4-00
E152 (location on the I/O ATM module)
955A (last 4 digits of the ROMs checksum)
- 1.1.2 23-037Z4-00 replaces 23-009Z4-00 (part of the V1.4 upgrade)
CPU_1 FLASH
23-037Z4-00
E150 (location on the I/O ATM module)
FBF0 (last 4 digits of the ROMs checksum)
