FIELD CHANGE ORDER	NUMBER: RF31-0001
--------------------	-------------------

This "0" coded FCO is applicable only to RF31 options, revisions F06, H06, or J06, installed in VAX 4000, 5000, dual host 3800 and VAXft systems.

The FCO consists of a module with new firmware (PN 23-019EA-00) to be installed. This will change the option revision from F06, H06, J06 to K06.  
(Continued on Page 2)

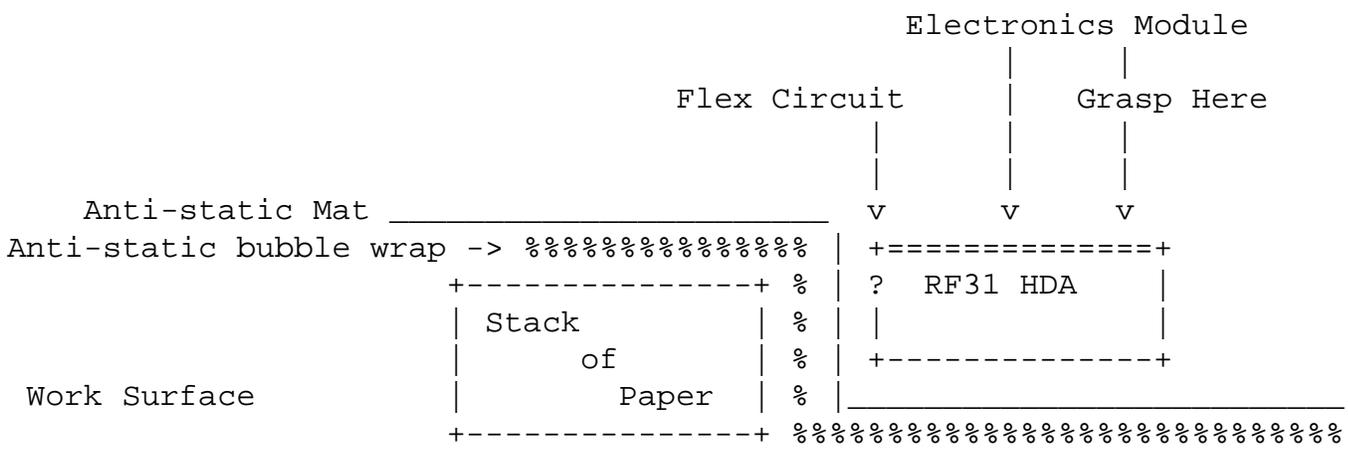
Figure 1 Before Module Removed

Nodename, Allclass, Unitnum, Forceuni, Forcename, SystemID
3. Perform an orderly system shutdown, using the appropriate system shutdown procedures.
4. Power down the entire system and expander boxes if applicable.
5. Setup an anti-static work surface as shown in Figure 1. Note the stack of paper (Manuals etc.), this paper is used to support the module once it is removed from the Mechanic Set (HDA).
6. Remove the RF31 from the storage enclosure, or mounting hardware as required, consult the appropriate manuals for this procedure.
7. Place the RF31 to be upgraded on the Anti-static work surface with

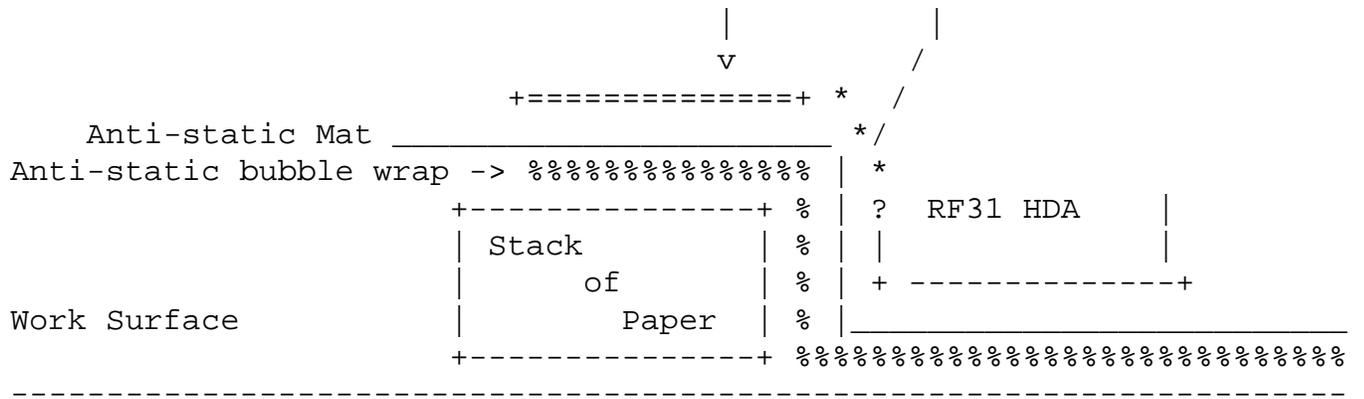
Figure 2 After Module Removal

FT 7. Separate the 2 FRU's by lifting module from DSSI connector end.  
WARNING: Proceed with caution, flex circuit is very delicate and can be easily damaged.

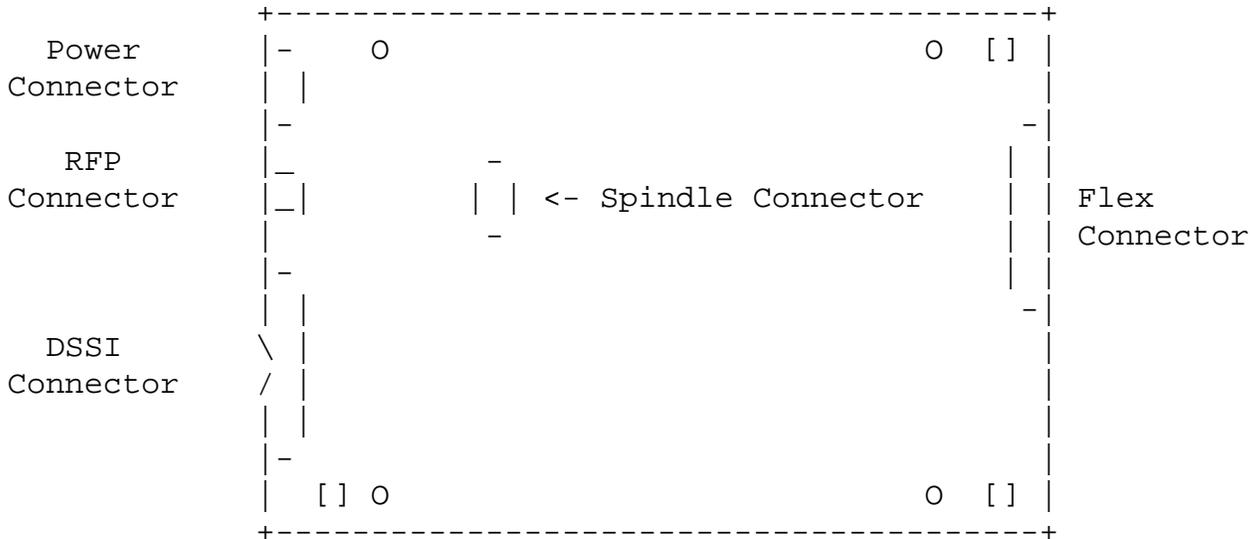
Figure 3, Module, side 1 up.

O - Four Mounting Screw Holes

[] - Three Tooling Holes
