DIGITAL StorageWorks
HSD50 Array Controller

H5OF Version 5.1
Service Manual

Part Number: EK-HSD50-SV.B01

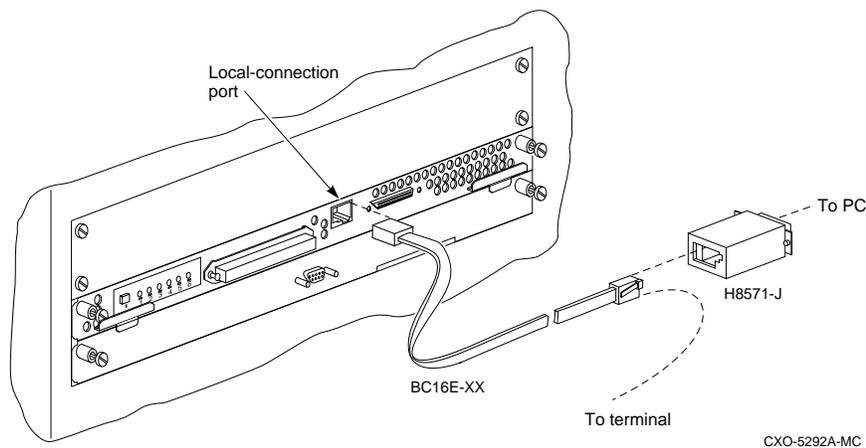
1. Terminate all running utilities and disable all other terminal.
2. Have the replacement modules at hand. The modules should be factory-fresh or should have been shut down cleanly (with the SHUTDOWN command) in their last application.
3. Connect a maintenance terminal to the controller that you are *not* replacing. See Figure 2-1.

Figure 2-1 Connecting a maintenance terminal to the controller

7. Connect the maintenance terminal to the new controller. See Figure 2-1).
8. Enter the following command from the *new* controller to put the controllers into dual-redundant mode.

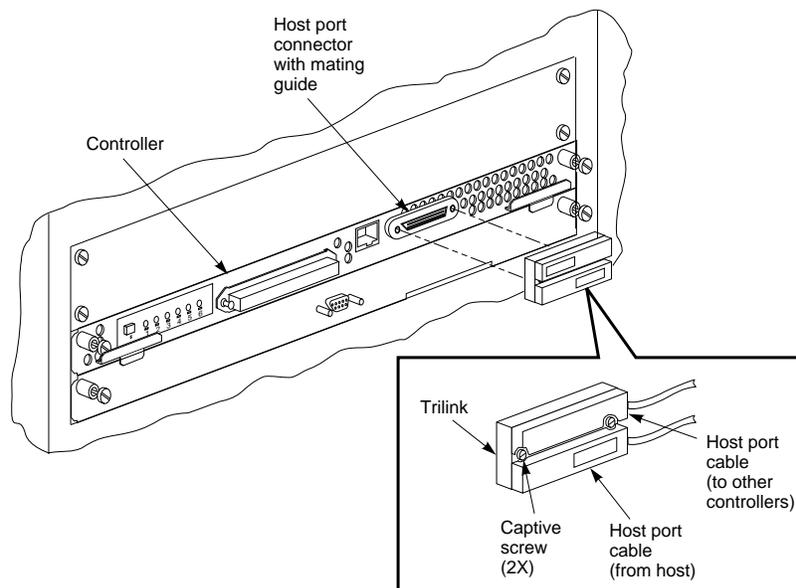
CXO-5297A-MC

8. With a small flat-head screwdriver, loosen the captive screws that secure the trilink connector to the controller. See Figure 2-2. Do not remove the connector yet.

Figure 2-2 Loosening the trilink connector

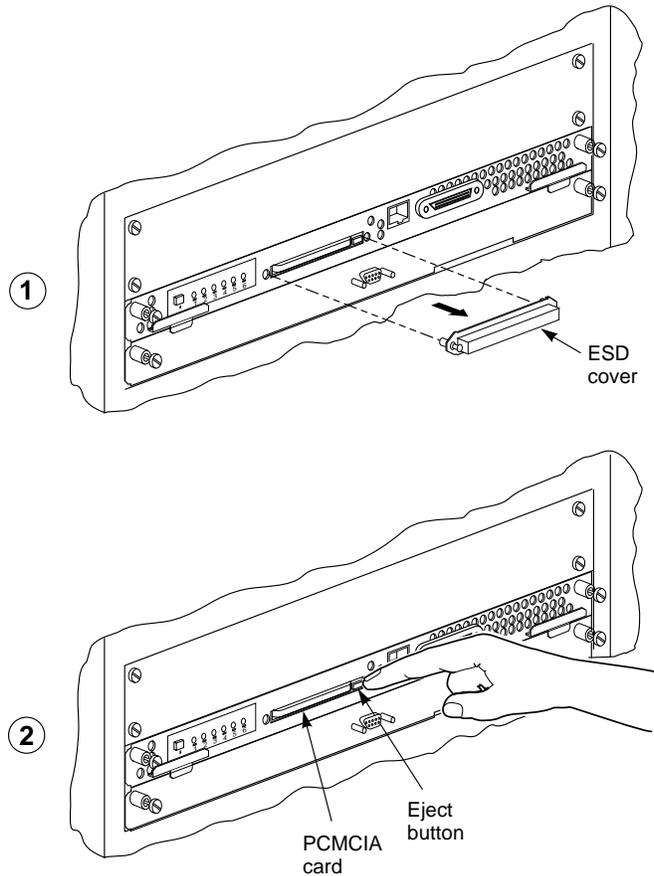
CXO-5302A-MC

11. Attach or clip the other end of the ESD wrist strap to the cabinet grounding stud or a convenient cabinet grounding point (nonpainted surface).
12. Unsnap and remove the program card ESD cover on the controller you are removing.
13. While pressing and holding the Reset (//) button, eject the program (PCMCIA) card by pushing the eject button next to the card. See Figure 2-3. Pull the card out and save it for use in the replacement controller module.

Figure 2-3 Removing the program card

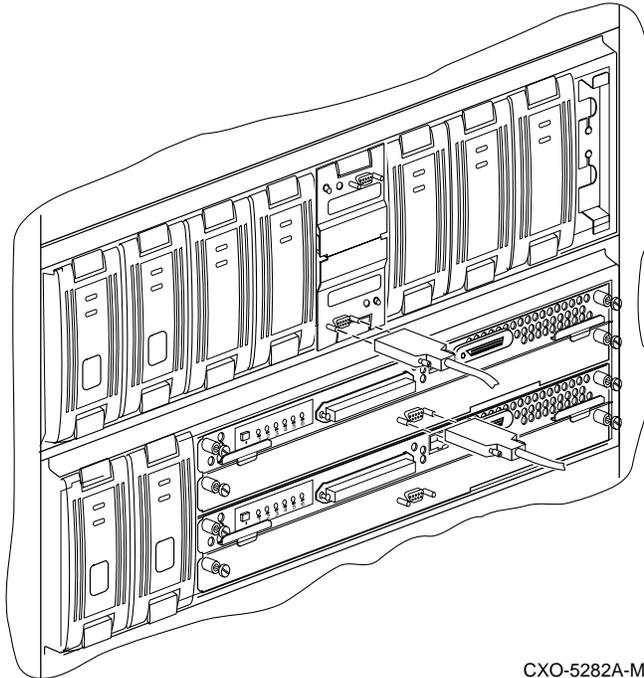
CXO-5282A-MC

7. Disable the ECB by pressing the battery disable switch until the LED on the ECB stops flashing. Disconnect the ECB cable from the cache module. See Figure 2-4.

Figure 2-4 Disconnecting the ECB cable

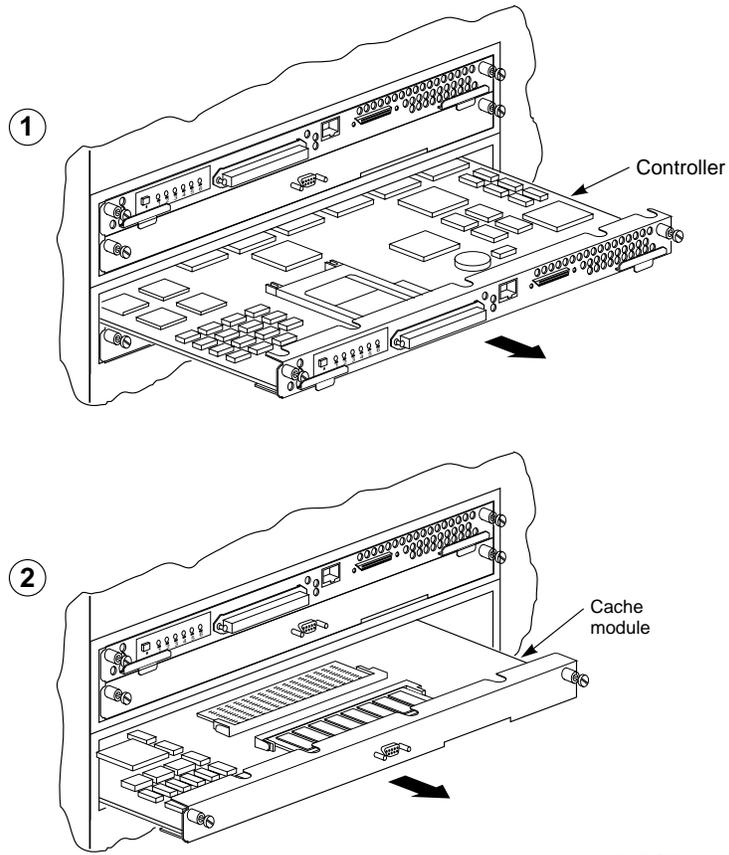
CXO-5284A-MC

8. Slide the controller and cache modules out of the shelf and note in which rails the module was seated. Place the modules on an ESD mat. See Figure 2-5.

Figure 2-5 Removing the controller and cache modules

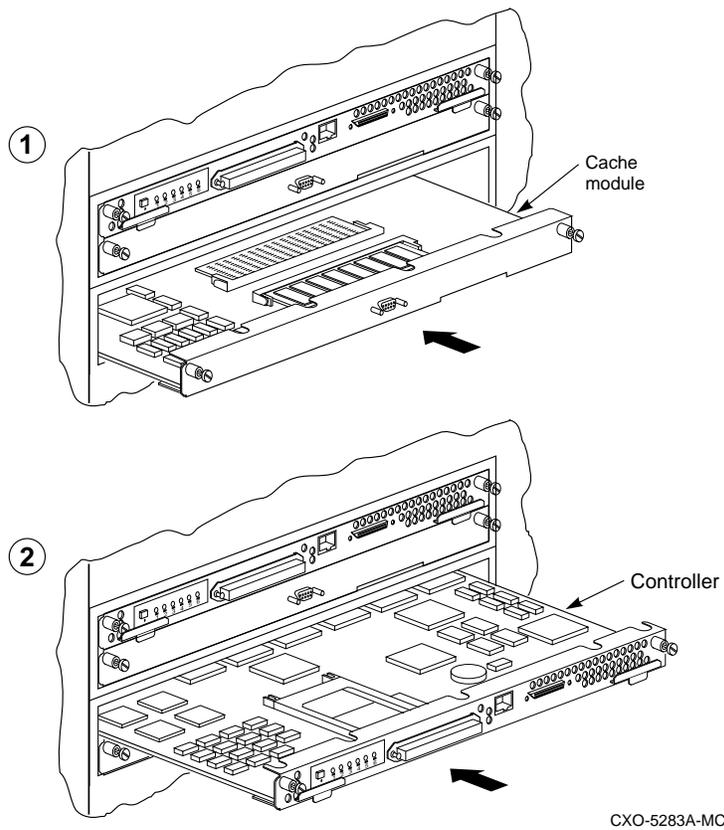
6. If necessary, install the cache module. Slide the module straight in along the rails and then push firmly to seat it in the backplane. See Figure 2-6.

Figure 2-6 Installing the new cache and controller module

7. Slide the module straight in along the rails and then push firmly to seat it in the backplane. See Figure 2-6.

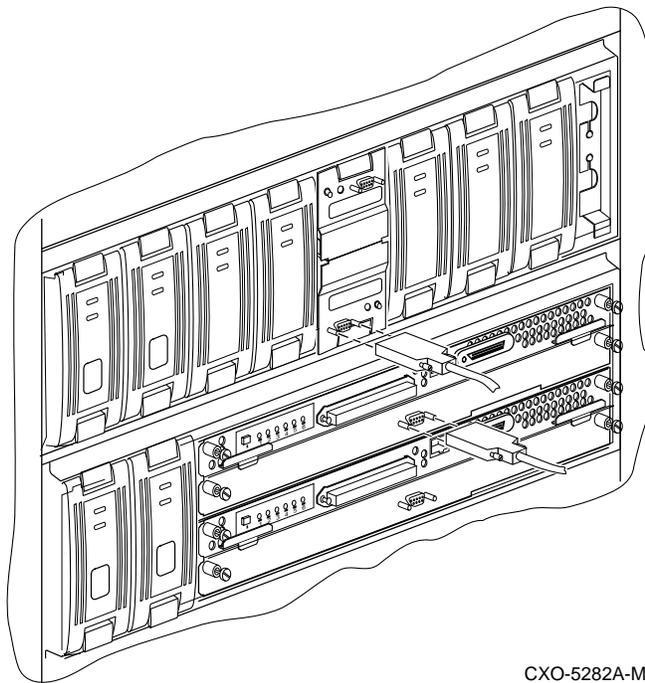
CXO-5282A-MC

9. Reconnect the trilink cable to the controller's front panel.
10. Reconnect the open end of the ECB cable to the cache module (see Figure 2-7). Tighten the battery cable connector mounting screws.

Figure 2-7 Reconnecting the ECB cable

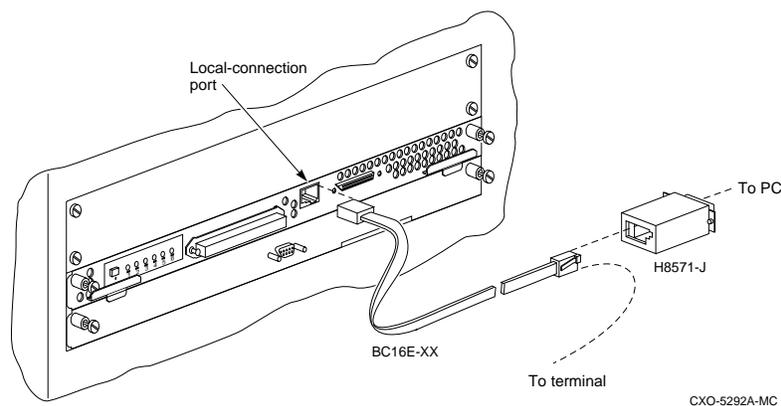
1. If the controller is still or partially functioning, connect a maintenance terminal to the controller. See Figure 2-8.

Figure 2-8 Connecting a maintenance terminal to the controller

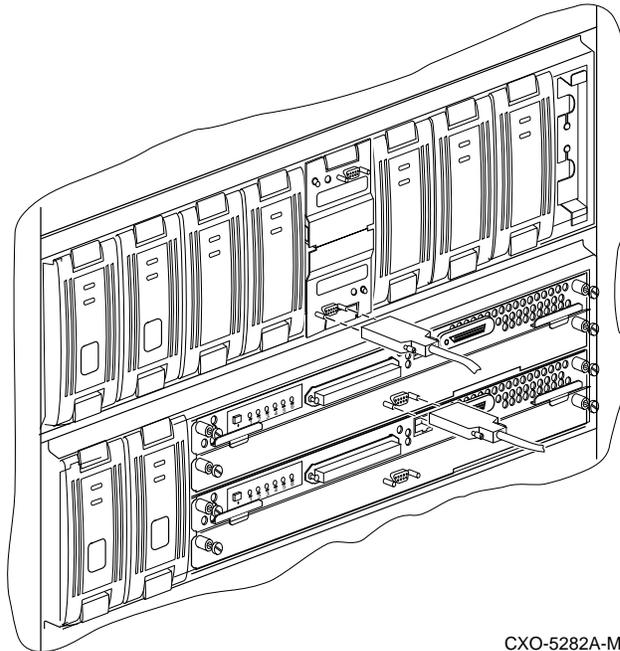
CXO-5282A-MC

- The Reset (//) light is lit continuously.
 - Port lights 1, 2, 3, are also lit continuously.
3. Obtain and place an ESD wrist strap around your wrist. Ensure that the strap fits snugly around your wrist.
 4. Attach or clip the other end of the ESD wrist strap to the cabinet grounding stud or a convenient cabinet grounding point.
 5. Remove the power cords from the controller power supply.
 6. Disable the ECB by pressing the battery disable switch on the batter module's front panel.
 7. Disconnect the ECB battery cable from the cache module. See Figure 2-9.

Figure 2-9 Disconnecting the ECB cable

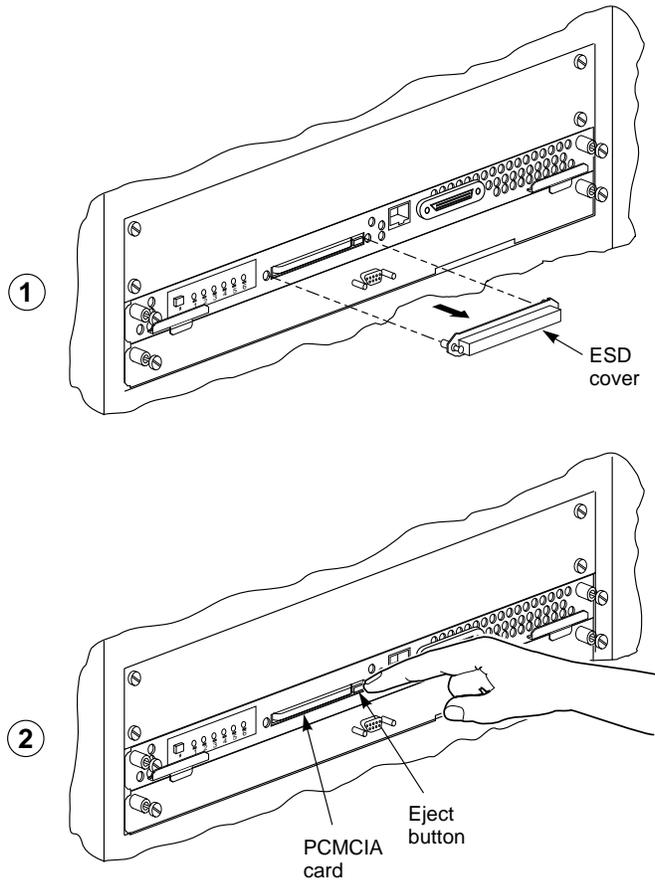
CXO-5302A-MC

8. Unsnap and remove the program card ESD cover. See Figure 2-10.
9. While pressing and holding the Reset (//) button, eject the program (PCMCIA) card by pushing the eject button next to the card. See Figure 2-10. Pull the card from the controller module. Save the program card for the replacement controller.

Figure 2-10 Removing the program card

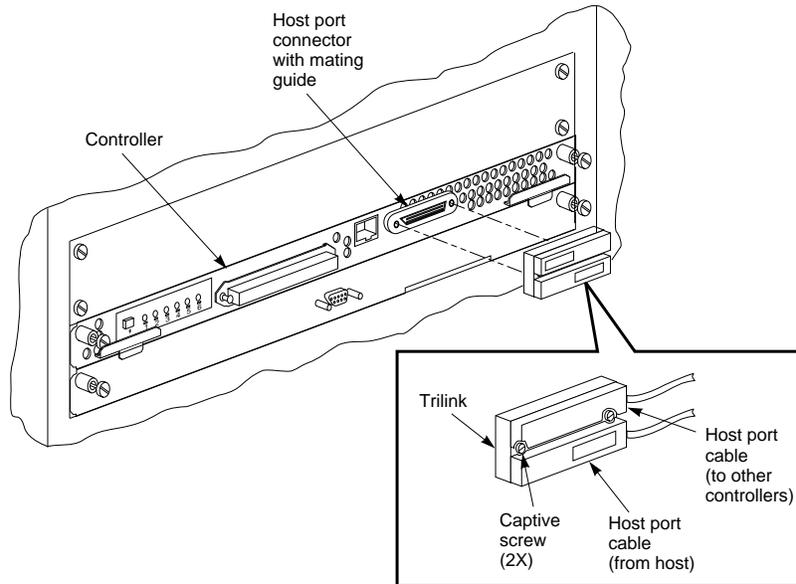
CXO-5297A-MC

10. With a small flat-head screwdriver, loosen the captive screws on the trilink connector at the controller's front panel and remove the trilink. See Figure 2-11.

Figure 2-11 Disconnecting the trilink connector

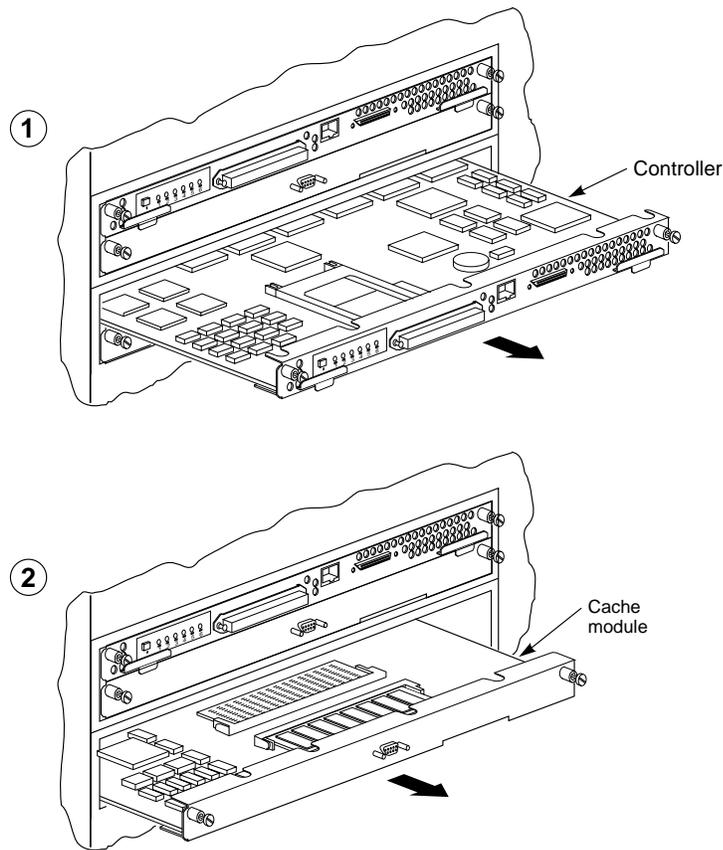
CXO-5284A-MC

Figure 2-12 Removing the controller and cache module

11. Loosen the two captive retaining screws at each corner of the controller and cache module front bezel.
12. Use a gentle rocking motion to loosen the controller module from the shelf backplane.
13. Slide the controller module out of the shelf and place it on an ESD mat. See Figure 2-12.
14. If you are also removing the cache module, loosen the captive screws at each corner of the cache module's front bezel. Use a gentle rocking motion to loosen the cache from the shelf backplane.
15. Slide the cache module out of the shelf.

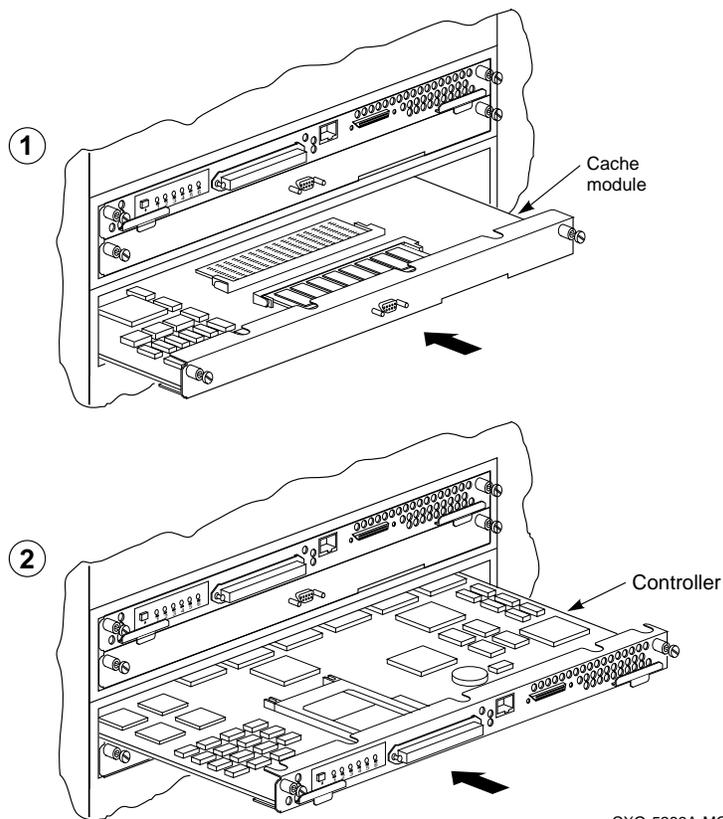
CXO-5283A-MC

1. If required, install the replacement cache module into the shelf. See Figure 2-13.
2. Slide the new controller module into the shelf using the same rails as the removed module. See Figure 2-13.

Figure 2-13 Installing the new cache and controller modules

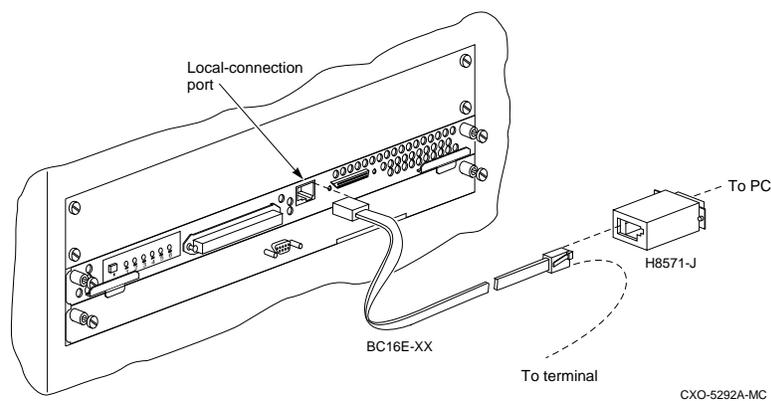
1. Determine that one controller is still operating properly.
2. If the controller you are removing is partially functioning, connect a maintenance terminal to the controller. If the controller has failed, connect a maintenance terminal to the other controller. See Figure 2-14.

Figure 2-14 Connecting a maintenance terminal to the controller

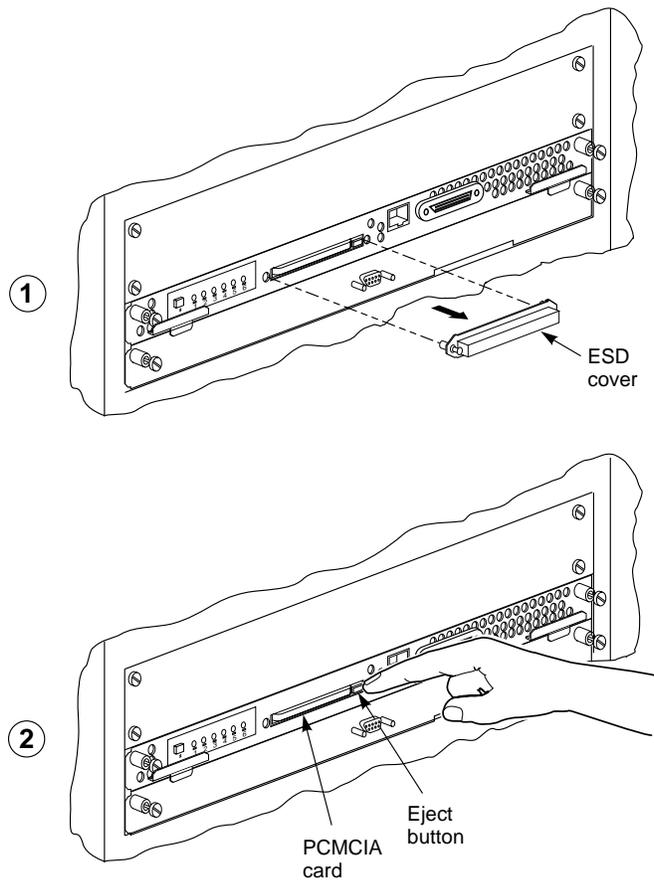
CXO-5302A-MC

5. Obtain and place a ESD wrist strap around your wrist. Ensure that the strap fits snugly around your wrist.
6. Attach or clip the other end of the ESD wrist strap to the cabinet grounding stud or a convenient cabinet grounding point.
7. Unsnap and remove the program card ESD cover, as shown in the first illustration in Figure 2-15.

Figure 2-15 Removing the program card

8. While pressing and holding the Reset (//) button, eject the program (PCMCIA) card by pushing the eject button next to the card. See Figure 2-15. Pull the card out and save it for use in the replacement controller module.

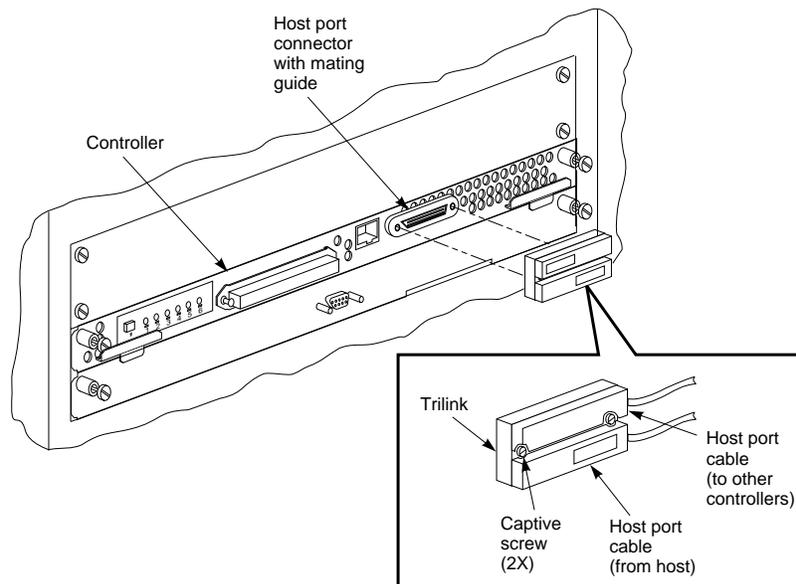
CXO-5297A-MC

9. With a small flat-head screwdriver, remove the trilink connector from the controller's front panel. Do not remove the host cables from the trilink. See Figure 2-16.

Figure 2-16 Disconnecting the trilink connector

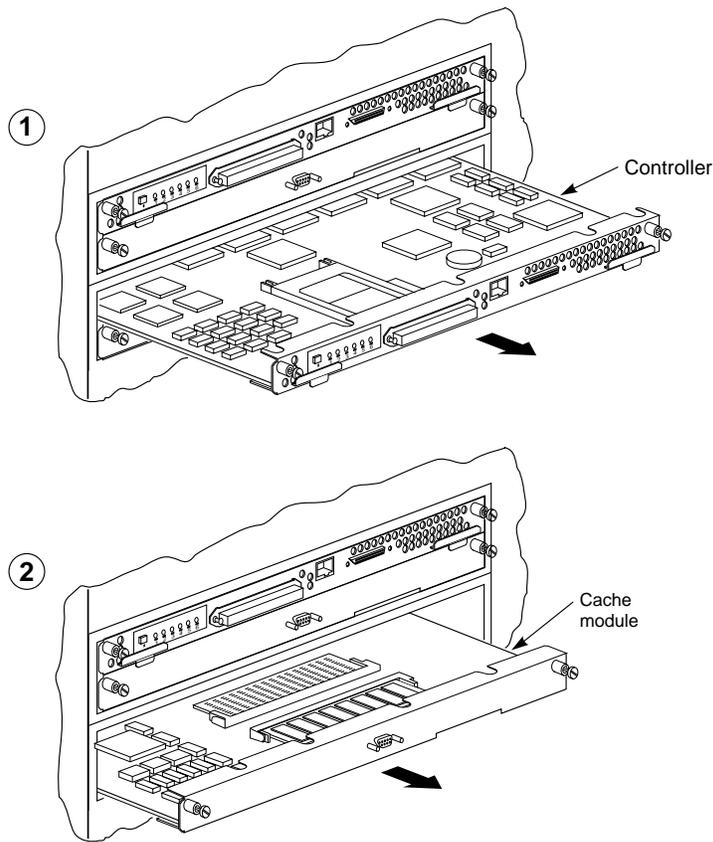
CXO-5284A-MC

11. Loosen the front bezel captive screws on the controller and cache module.
12. Use a gentle rocking motion to loosen the controller module from the shelf backplane.
13. Slide the controller module out of the shelf (noting which rails the module was seated in) and place it on an approved ESD mat. See Figure 2-18.
14. If necessary remove the cache module and note in which rails it was seated. Place it on an approved ESD mat. See Figure 2-18.

Figure 2-18 Removing the controller and cache modules

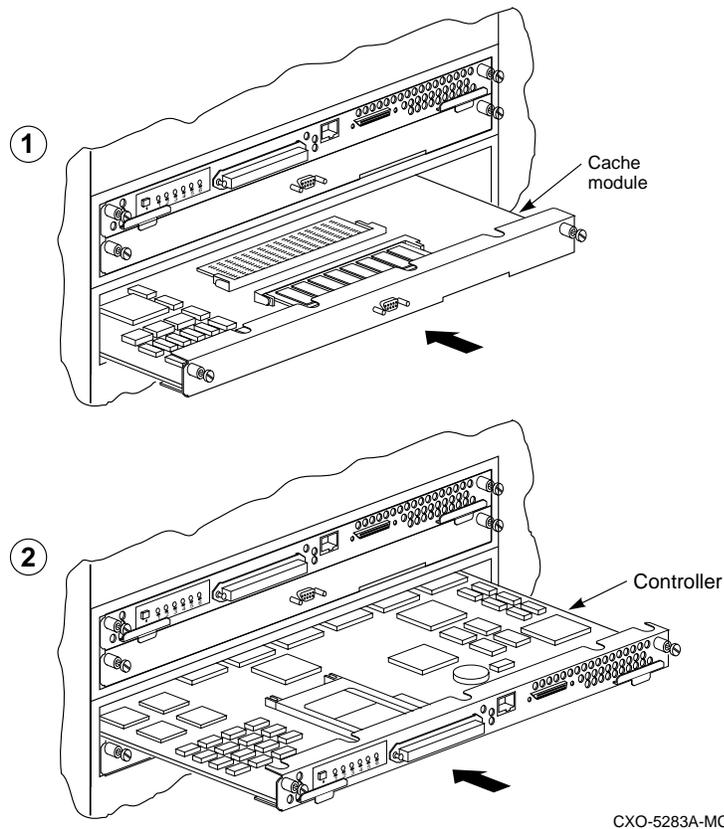
1. Reinstall the cache module if it has been removed. See Figure 2-19.
2. Use a gentle rocking motion to help seat the module into the backplane. Press firmly on the module until it is seated.

- Slide the controller module into the shelf using the same rails as the removed module. See Figure 2-19.

Figure 2-19 Installing the new cache and controller module

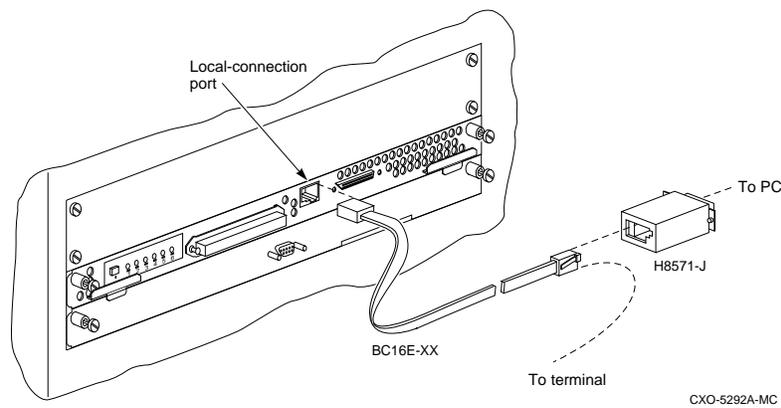
1. Connect a maintenance terminal to the controller that contains the cache module to be replaced. See Figure 2-20.
2. Take the controller out of service:

Figure 2-20 Connecting a maintenance terminal to the controller

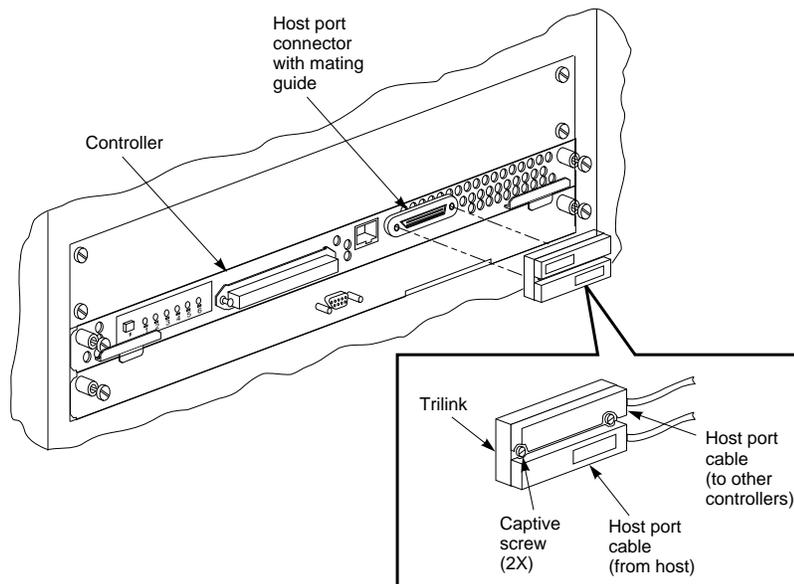
CXO-5297A-MC

9. With a small flat-head screwdriver, remove the trilink connector from the controller's front panel. Do not remove the host cables from the trilink. See Figure 2-21.

Figure 2-21 Disconnecting the trilink connector

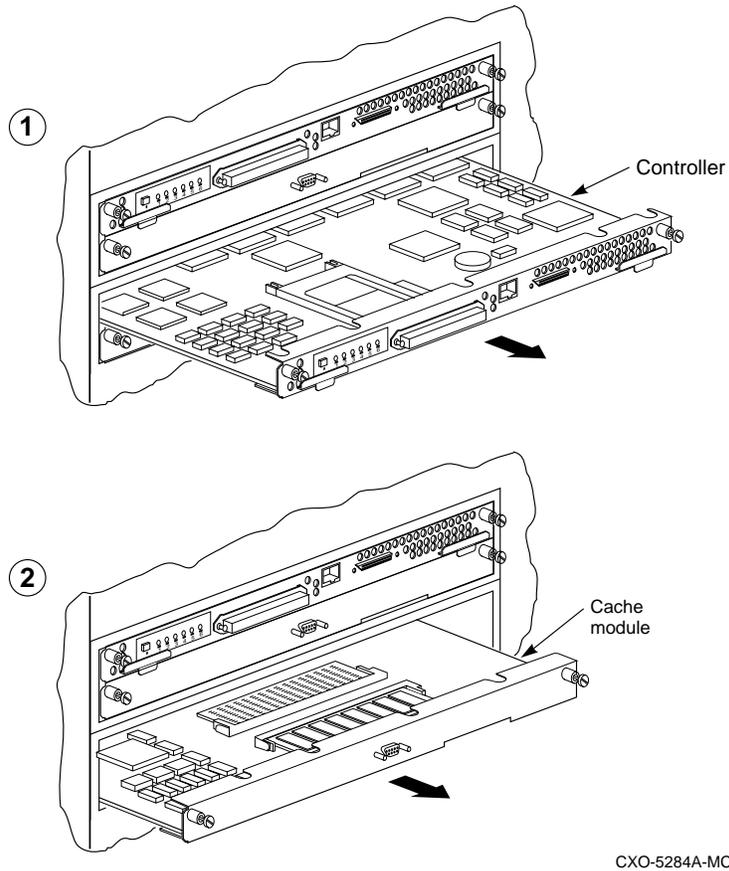
Figure 2-22 Removing controller and cache modules.

12. Slide the controller module out of the shelf (noting which rail it was seated in) and place it on an ESD mat. See Figure 2-22.
13. Slide the cache module out of the shelf. See Figure 2-22.

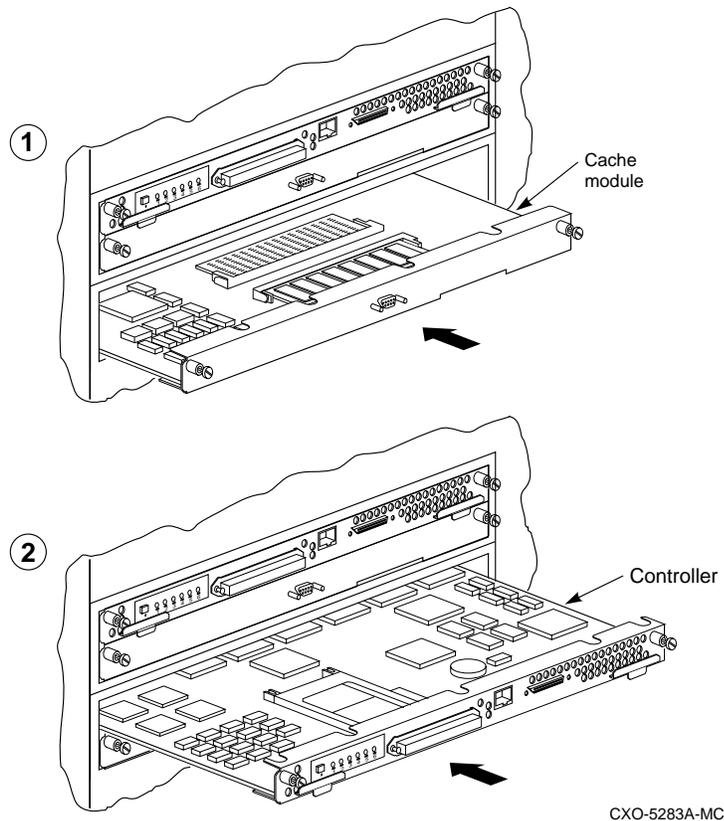
1. Install the replacement cache module into the shelf using the same rails as the removed modules. See Figure 2-23.
2. Install the replacement cache module into the shelf using the same rails as the removed modules. See Figure 2-23.

Figure 2-23 Installing cache and controller module

3. Reinstall the controller module into the shelf using the same controller rails, then tighten the two captive retaining screws on the controller and cache modules. See Figure 2-23.
4. Reconnect the open end of the ECB cable to the cache module. Tighten the battery cable connector mounting screws.
5. Reconnect the power cords to the controller power supplies.

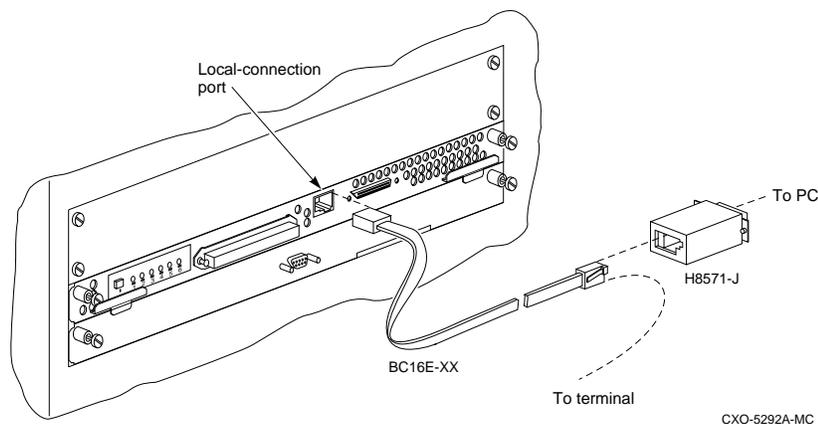
1. For the purpose of this procedure, mark one controller A and the other controller B. This procedure assumes that controller A is connected to the ECB being replaced.
2. Connect a maintenance terminal to controller B. See Figure 2-24.

Figure 2-24 Connecting a maintenance terminal to the controller

```
HSD50> RESTART OTHER_CONTROLLER
```
2. Connect the maintenance terminal to controller A (see Figure 2-24).
3. Press and hold the Reset (//) button on controller A while inserting the program card into Controller A.

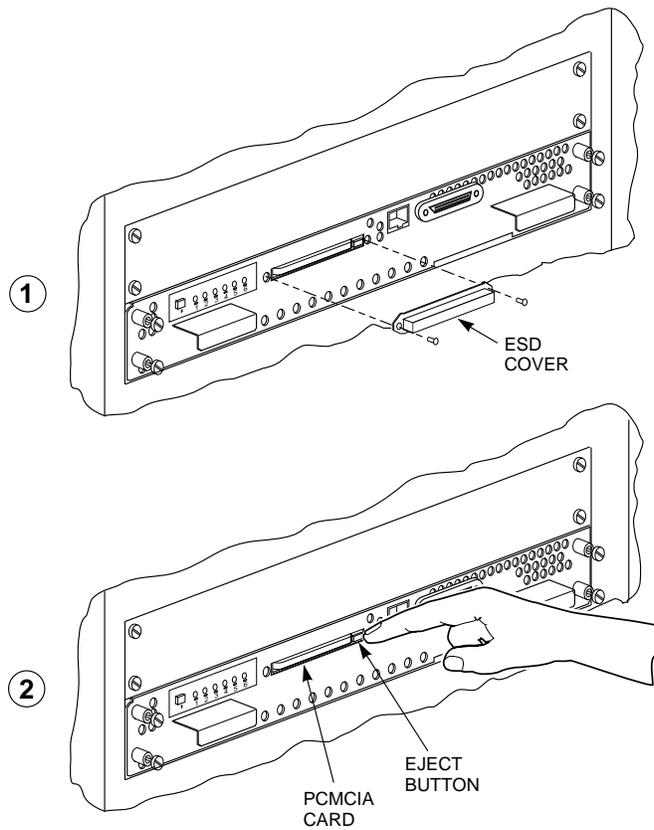
CXO-5174A-MC

9. While pressing and holding the Reset (//) button, eject the program (PCMCIA) card by pushing the eject button next to the card. See Figure 2-25.

Figure 2-25 Removing the program card

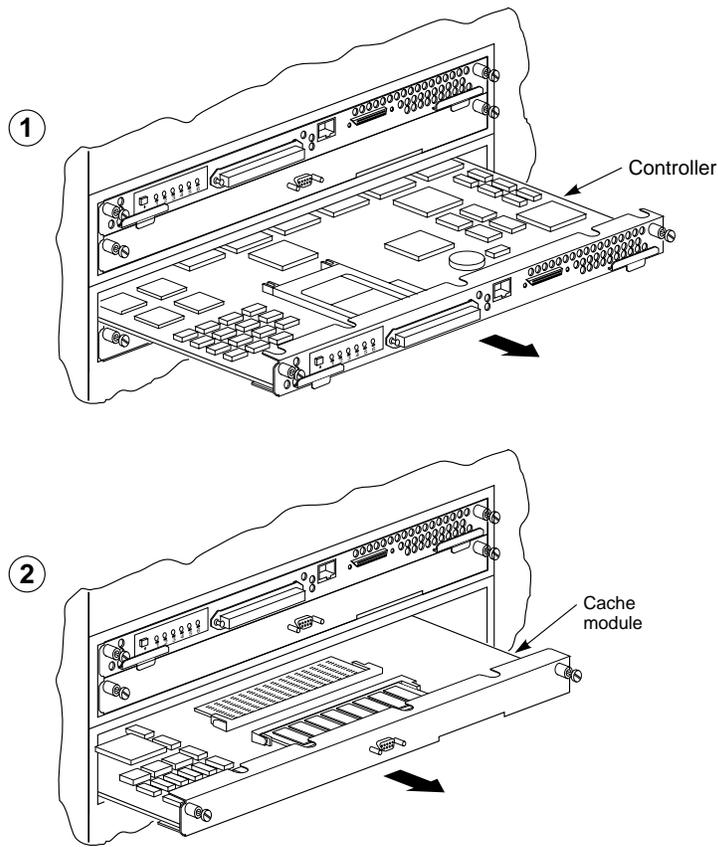
CXO-5284A-MC

11. Slide controller A out of the shelf (note the rails in which the module is seated) and place it on an ESD mat. Do not remove the trilink connector. See Figure 2-26.

Figure 2-26 Removing the controller and cache module

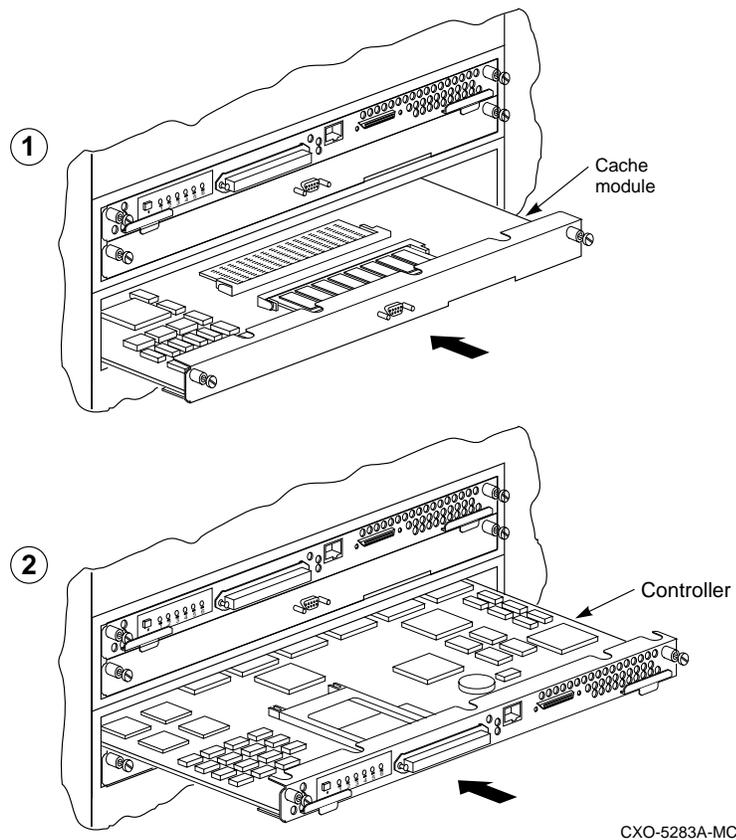
6. Slide the cache module for controller A all the way back into the shelf and push firmly to seat it in the backplane. See Figure 2-28.

Figure 2-28 Reinstalling the cache and controller module

7. Reinstall controller A into its original location. Slide the controller module along the rails and then push firmly to seat it in the backplane. See Figure 2-28.

7. Install controller B. Slide the controller module along the rails and then push firmly to seat it in the backplane. See Figure 2-28.
8. Tighten the front bezel captive screws on the cache module and the controller module.
9. Press **Return** on the maintenance terminal attached to controller A.
10. Wait for the following text to be displayed on the maintenance terminal:

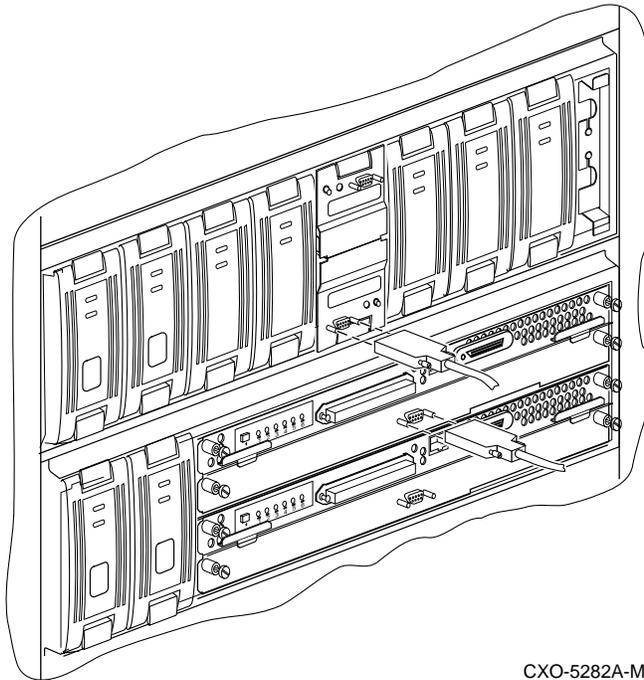
CXO-5282A-MC

12. Pull the cache module for controller B out of the shelf far enough to disconnect it from the backplane. It is not necessary to remove the cache module completely from the shelf.
13. Disconnect the cable from the ECB which is mounted in the same SBB as the failed ECB, and connect it to the second ECB in the new SBB.

Figure 2-29 ECB Cable Connection

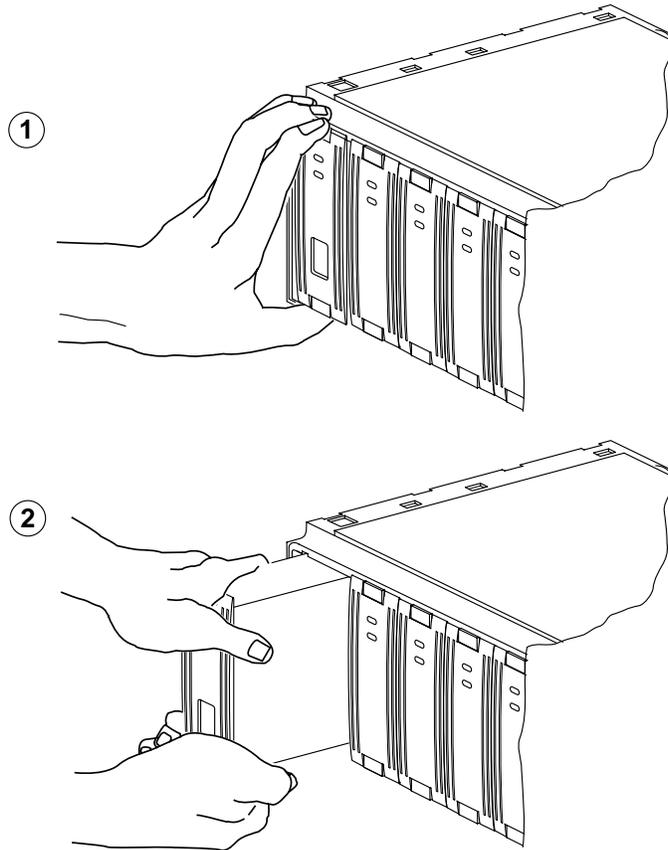
CXO-5228A-MC

```
HSD50> SHUTDOWN OTHER_CONTROLLER
HSD50> SHUTDOWN THIS_CONTROLLER
```
3. Disconnect the power cord from the power supply.
4. Press the two mounting tabs together to release the power supply from the shelf and partially pull it out of the shelf. See Figure 2-30.
5. Use both hands to pull the power supply out of the shelf.

Figure 2-30 Removing the power supply

1. Press the two mounting tabs together to release the power supply from the shelf and partially pull it out of the shelf. See Figure 2-30.
2. Use both hands to pull the power supply out of the shelf.
3. Firmly push the power supply into the shelf until the mounting tabs snap into place.
4. Reconnect the power cord to the power supply.

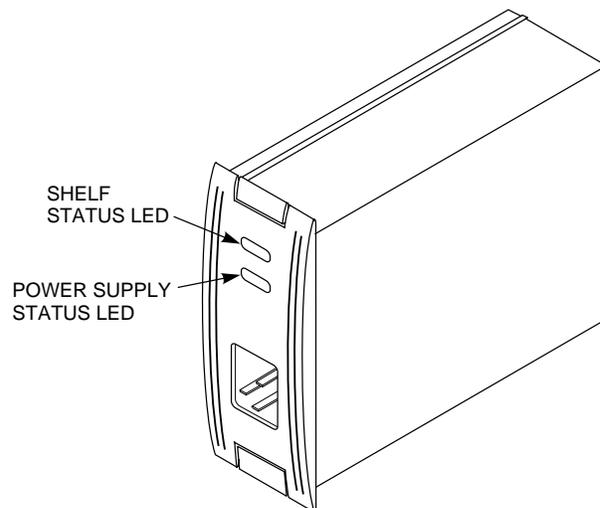
Figure 2-31 The power supply status indicators

1. Firmly push the power supply into the shelf until the mounting tabs snap into place.
2. Reconnect the power cord to the power supply.
3. Observe the power and shelf status indicators to make sure they are on. If the status indicators are not on, refer to the installation section, tables 46 and 47 of this manual. See Figure 2-31.

5. Observe the power and shelf status indicators to make sure they are on. If the status indicators are not on, refer to the installation section, tables 46 and 47 of this manual. See Figure 2-31.

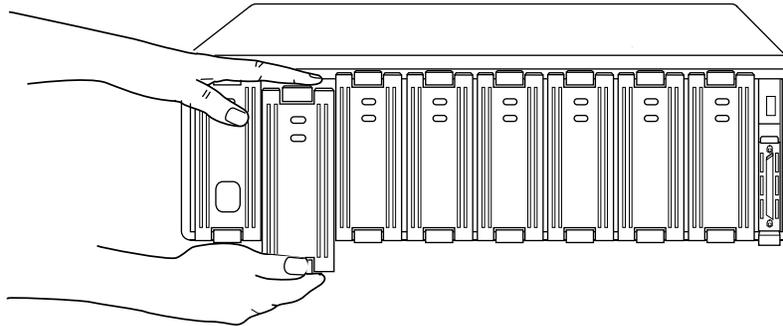
Figure 2-32 Removing a disk drive

1. Press the two mounting tabs together to release the disk drive from the shelf and partially pull it out of the shelf. See Figure 2-32.

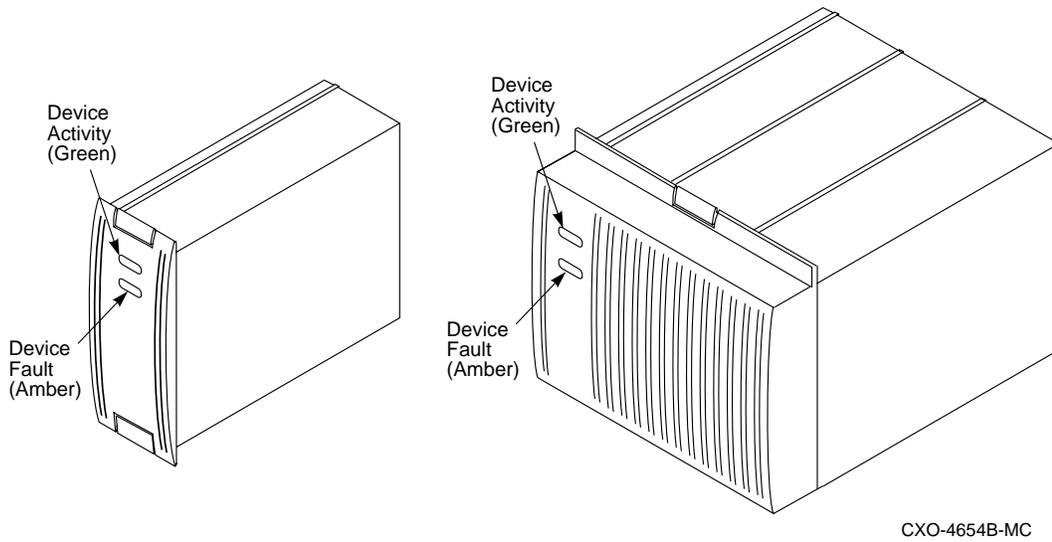
Figure 2-33 Status indicators for 3.5- and 5.25-inch SBBs

2. Using both hands, pull the disk drive out of the shelf. Notice that the corresponding port LED is flashing.
3. When the port LED stops flashing, align the replacement disk drive with the shelf rails.
4. Push the disk drive all the way into the shelf until the locking tabs snap into place.
5. Observe the status indicator for the following indications. See Figure 2-33.
 - The device fault (amber) LED is off.

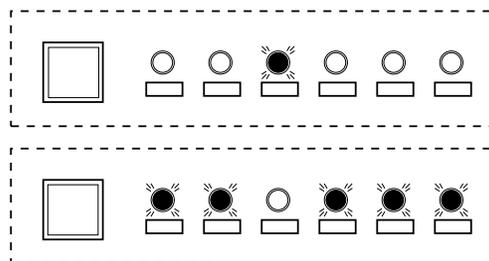
1. Halt all I/O activity to the appropriate port using the using the required procedure for your operating system.
2. Quiesce the port by pressing the OCP button for that port.
3. When the OCP LEDs flash in an alternating pattern the device port is quiesced. For example, when you quiesce device port three and I/O has halted, the OCP LEDs are flashing in an alternating pattern as shown in the following illustration. The flashing LEDs are represented by the dark circles with lines radiating from them.

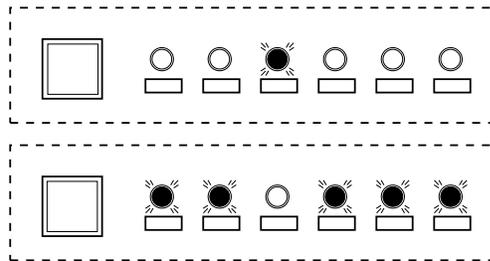
6. Check and match, if necessary, the SCSI address of the failed tape drive to the replacement drive.
7. Quiesce the port again. Look for the following OCP indicators. The flashing LEDs are represented by the dark circles with lines radiating from them.

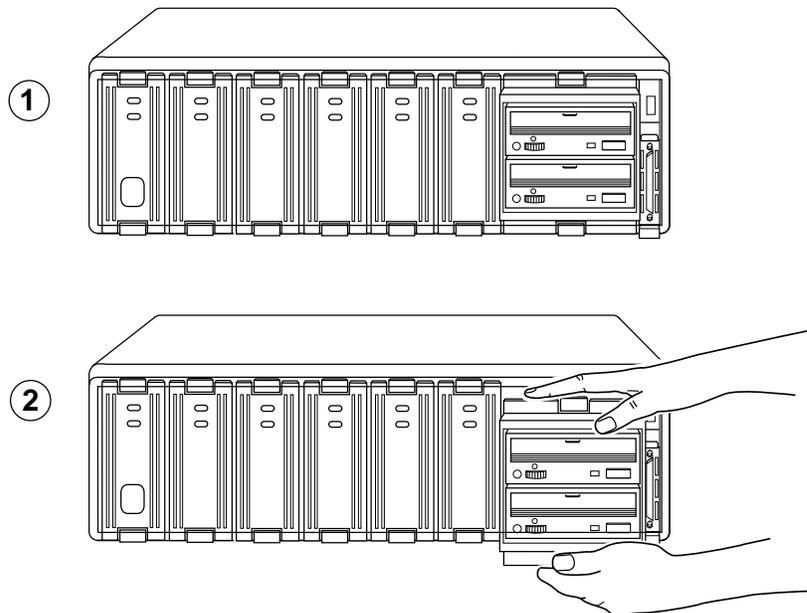
Figure 2-34 Removing a CD-ROM drive

```
HSD50> SHUTDOWN OTHER_CONTROLLER  
HSD50> SHUTDOWN THIS_CONTROLLER
```
4. Remove the power cords from the shelf that contains the failed solid-state disk drive, optical or CD-ROM drive.
5. Press the two mounting tabs together to remove the storage building block (SBB) from the shelf (see Figure 2-34).

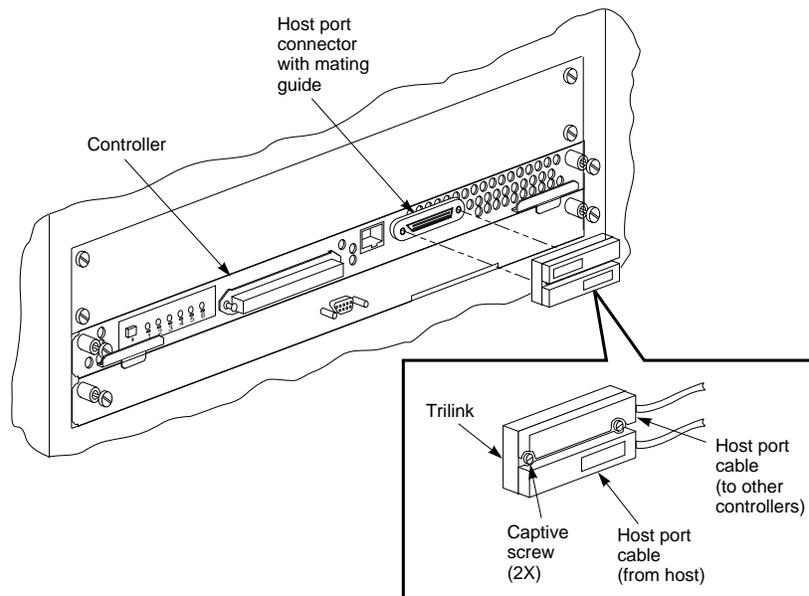
Figure 2-35 Disconnecting the DSSI host cable

1. Halt all I/O activity using the appropriate procedures for your operating system.
2. Dismount all units using the procedures for your operating system.
3. Disconnect the DSSI host cable from the host or other device.
4. Use a small flat-head screwdriver to loosen the captive screws on the trilink connector at the controller's front bezel. Disconnect the cable from the trilink connector. See Figure 2-35.

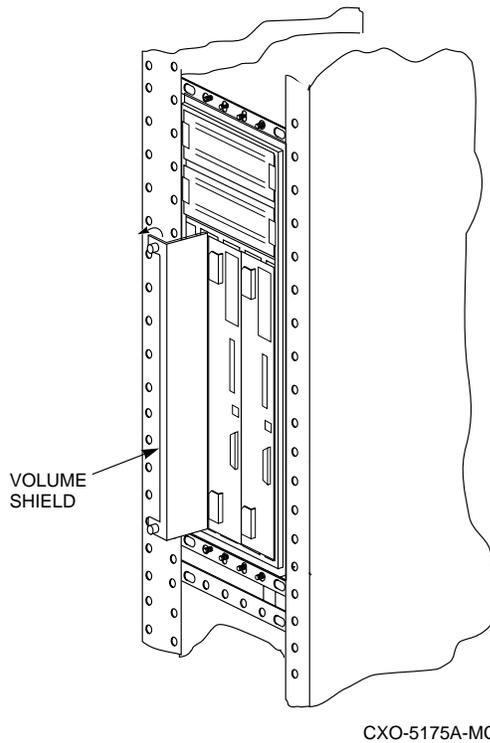
Figure 2-36 Removing the volume shield

1. Halt all I/O activity to the controller, using the appropriate procedures for your operating system.
2. Dismount all units using the appropriate procedures for your operating system.
3. Remove each controller and cache module using the Replacing Cache Module procedures in this manual.
4. Use a flat-head screwdriver to loosen the two captive screws on each side of the volume shield and remove the shield (see Figure 2-36).

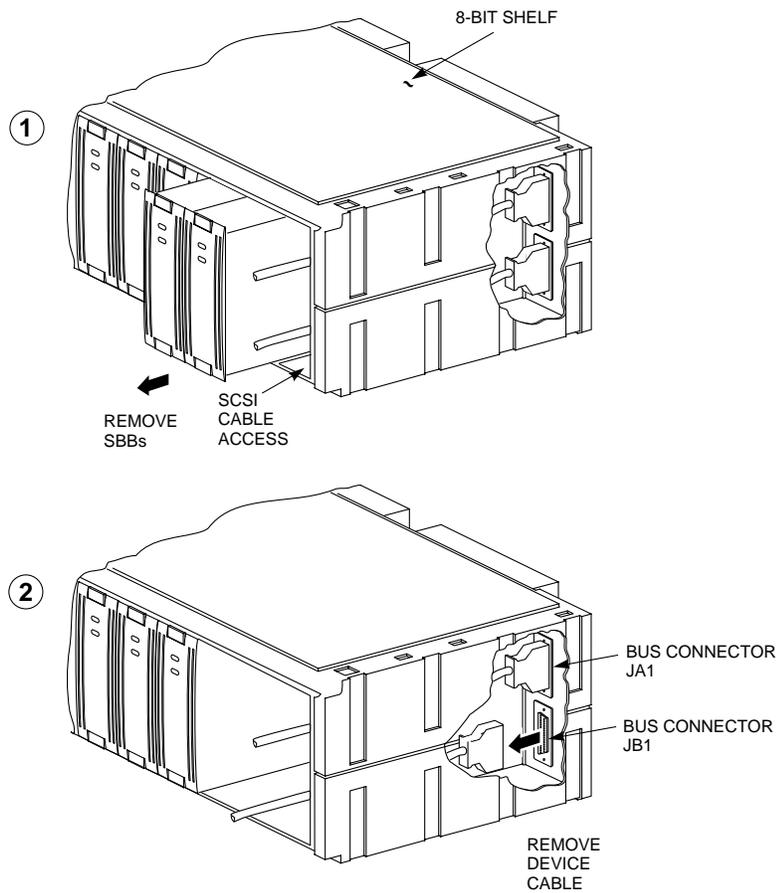
Figure 2-37 Access to the SCSI cables

6. Before removing the disk drives from the shelf, let the drive spin down for at least 30 seconds. Gyroscopic motion from a spinning disk may cause you to drop and damage the disk.
7. Remove any SBBs necessary to gain access the SCSI cable. See Figure 2-37.

8. Remove the failed cable from the device shelf backplane by pinching the cable connector side clips and disconnecting the cable. See Figure 2-37.
9. To install a new SCSI device port cable at the device shelf, gently slide the cable connector in from one side to the other, and rock the connector to help seat it. Listen for the connector to snap into the place. Take care not to bend any connector pins.

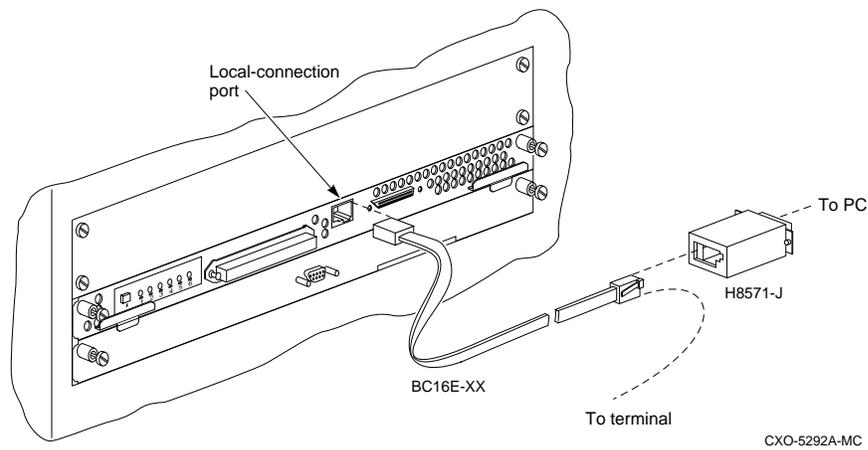
Figure 3-1 Connecting a maintenance terminal to the controller

1. Connect a maintenance terminal to the controller. See Figure 3-1.

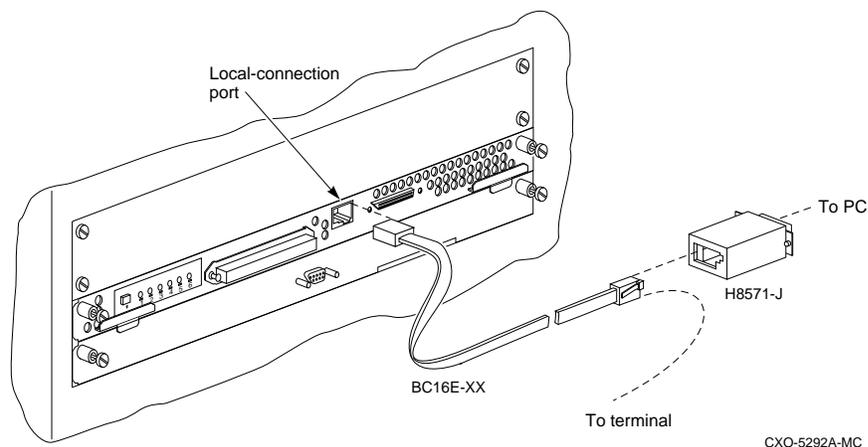
Figure 3-2 Connecting a maintenance terminal to the controller

1. Obtain the appropriate patch data for your controller's firmware version from your Digital Equipment Corporation representative.
2. Connect a maintenance terminal to the controller. See Figure 3-2.
