DIGITAL StorageWorks
HSD50 Array Controller

H5OF Version 5.1
Service Manual

Part Number: EK-HSD50-SV.B01

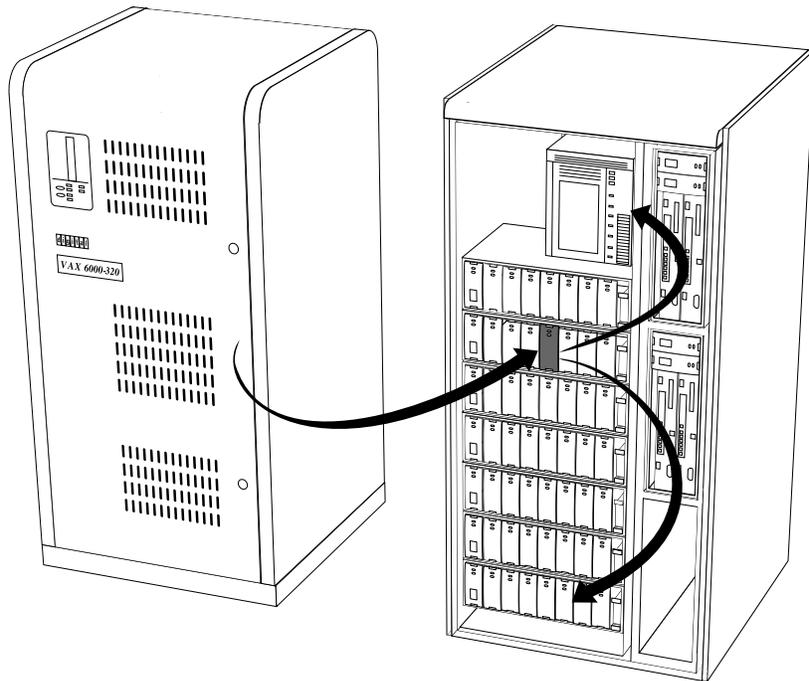
Installing new firmware on a disk or tape drive is a two-step process as shown in Figure 3-3. First, you copy the new firmware from your host to a disk drive in your subsystem, then use HSUTIL to distribute the firmware to devices in your subsystem.

**Figure 3-3 Copy the firmware to a disk drive in your subsystem, then distribute it to the devices you want to upgrade.**

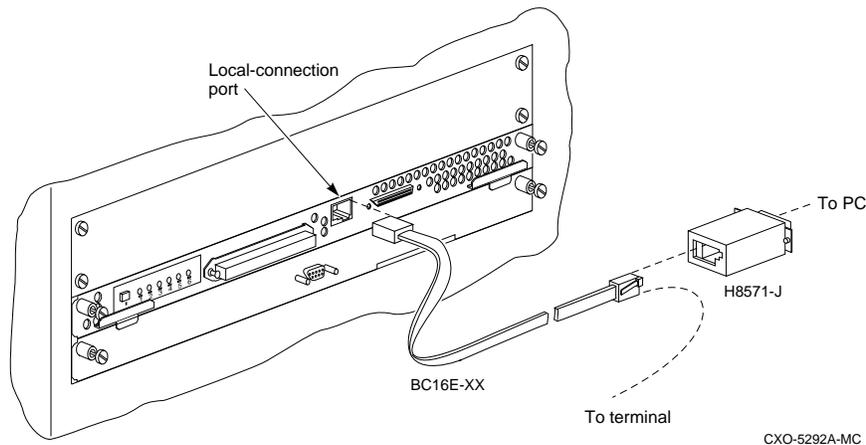
**Figure 3-4 Connecting a maintenance terminal to the controller**

- Connect a maintenance terminal to the controller. See Figure 3-4.

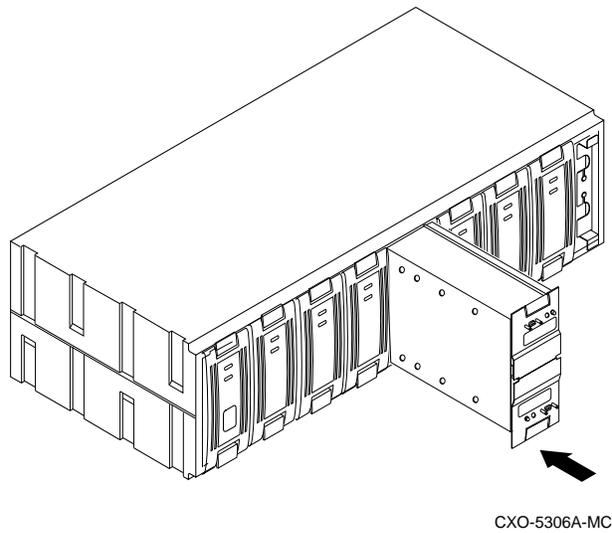
**Figure 3-5 Installing an SBB battery module**

5. Install an SBB battery module into a convenient device slot. See Figure 3-5.

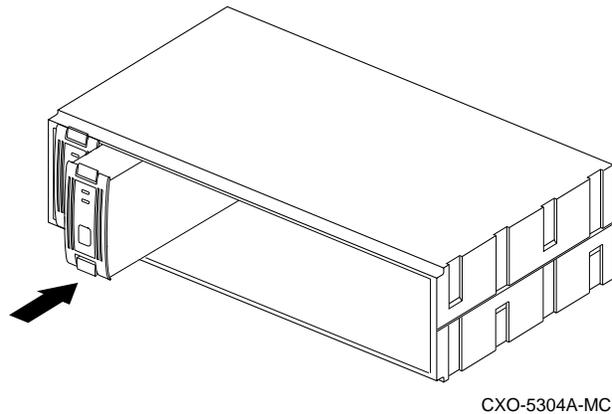
**Figure 3-6 Installing power supplies into the controller shelf**

6. Install the controller power supplies into the controller shelf. See Figure 3-6.

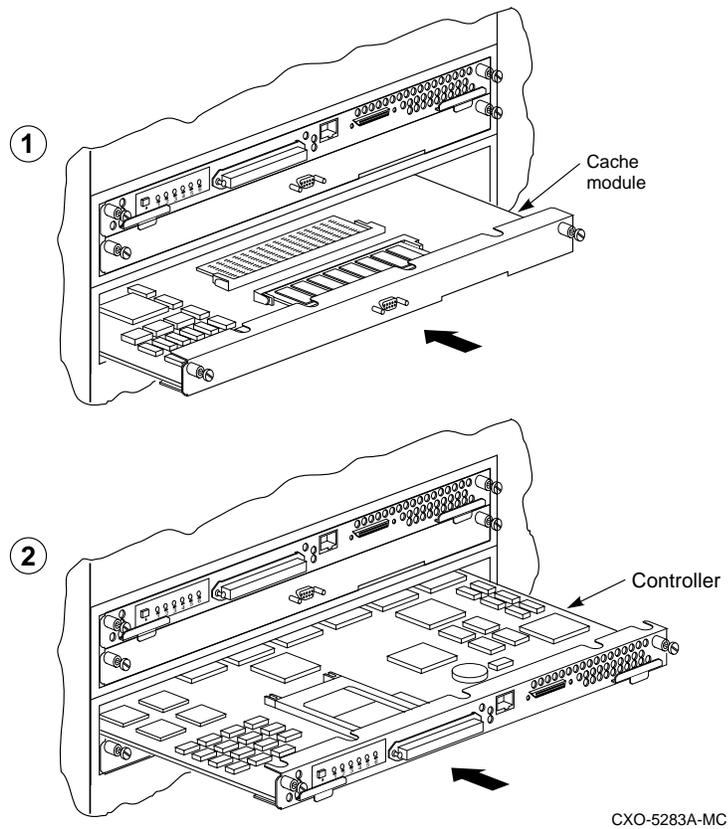
**Figure 3-7 Installing a single controller (SW500 cabinet)**

7. Slide the cache module into the controller shelf. Push the module firmly into the slot until it is seated. See Figure 3-7.

8. Install the controller module into the shelf slot that corresponds to SCSI ID7. See Figure 3-7 and Figure 3-8.

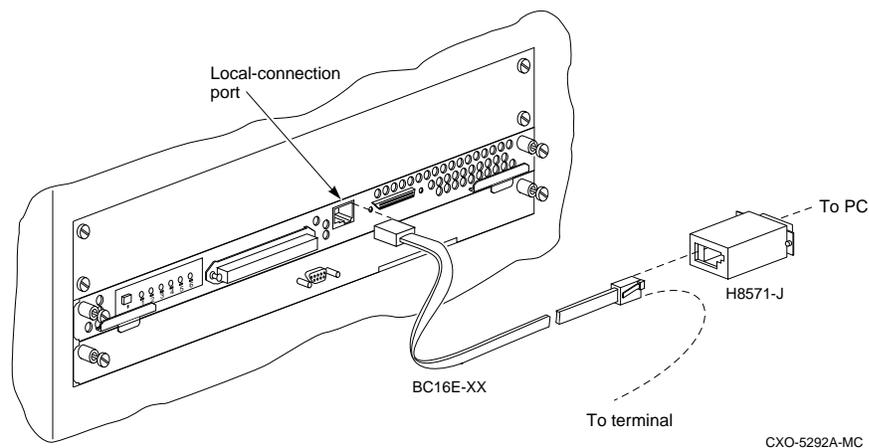
**Figure 3-9 Connecting a maintenance terminal to the controller**

1. Connect a maintenance terminal to the operating controller. See Figure 3-9.

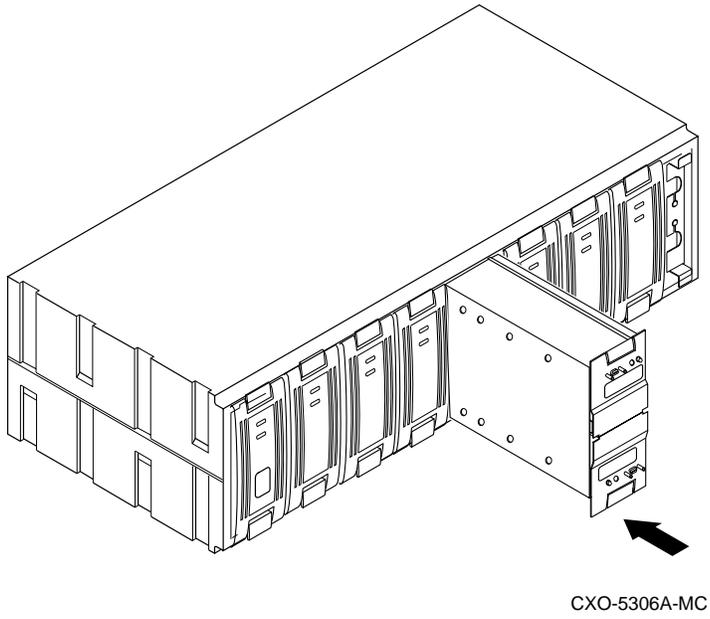
**Figure 3-10** Installing an SBB Battery module

11. Install an SBB battery module into a convenient device slot. See Figure 3-10.

- a) Press the shutdown button on the single ECB until the LED stops flashing.
- b) Remove the ECB cable from the single ECB.
- c) Remove the single ECB from the device slot.
- d) Install the dual ECB into the device slot.

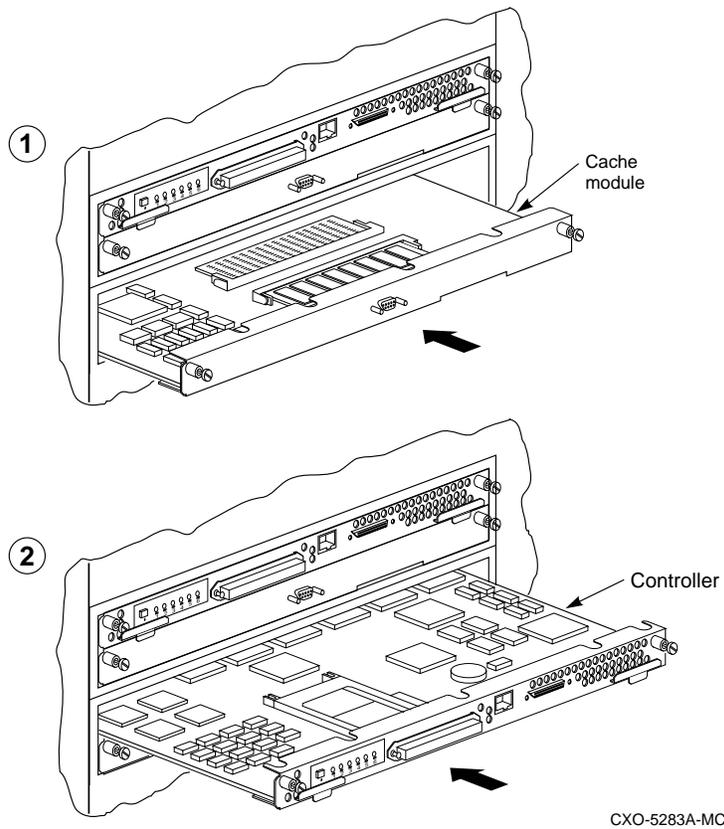
**Figure 3-11 Installing the second controller and cache module**

- Slide the cache module into the appropriate slot in the controller shelf. Push the module firmly into the slot until it is seated. See Figure 3-11.

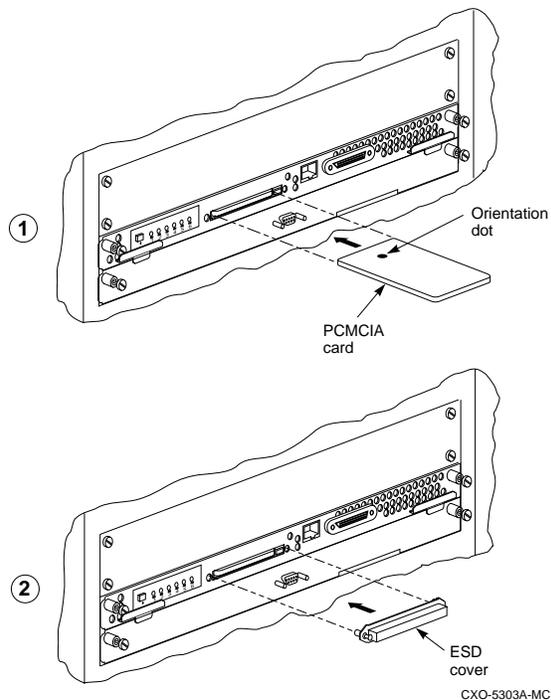
**Figure 3-12 Inserting the program card**

19. Press and hold the Reset button (//) while reinserting the program card. Release the Reset button. The controller will initialize and perform all internal self tests. See Figure 3-12.

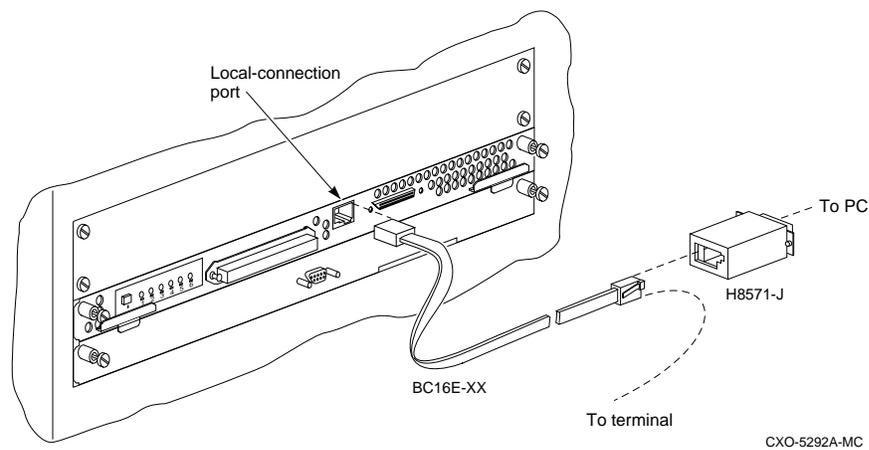
**Figure 3-13 Connecting a maintenance terminal to the controller**

1. Have the new module at hand. The module should be factory-fresh or should have been shut down cleanly (with the SHUTDOWN command) in its last application.
2. Connect a maintenance terminal to the existing controller. See Figure 3-13.

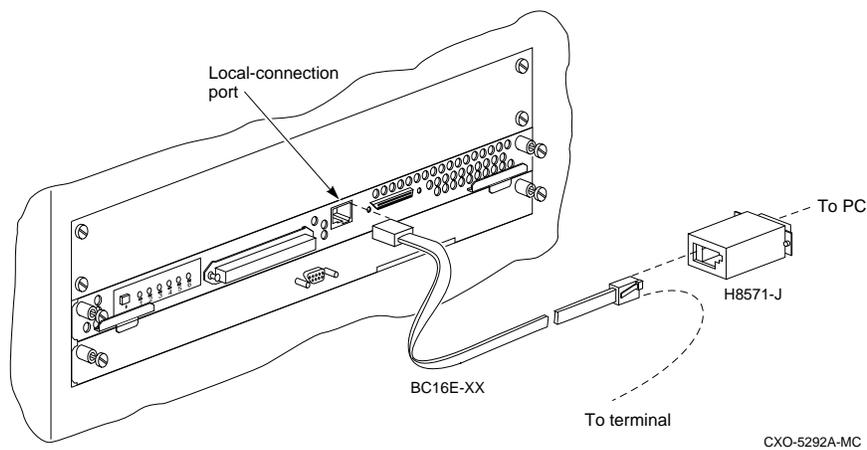
**Figure 3-14 Connecting a maintenance terminal to the controller**

1. Connect a maintenance terminal to the controller. See Figure 3-14.

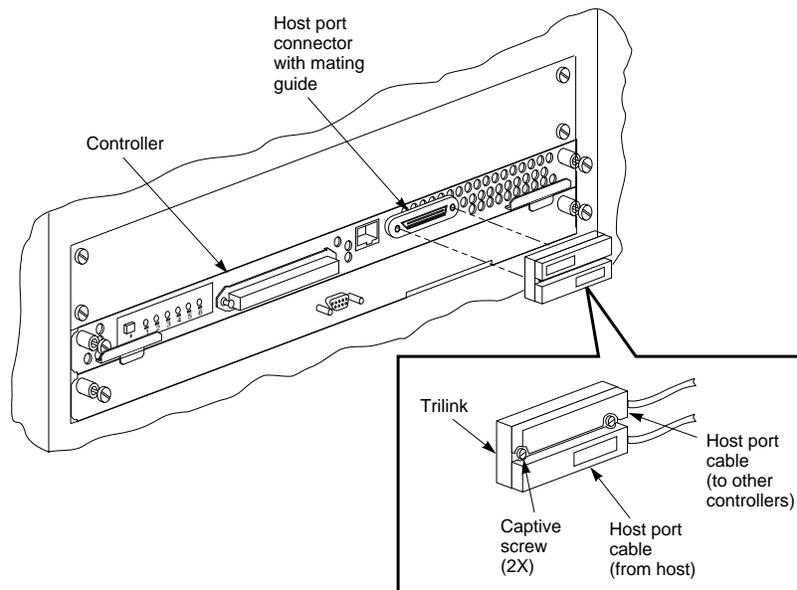
**Figure 3-15 Disconnecting the trilink adapter**

```
CLI> SHUTDOWN THIS_CONTROLLER
```
4. After the controller has shut down, remove the maintenance terminal cable and remove power cables from the controller shelf.
5. Obtain and place an ESD wrist strap around your wrist. Ensure that the strap fits snugly around your wrist.
6. Attach or clip the other end of the ESD strap to the cabinet grounding stud or a convenient cabinet grounding point (nonpainted surface).
7. With a small flat-head screw driver, loosen the captive screws on the trilink connector of the controller. Do not disconnect the host cable from the trilink connector. See Figure 3-15.

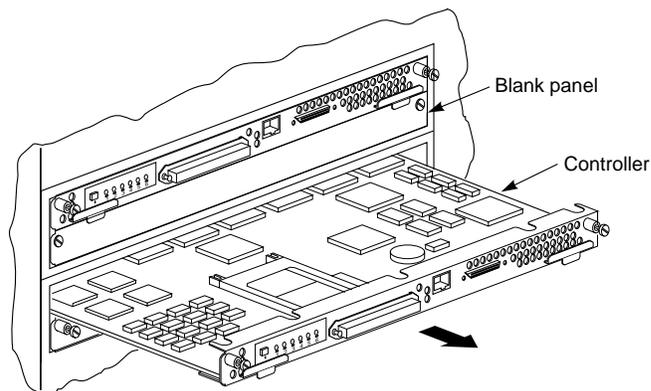
**Figure 3-16 Removing controller modules**

8. Use a gentle rocking motion to loosen the controller modules.
9. Slide the controller modules out of the shelf and place them on an ESD mat. See Figure 3-16.

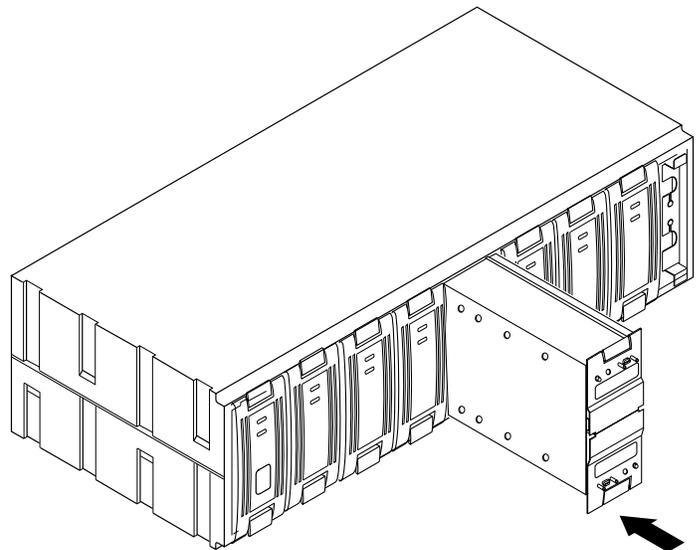
**Figure 3-17 Installing an SBB battery module**

1. Install the SBB battery module into a convenient device shelf slot. See Figure 3-17.

- a) Press the shutdown button on the single ECB until the LED stops flashing.
- b) Remove the ECB cable from the single ECB.
- c) Remove the single ECB from the device slot.
- d) Install the dual ECB into the device slot.

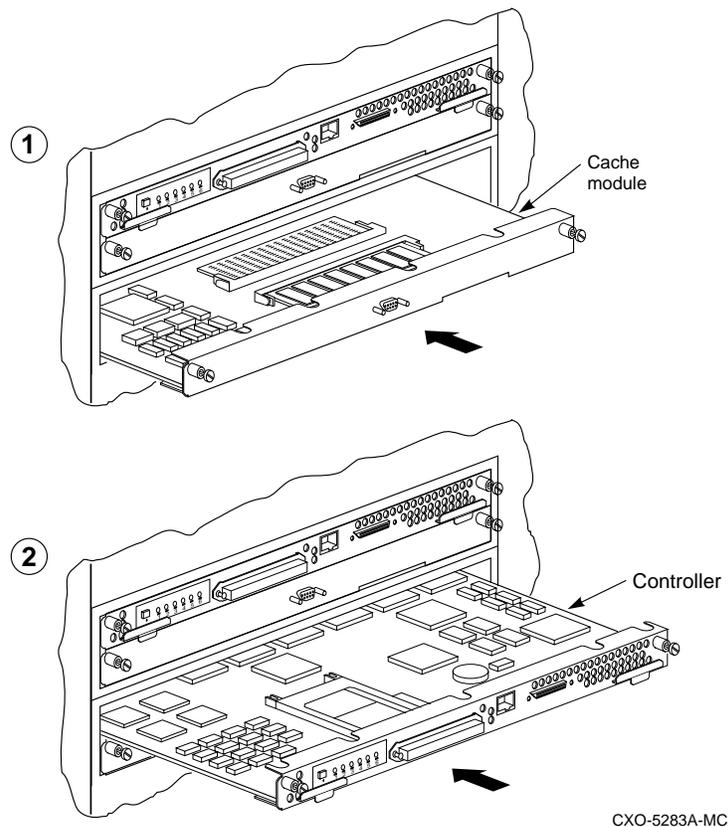
**Figure 3-18 Installing the cache and controller modules**

2. Slide the write-back cache module into the appropriate slot. Push the module firmly into the slot until it is seated. See Figure 3-18.

3. Reinstall the controller module into its original slot. Push the module firmly into the slot until it is seated. See Figure 3-18.
4. Tighten the front panel captive screws on the controller and cache module. Do not over tighten.
5. Connect the ECB battery cables starting at the cache modules.

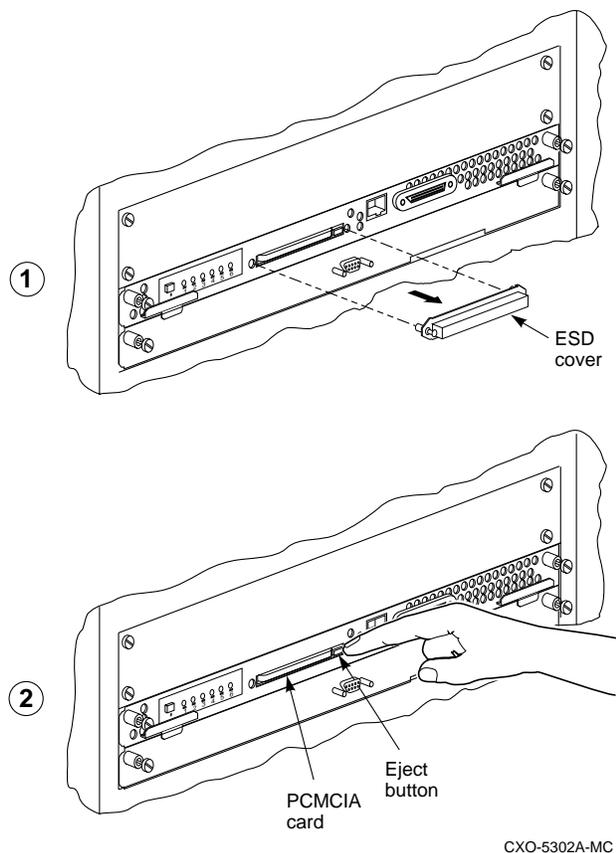
**Figure 3-19 Removing the program card**

1. Unsnap and remove the program card ESD cover.
2. Remove the program card from the controller by pressing in and holding the Reset (//) button, then pressing the eject button next to the program card.

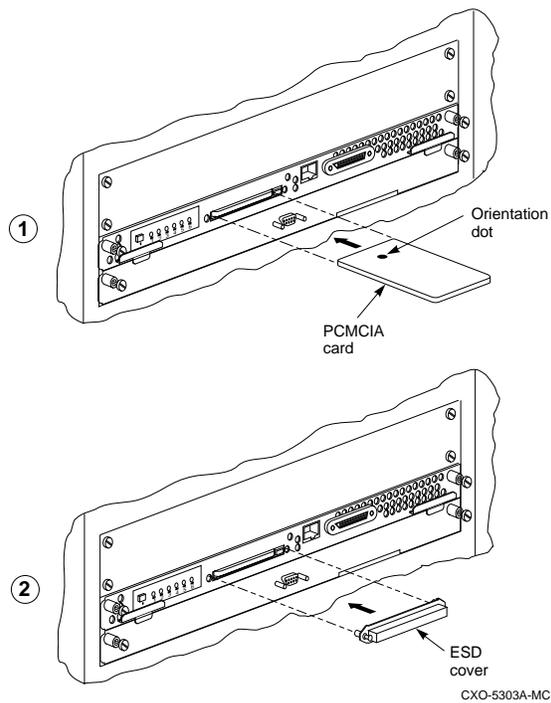
**Figure 3-20 Installing the program card**

3. Reconnect power cords to the controller power supplies.
4. Press and hold the Reset button (//) on each controller while reinserting the program card. Release the Reset button. The controller will initialize and perform all internal self tests. See Figure 3-20.

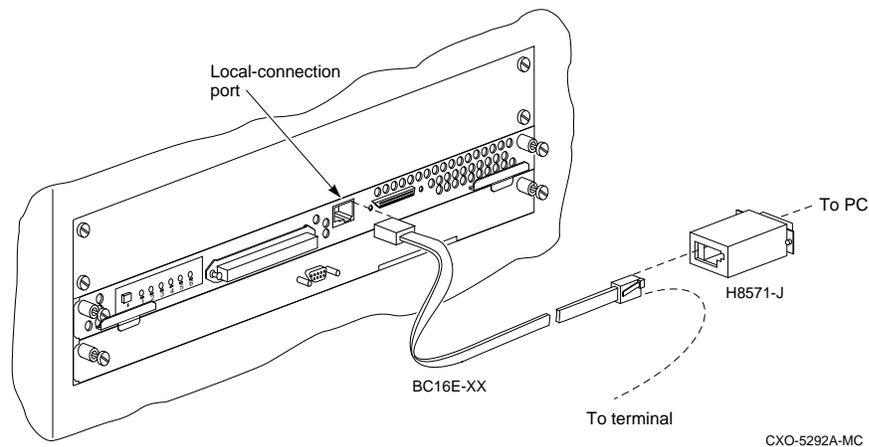
**Figure 3-21 Connecting a maintenance terminal to the controller**

1. Connect a maintenance terminal to the controller. See Figure 3-21.

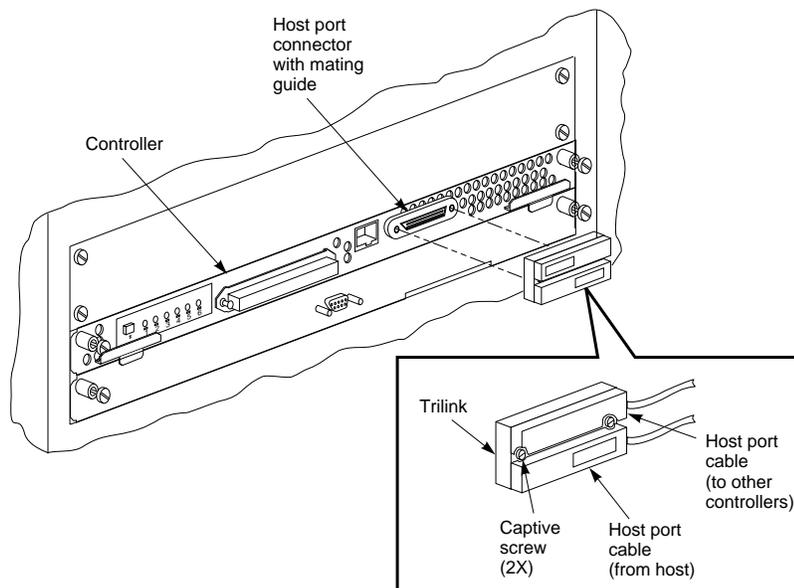
**Figure 3-22 Disconnecting the trilink**

9. Disconnect the ECB cable from the SBB battery module.
10. With a small flat-head screw driver, loosen the captive screws on the trilink adapter of each controller and remove the trilink adapters. Do not remove the host cables from the trilink adapters. See Figure 3-22.

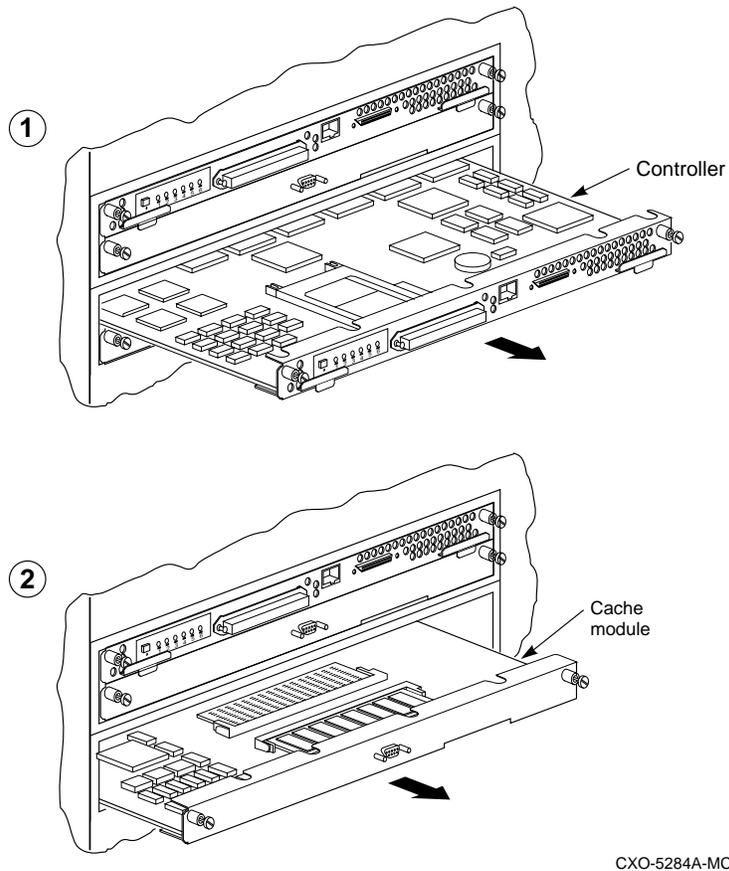
**Figure 3-23 Removing controller and cache modules**

11. Use a gentle rocking motion to loosen the controller modules.

- Slide the controller modules out of the shelf and place them on a ESD mat. See Figure 3-23.

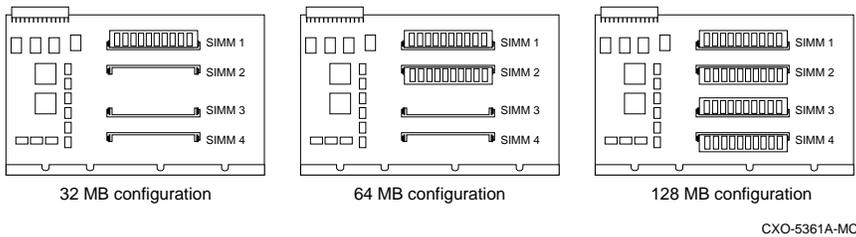
**Figure 3-24 Cache configurations for cache version 3**

- Refer to Table 3-11 and install as many SIMM cards into each cache module as are required (up to 4x32MB maximum). The cache board is marked by SIMM slot numbers as shown in Table 3-11.

Figure 3-24 shows all possible cache configurations.

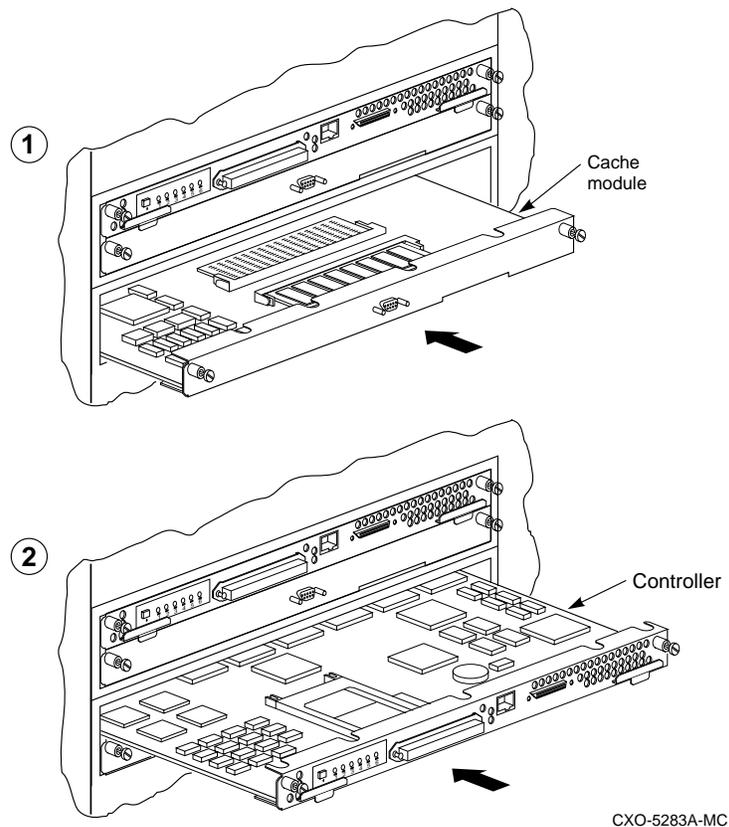
**Figure 3-25 Installing the controller and cache module**

- Reinstall the cache modules into the controller shelf.
- Reinstall the controller modules into their original slots. Use a gentle rocking motion to help seat the module. If you are using a single controller configuration, use the slot that is designated SCSI ID 7. See Figure 3-25.

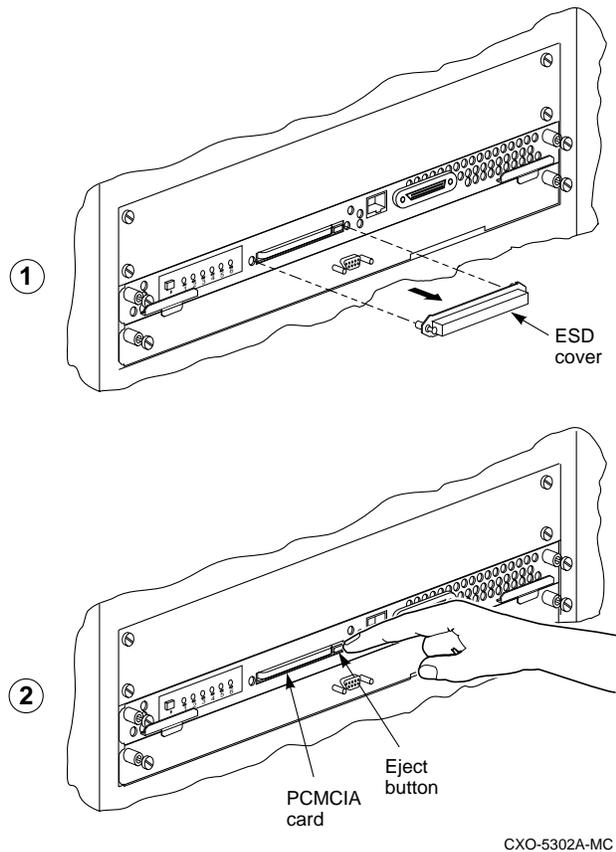
**Figure 3-26 Removing the program card**

17. Connect one end of the battery cable to the cache module and the other end to the ECB.
18. Tighten the ECB cable mounting screws.
19. Tighten the two front panel captive screws on the cache module and the two captive screws on the controller module.
20. Remove the program cards from each controller. See Figure 3-26.

21. Reconnect the power cords to the controller power supplies.
22. Press and hold the Reset button (//) on each controller while pushing in the program card.
23. The controllers will initialize.  
When the reset light on each controller flashes at a rate of once every second, the initialization process is complete.
24. Snap the ESD cover into place over each program card. Push the pins inward to lock the covers in place.

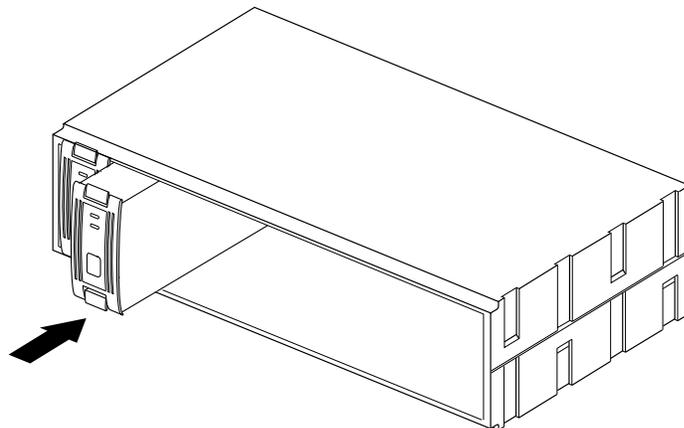
**Figure 3-27 Installing a power supply SBB**

1. Firmly push the power supply into the shelf until the mounting tabs snap into place. See Figure 3-27.

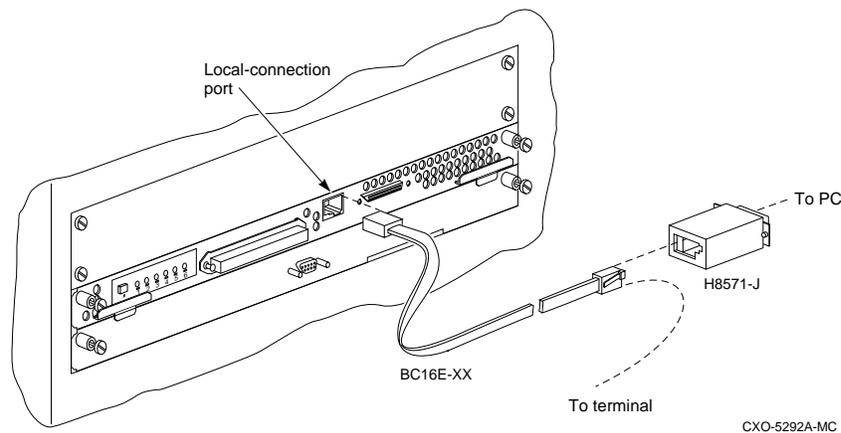
**Figure 5-1 Connecting a maintenance terminal to the controller**

1. Connect a maintenance terminal to one of the controllers. See Figure 5-1.

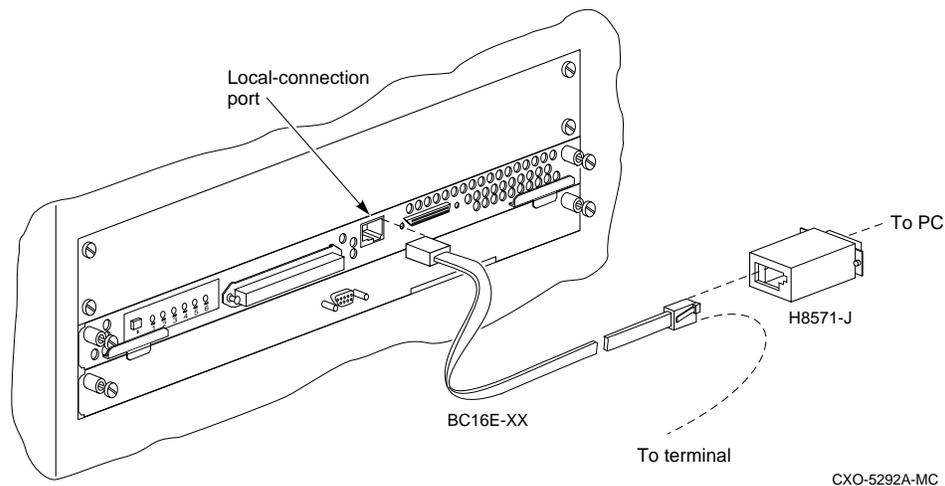
**Figure 5-2 Connecting a maintenance terminal to the controller**

1. Connect a maintenance terminal to the controller to be removed. See Figure 5-2.

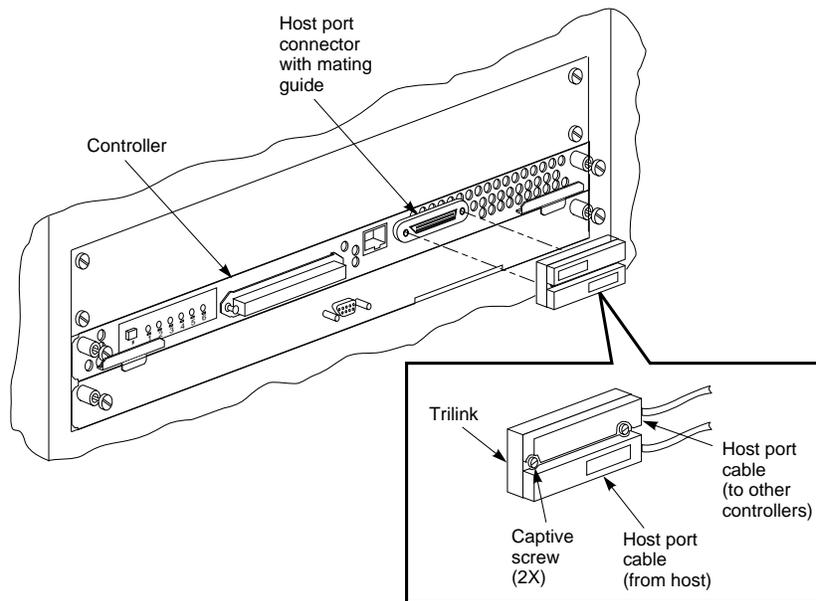
**Figure 5-3 Disconnecting the tralink connector**

3. Ensure that the controller has shutdown cleanly. Check for the following indications on the controller's OCP (operator control panel).
  - The Reset (//) light is on.
  - Port lights 1, 2, 3 are continuously lit.
4. With a small flat-head screwdriver, loosen the captive screws that secure the tralink to the controller. See Figure 5-3.

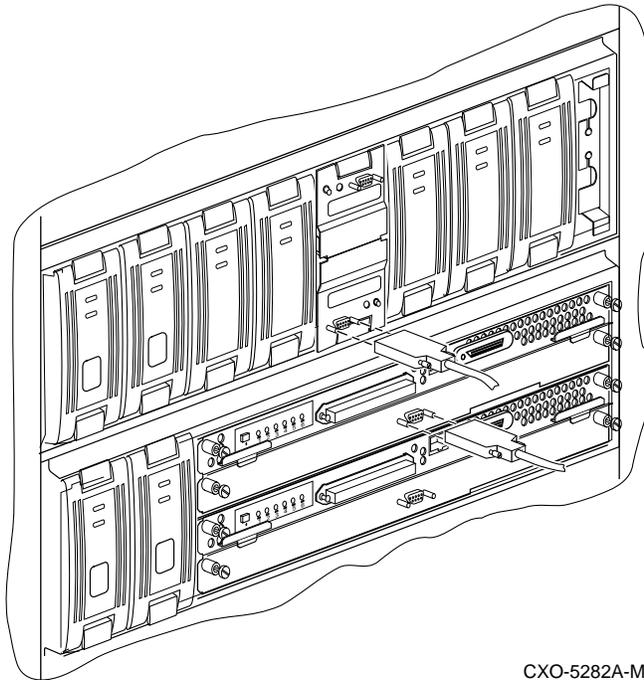
**Figure 5-4 Removing the ECB cables**

7. Disconnect the ECB cables (see Figure 5-4).

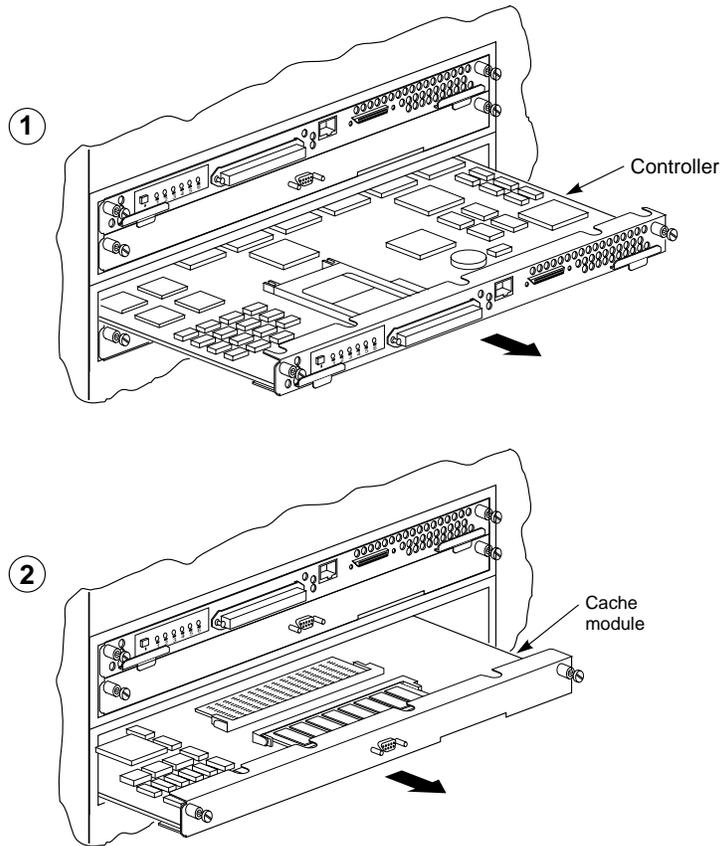
**Figure 5-5 Removing the controller and cache module**

8. Loosen the captive screws on the controller and cache module's front bezel.
9. Obtain and place an ESD wrist strap around your wrist. Ensure that the strap fits snugly around your wrist.
10. Attach the other end of the ESD strap to the cabinet grounding stud or a convenient cabinet grounding point (non-painted surface).
11. Slide the controller out of the shelf. See Figure 5-5. Place the controller in an ESD bag.

12. If required, slide the cache module out of the shelf. See Figure 5-5. Place the cache module in an ESD bag.
13. Remove the ECB and store it with the cache module.

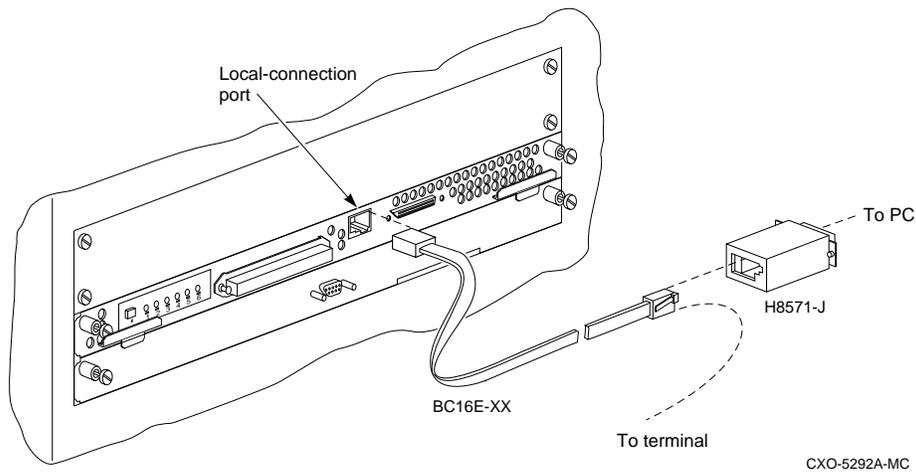
**Figure 5-7 Connecting a maintenance terminal to the controller**

1. Connect a maintenance terminal to the controller (see Figure 5-7).

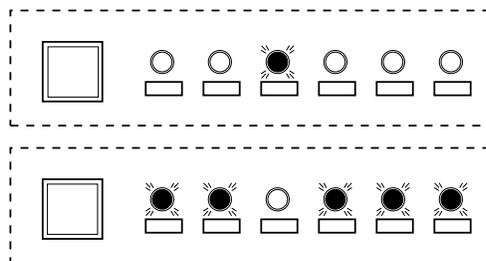
1. Halt all I/O activity to the tape drive using the appropriate procedures for your operating system.
2. Quiesce the appropriate device port by pushing the device port button on the controller's OCP (operator control panel).
3. When the OCP LEDs flash in an alternating pattern the device port is quiesced. For example when you quiesce device port 3 and I/O has halted, the OCP LEDs are flashing in an alternating pattern as shown below. The flashing LEDs are represented by the dark circles with lines radiating from them.
