DIGITAL StorageWorks HSJ50 Array Controller

HSOF Version 5.1 Service Manual

Part Number: EK-HSJ50-SV.B01

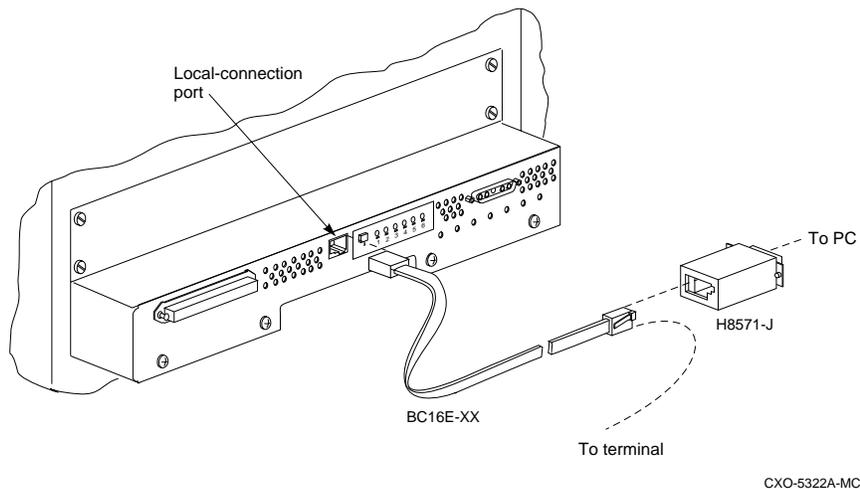
**Figure 2-1 Connecting a maintenance terminal to the controller**

3. Connect a maintenance terminal to the controller that you are *not* replacing. See Figure 2-1.

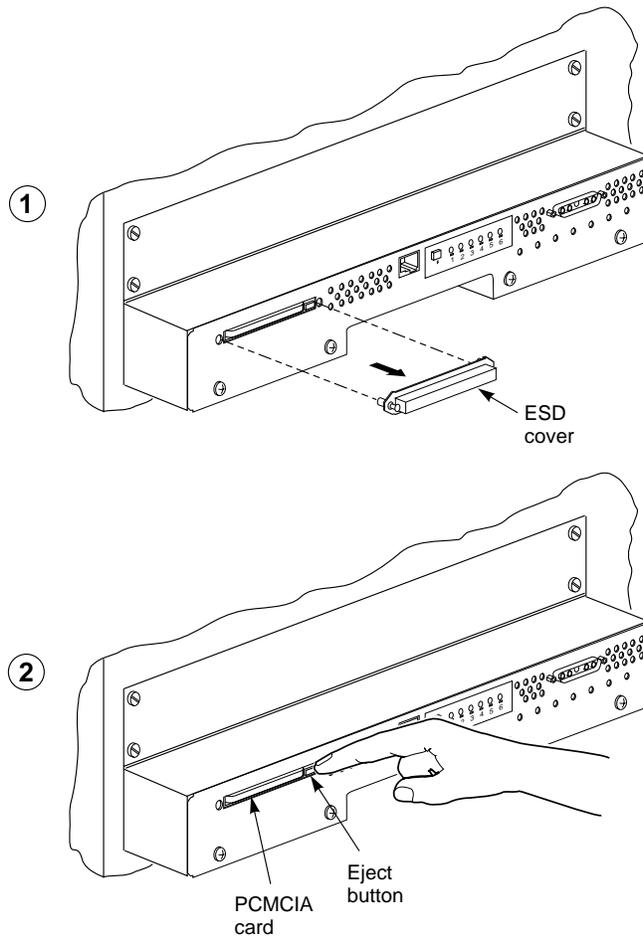
Figure 2-2 Removing the program card

14. Figure 2-2. Pull the card out and save it for use in the replacement controller module.

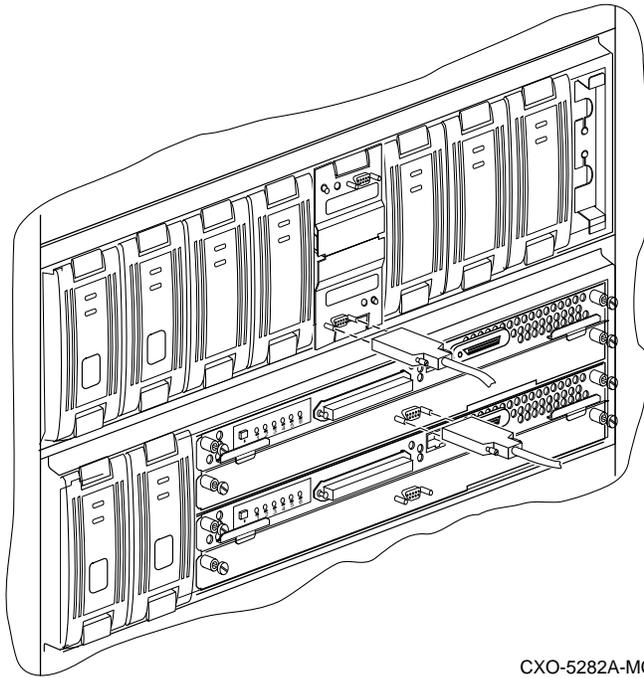
**Figure 2-3 Disconnecting the ECB cable**

6. Disconnect the ECB cable from the cache module. Disable the ECB by pressing the battery disable switch until the LED goes out. See Figure 2-3.

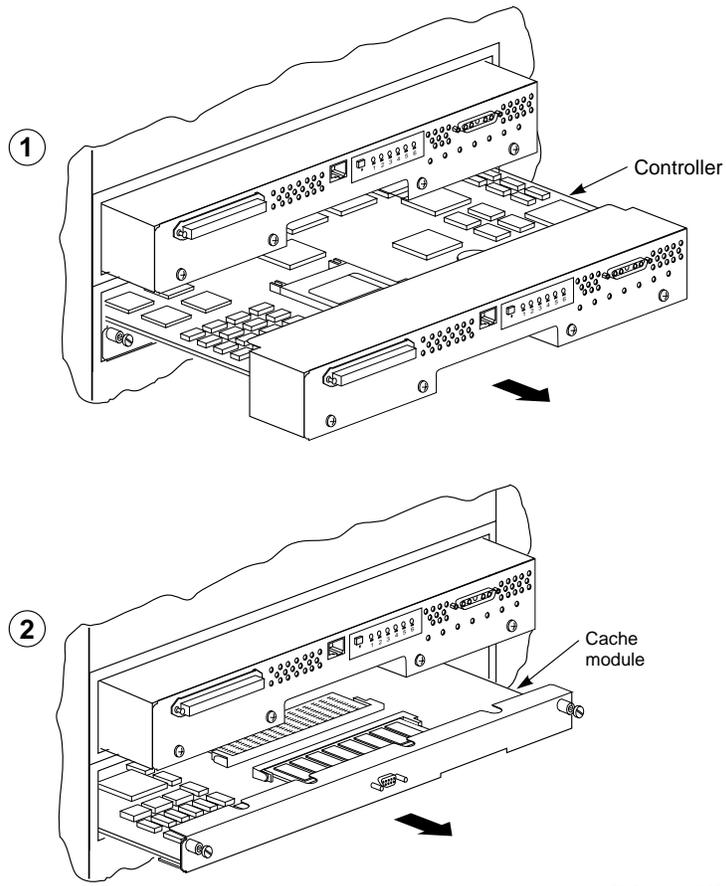
Figure 2-4 Removing the controller and cache modules

7. Slide the controller and cache modules out of the shelf. Note in which rails the module was seated and place the modules on an ESD mat. See Figure 2-4.

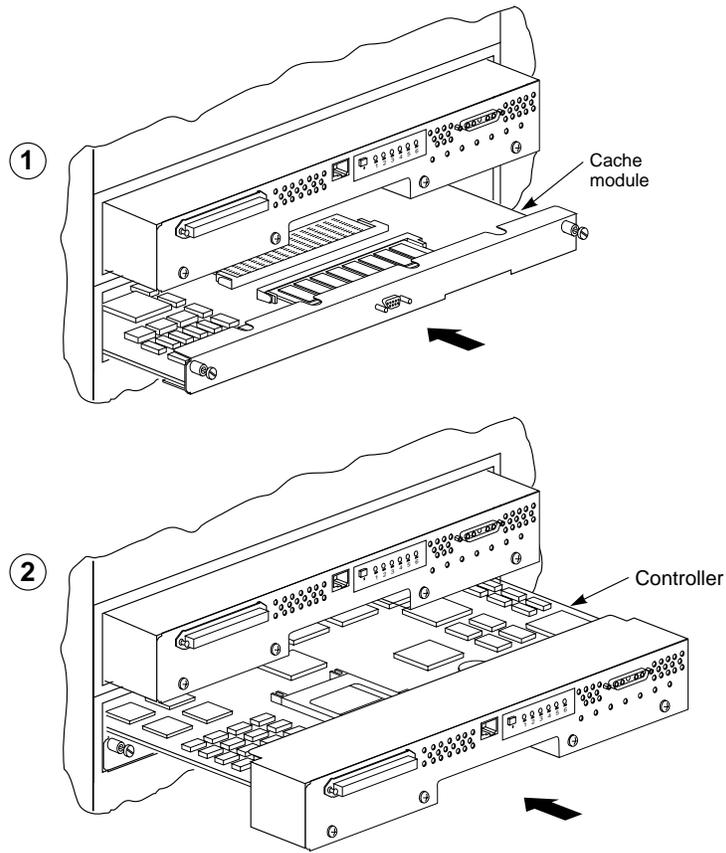
**Figure 2-5 Installing the new cache and controller module**

6. If necessary, install the cache module. Slide the module straight in along the rails and then push firmly to seat it in the backplane. See Figure 2-5.

7. Slide the module straight in along the rails and then push firmly to seat it in the backplane. See Figure 2-5.

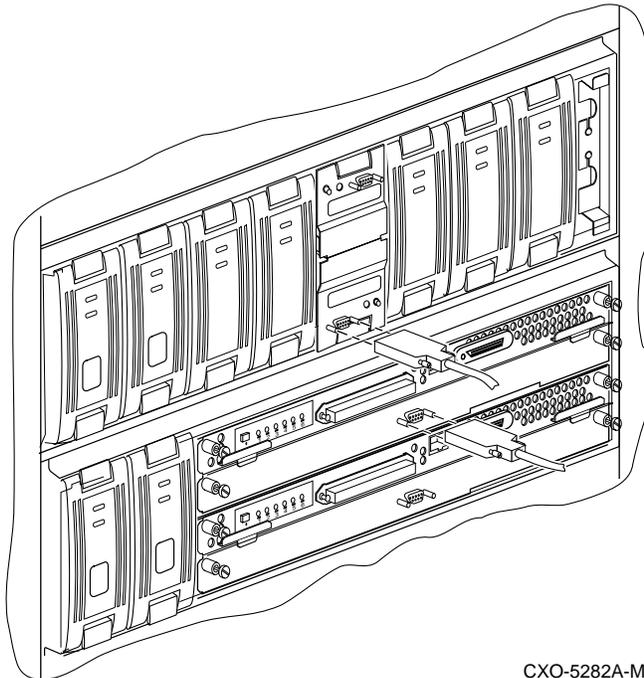
**Figure 2-6 Reconnecting the ECB cable**

8. Tighten the two front panel captive screws on the controller and cache module.
9. Reconnect the CI cable to the controller's front panel.
10. Reconnect the open end of the ECB cable to the cache module. Tighten the ECB cable captive screws. See Figure 2-6.

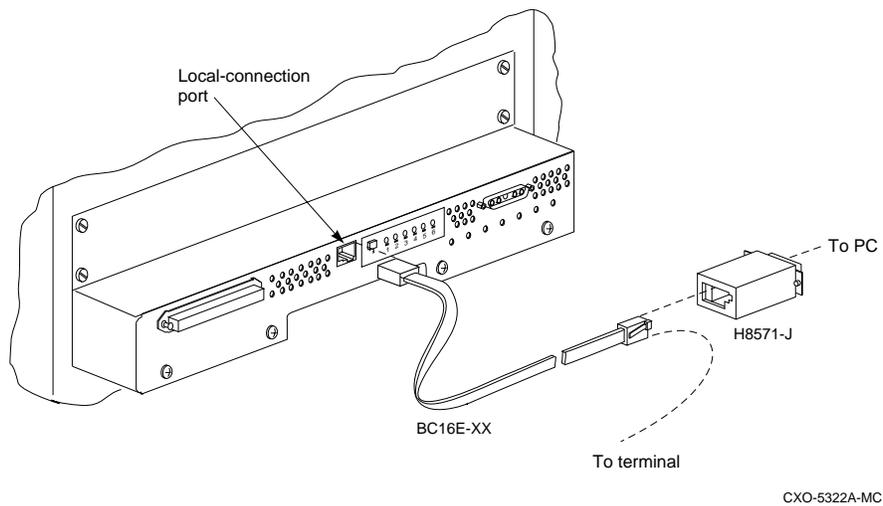
**Figure 2-7 Connecting a maintenance terminal to the controller**

1. If the controller is still or partially functioning, connect a maintenance terminal to the controller. See Figure 2-7.

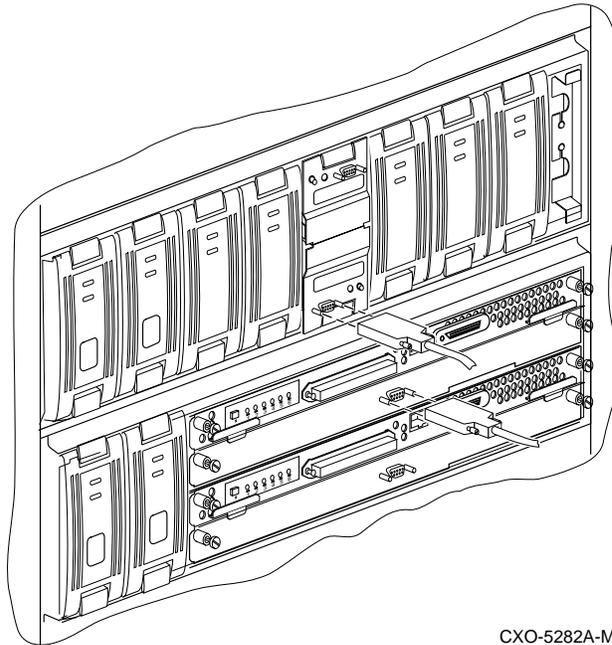
**Figure 2-8 Disconnecting the ECB cable**

- The Reset (//) light is lit continuously.
  - Port lights 1, 2, 3, are also lit continuously.
3. Obtain and place an ESD wrist strap around your wrist. Ensure that the strap fits snugly around your wrist.
  4. Attach or clip the other end of the ESD wrist strap to the cabinet grounding stud or a convenient cabinet grounding point.
  5. Remove the power cords from the controller power supplies.
  6. Disable the ECB switch by pressing the battery disable switch on the battery module front panel. See Figure 2-8.

7. Disconnect the ECB cable from the cache module. See Figure 2-8.
8. Unsnap and remove the program card ESD cover. See Figure 2-9.

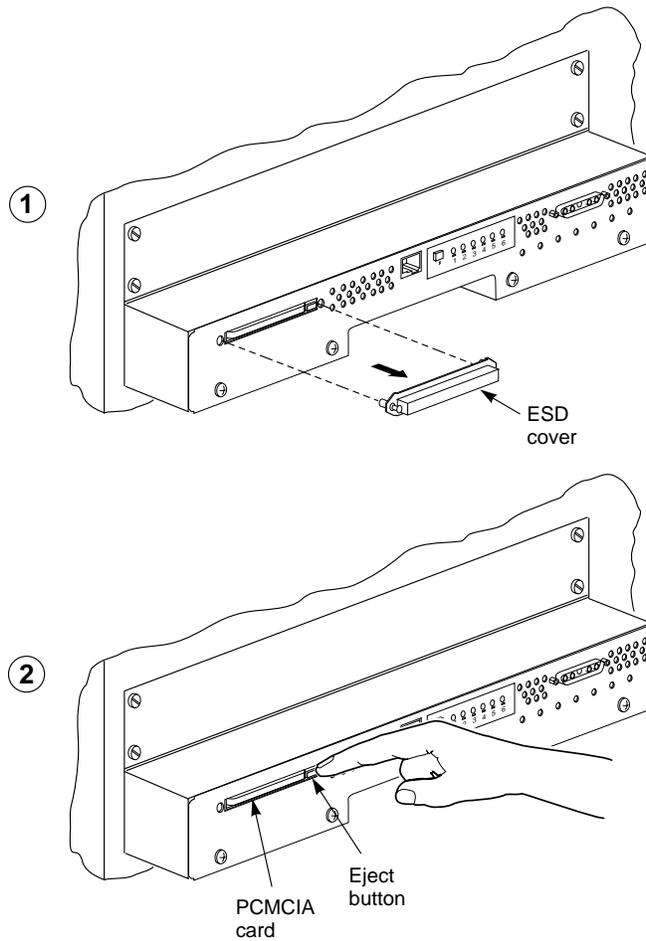
**Figure 2-9 Removing the program card**

9. Remove the program card by pressing and holding in the Reset button, then pressing the eject button next to the card. See Figure 2-9. Pull the card from the controller module. Save the program card for the replacement controller.

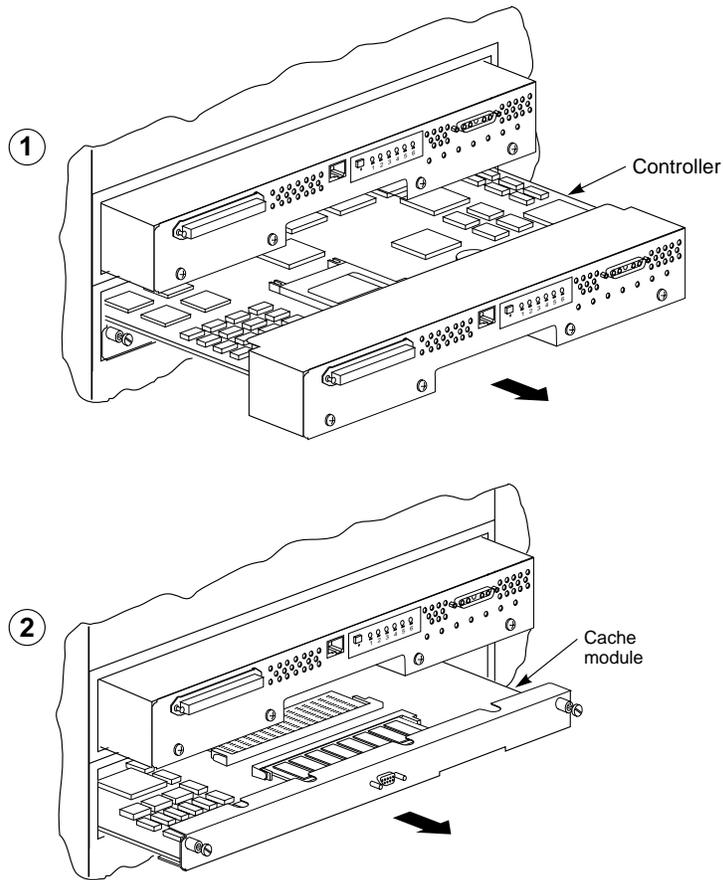
**Figure 2-10 Removing the controller and cache module**

11. Loosen the two captive retaining screws at each corner of the controller's front bezel.
12. Use a gentle rocking motion to loosen the controller module from the shelf backplane.
13. Slide the controller module out of the shelf and place it on an ESD mat. See Figure 2-10.
14. If you are also removing the cache module, loosen the captive screws at each corner of the cache module's front bezel. Use a gentle rocking motion to loosen the cache from the shelf backplane.
15. Slide the cache module out of the shelf. See Figure 2-10.

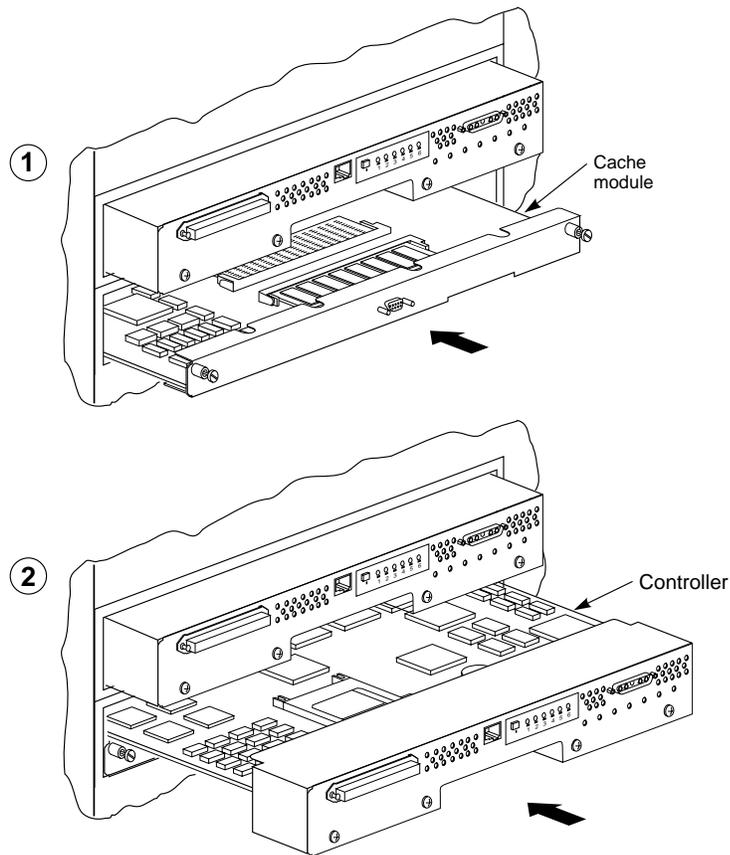
**Figure 2-11 Installing the new cache and controller modules**

1. If required, install the replacement cache module into the shelf. See Figure 2-11.

2. Slide the new controller module into the shelf using the same rails as the removed module. See Figure 2-11.

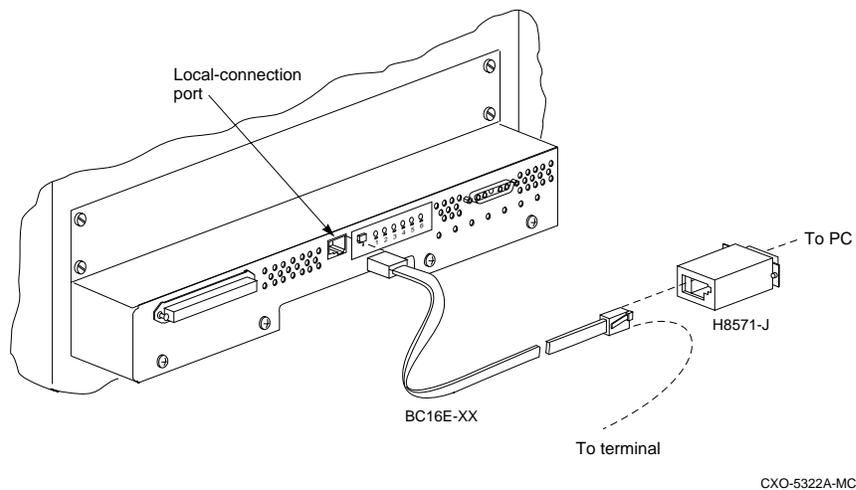
**Figure 2-12 Connecting a maintenance terminal to the controller**

1. Determine that one controller is still operating properly.
2. If the controller you are removing is partially functioning, connect a maintenance terminal to the controller. If the controller has failed, connect a maintenance terminal to the other controller. See Figure 2-12.

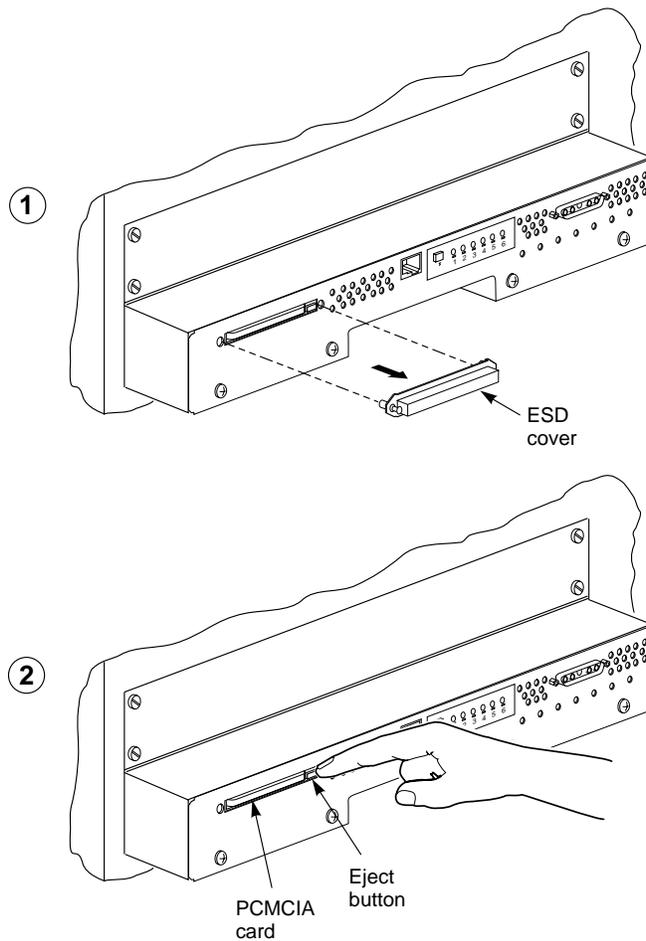
**Figure 2-13 Removing the program card**

6. Attach or clip the other end of the ESD wrist strap to the cabinet grounding stud or a convenient cabinet grounding point.
7. Unsnap and remove the program card ESD cover. See Figure 2-13.

8. Remove the program card by pressing and holding in the Reset button, then pressing the eject button next to the card. See Figure 2-13. Pull the card out and save it for use in the replacement controller module.

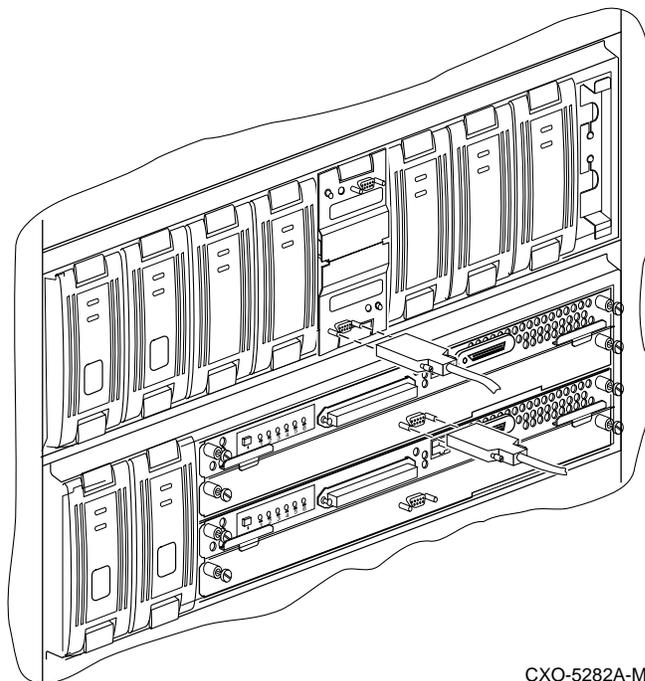
**Figure 2-14 Disconnecting the ECB cable**

9. With a small flat-head screwdriver, remove the CI connector from the controller's front panel.
10. Disconnect the ECB cable from the cache module. While holding the battery cable in one hand, disable the ECB by pressing the battery disable switch. See Figure 2-14.

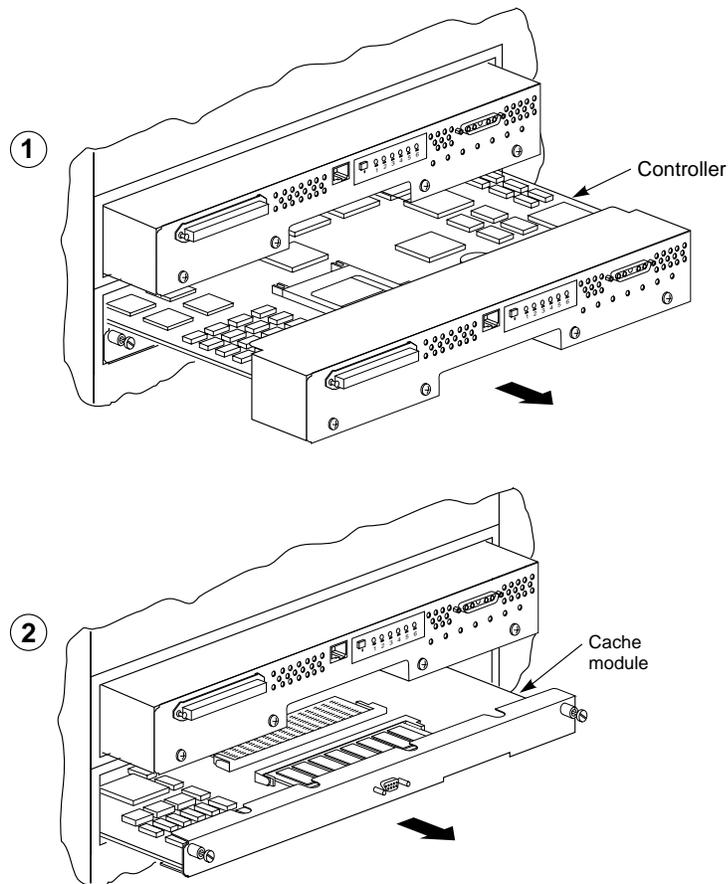
**Figure 2-15 Removing the controller and cache modules**

11. Loosen the front bezel captive screws on the controller and cache module.
12. Use a gentle rocking motion to loosen the controller module from the shelf backplane.
13. Slide the controller module out of the shelf (noting which rails the module was seated in) and place it on an approved ESD mat. See Figure 2-15.
14. If necessary remove the cache module and note in which rails it was seated. Place the module on an approved ESD mat. See Figure 2-15.

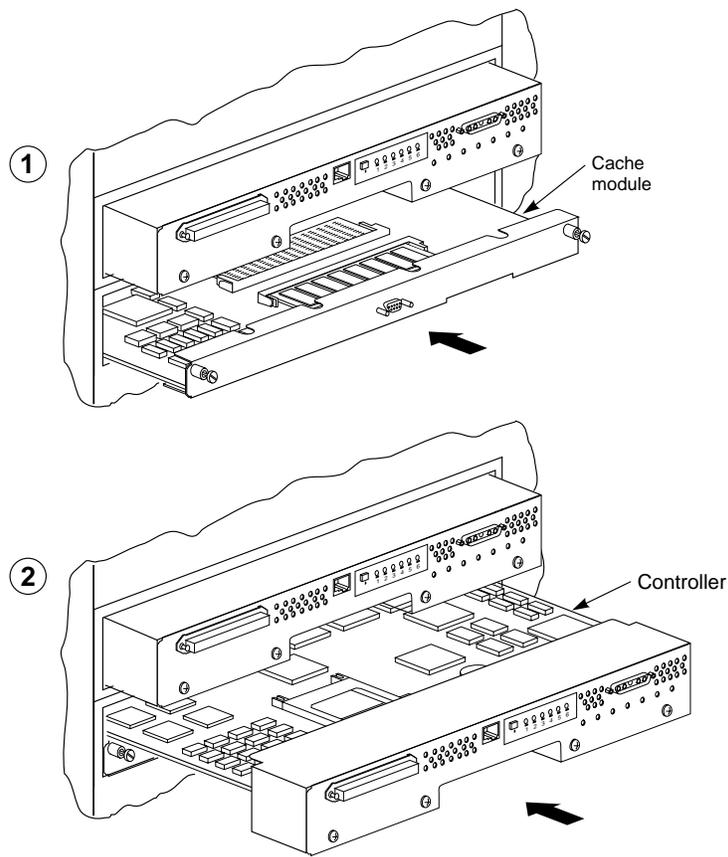
**Figure 2-16** Installing the new cache and controller module

1. Reinstall the cache module if it has been removed. See Figure 2-16.
2. Use a gentle rocking motion to help seat the module into the backplane. Press firmly on the module until it is seated.

3. Slide the controller module into the shelf using the same rails as the removed module. See Figure 2-16.
4. Tighten the two captive retaining screws on the front panel of the cache and controller modules.
5. Reconnect the CI connector to the controller's front panel.
6. Reconnect the open end of the ECB cable to the new cache module.
7. Press and hold the green reset (//) button, while inserting the program card. The program card eject button will extend when the card is fully inserted.

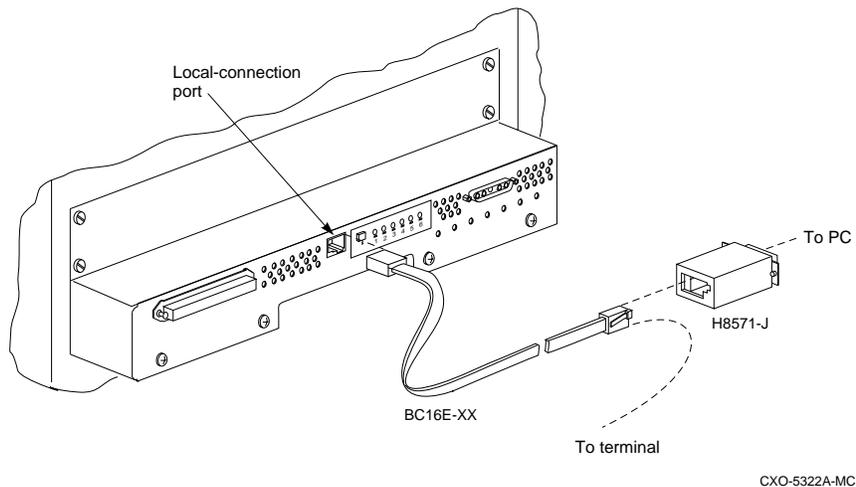
**Figure 2-17 Connecting a maintenance terminal to the controller**

1. Connect a maintenance terminal to the controller that contains the cache module to be replaced. See Figure 2-17.
2. Take the controller out of service.

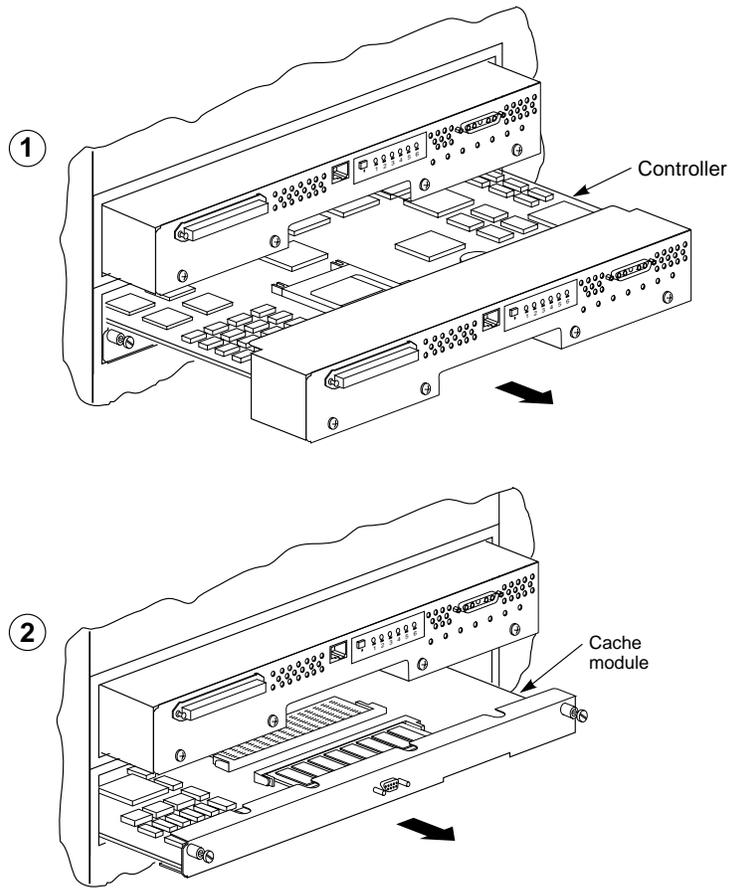
**Figure 2-18 Removing controller and cache modules.**

12. Slide the controller module out of the shelf, noting which rail it was seated in, and place it on an ESD mat. See Figure 2-18.

- Slide the cache module out of the shelf. See Figure 2-18.

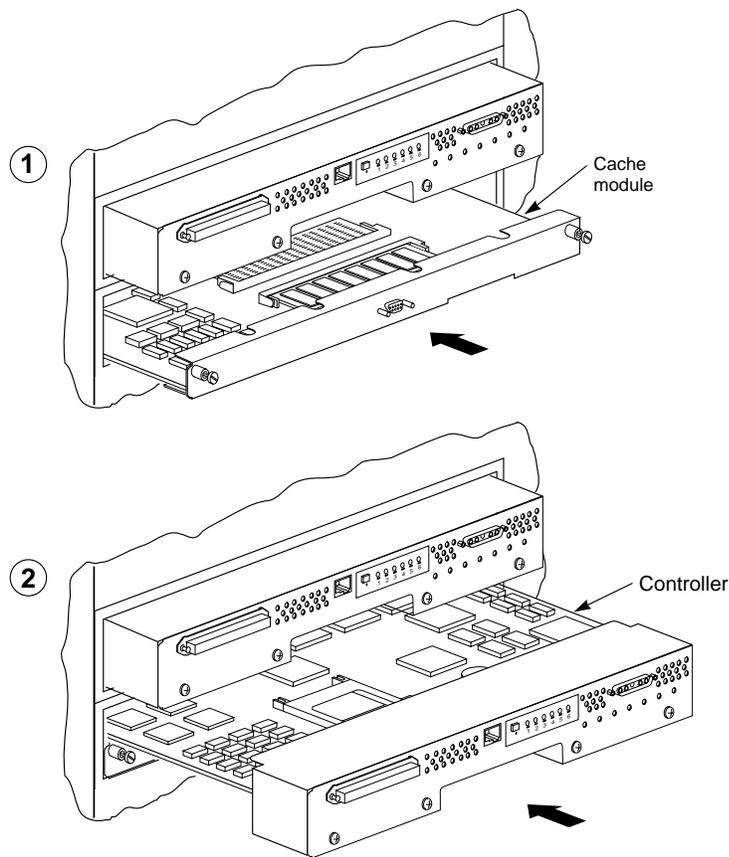
**Figure 2-19 Installing cache and controller module**

- Install the replacement cache module into the shelf using the same rails as the removed modules. See Figure 2-19.

- Reinstall the controller module into the shelf using the same controllers rails and tighten the two captive retaining screws on the controller and cache modules. See Figure 2-19.

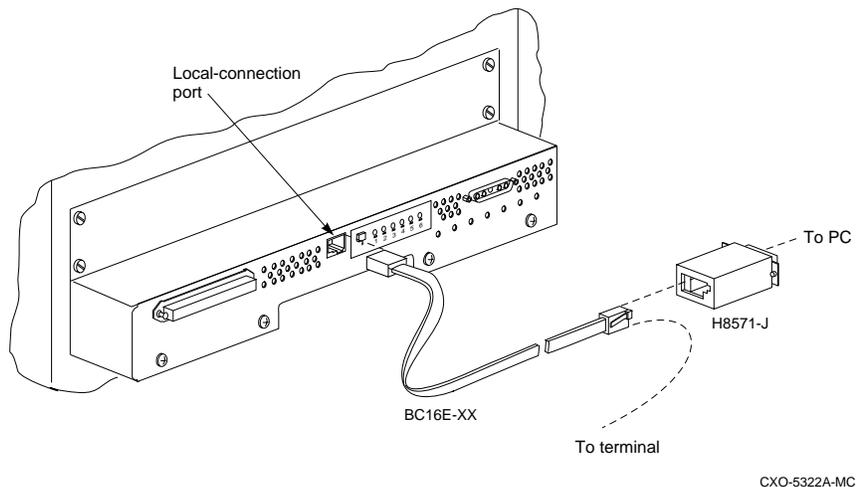
**Figure 2-20 Connecting a maintenance terminal to the controller**

1. For the purpose of this procedure, mark one controller A and the other controller B.
2. Connect a maintenance terminal to controller B. See Figure 2-20.

```
HSJ50> RESTART OTHER_CONTROLLER
```
2. Connect the maintenance terminal to controller A. See Figure 2-20.
3. Press and hold the Reset (//) button on controller A while inserting the program card.
4. Release the Reset button to initialize the controller. Wait for the CLI prompt to appear at the terminal. You will see a "Controllers misconfigured" message, which you can ignore.
5. Enter the following command:

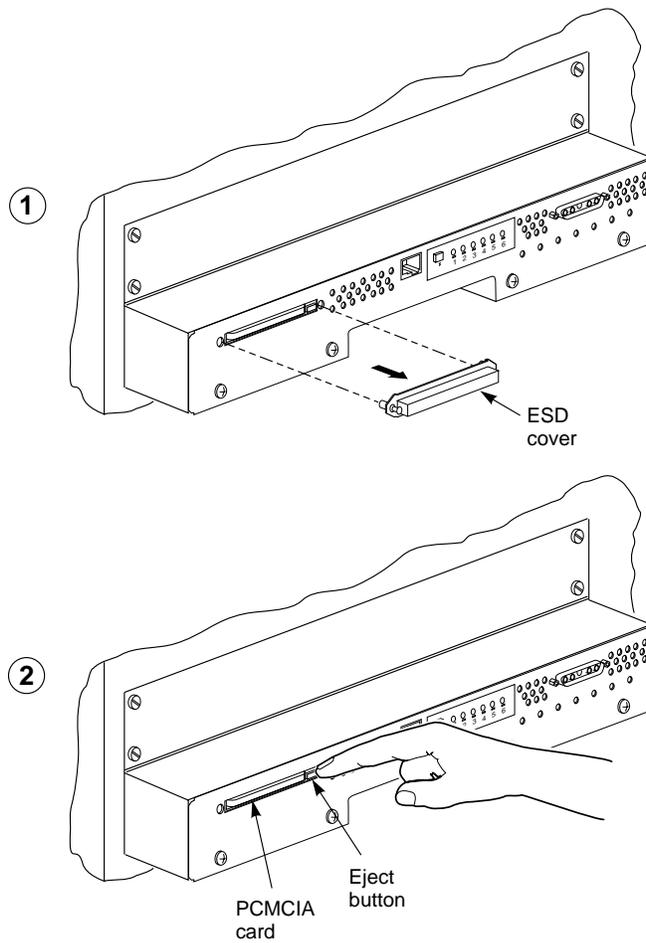
**Figure 2-21 Removing the program card**

9. Remove the program card by pressing and holding in the Reset button, then pressing the eject button next to the card. See Figure 2-21.

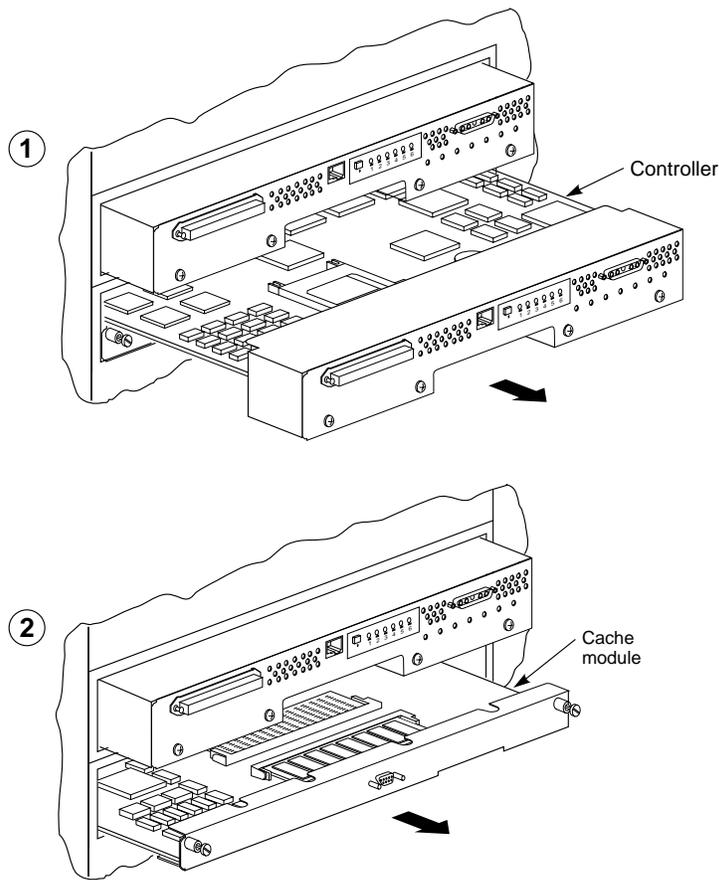
**Figure 2-22 Removing the controller and cache module**

11. Slide controller A out of the shelf and note the rails in which the module was seated. Place the module on an ESD mat. Do not remove the CI connector. See Figure 2-22.

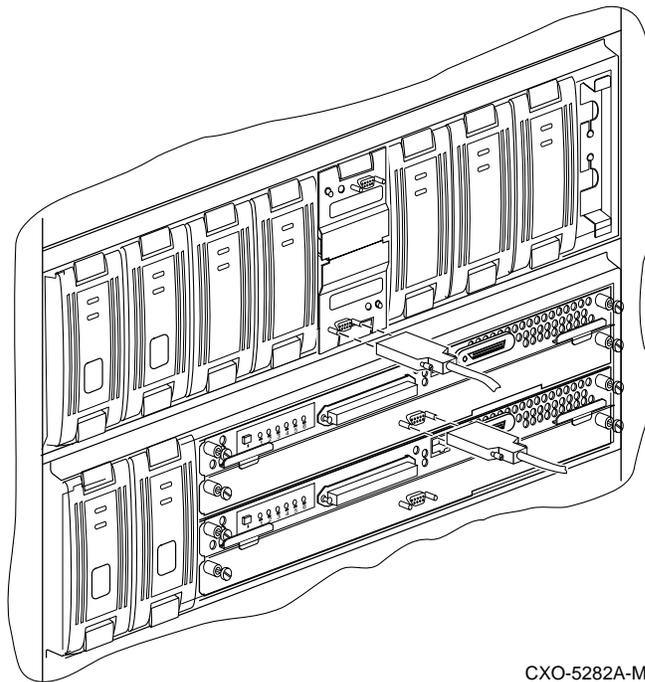
**Figure 2-23 ECB Cable Connection**

14. Disconnect the ECB cable from the ECB you are replacing and connect it to the new ECB. Tighten the battery cable connector mounting screws. Do not overtighten. See Figure 2-23.

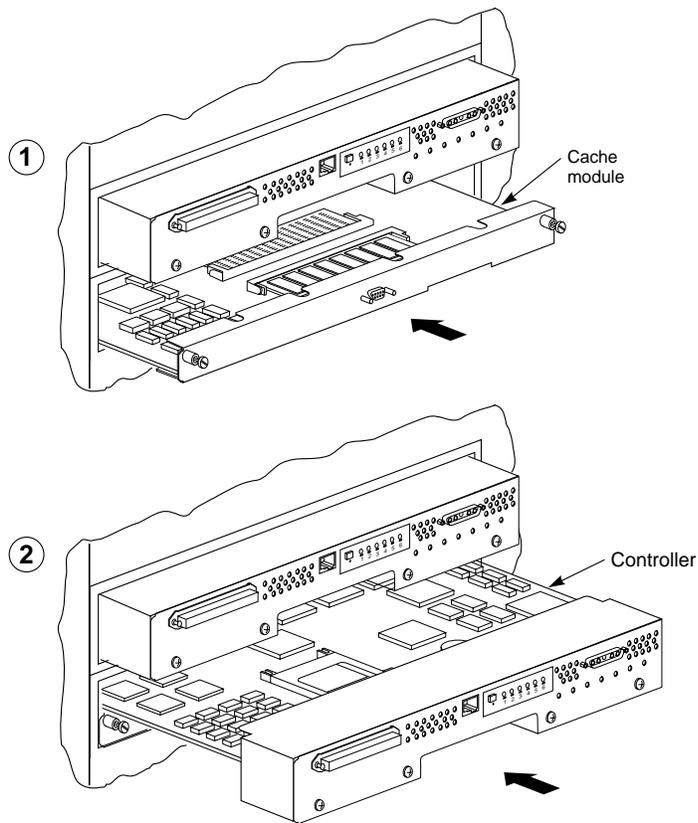
**Figure 2-24 Reinstalling the cache and controller module**

- Slide the cache module for controller A along the rails and then push firmly to seat it in the backplane. See Figure 2-24.

- Slide controller A along the rails and then push firmly to seat it in the backplane. See Figure 2-24.

```
Attempting to quiesce all ports.
Port 1 quiesced.
Port 2 quiesced.
Port 3 quiesced.
Port 4 quiesced.
Port 5 quiesced.
Port 6 quiesced.
All ports quiesced.
Insert the other HSJ50 WITHOUT its program card, and
press Return.
```
6. Slide the cache module for controller B all the way back into the shelf and push firmly to seat it in the backplane.
7. Install controller B. Slide the controller module along the rails and then push firmly to seat it in the backplane. See Figure 2-24.

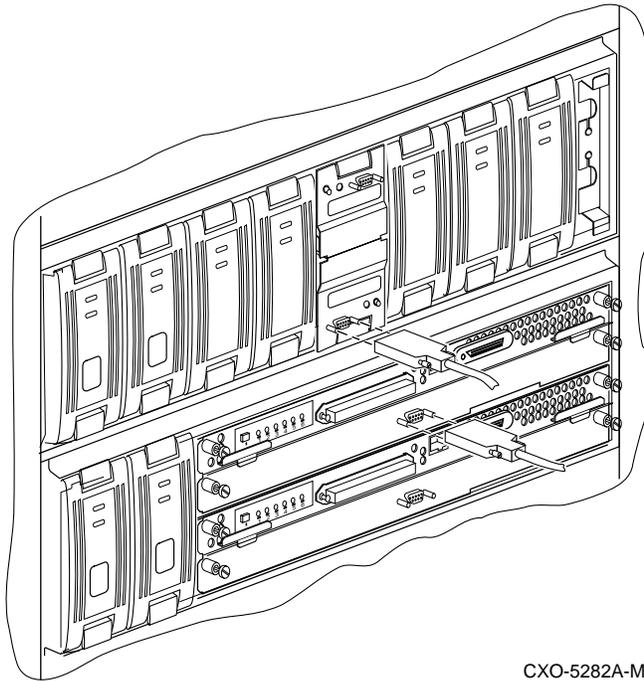
**Figure 2-25 ECB Cable Connection**

13. Disconnect the Controller B cache module ECB cable from the ECB you are replacing and connect it to the new ECB. See Figure 2-25. Tighten the battery cable connector mounting screws on the new SBB battery module. Leave the old SBB battery module in the device shelf.

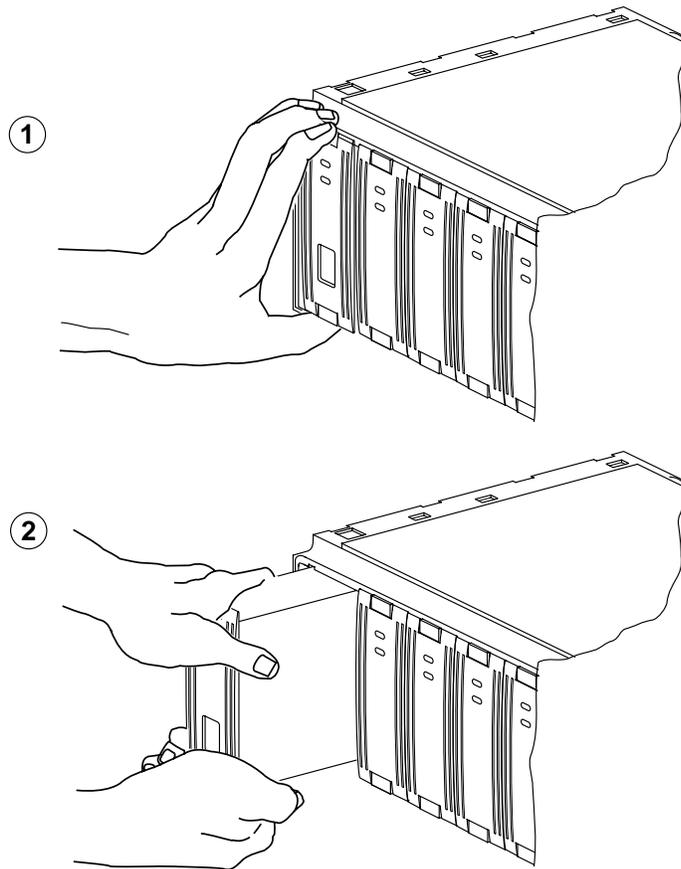
**Figure 2-26 Removing the power supply**

```
HSJ50> SHUTDOWN OTHER_CONTROLLER
HSJ50> SHUTDOWN THIS_CONTROLLER
```
3. Disconnect the power cords from the power supply.
4. Press the two mounting tabs together to release the power supply from the shelf and partially pull it out of the shelf. See Figure 2-26.
5. Use both hands to pull the power supply out of the shelf.

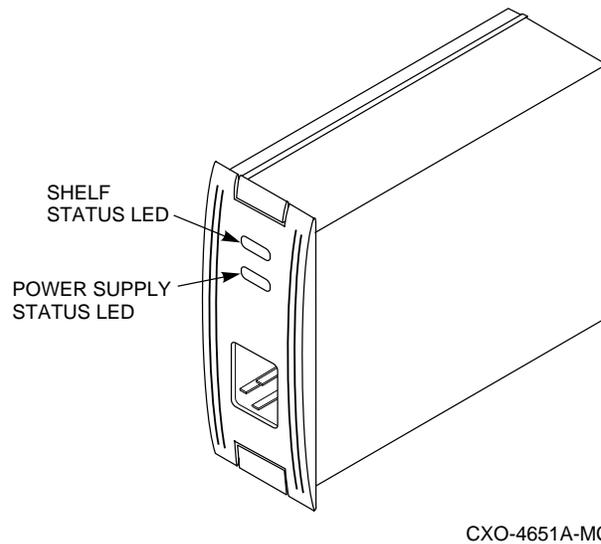
**Figure 2-27 The power supply status indicator**

3. Observe the power and shelf status indicators to make sure they are on. See Figure 2-27. If the status indicators are not on, refer to the installation section, tables 46 and 47 of this manual.

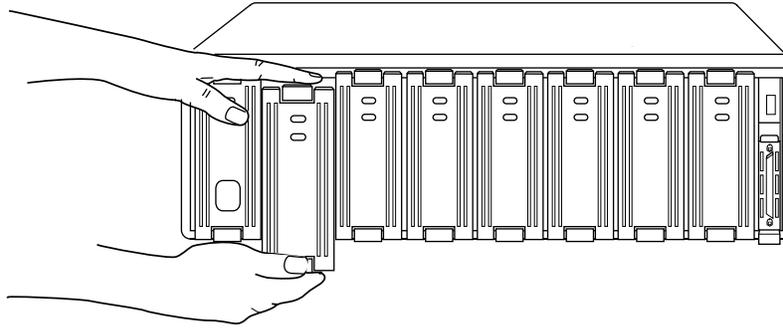
**Figure 2-28 Removing a disk drive**

1. Press the two mounting tabs together to release the disk drive from the shelf and partially pull it out of the shelf. See Figure 2-28.

2. Using both hands, pull the disk drive out of the shelf. See Figure 2-28. Notice that the corresponding port LED on the controller's OCP is flashing.
3. When the port LED stops flashing, align the replacement disk drive with the shelf rails.
4. Push the disk drive all the way into the shelf until the locking tabs snap into place.

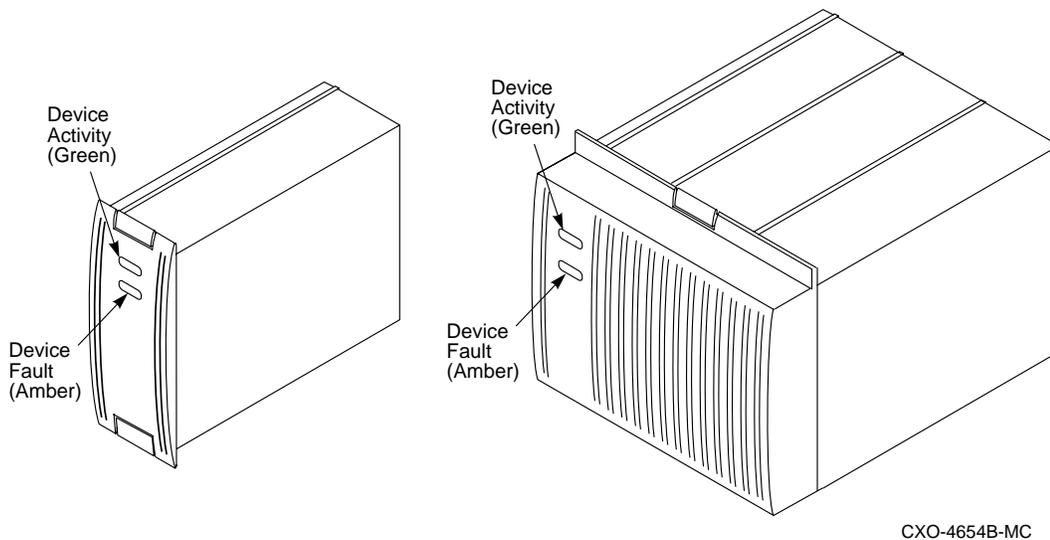
**Figure 2-29 Status indicators for 3.5- and 5.25-inch SBBs**

5. Observe the device status LED for the following indications.  
See Figure 2-29.
  - The device status indicator (amber) LED is off.

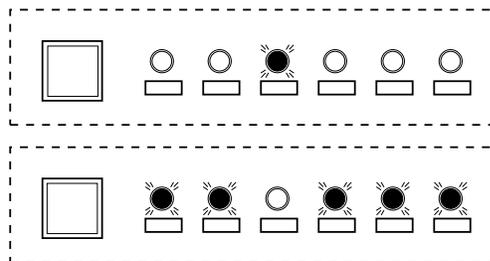
1. Halt all I/O activity to the appropriate port using the using the required procedure for your operating system.
2. Quiesce the port by pressing the OCP button for that port.
3. When the OCP LEDs flash in an alternating pattern the device port is quiesce. For example, when you quiesce device port three and I/O has halted, the OCP LEDs are flashing in an alternating pattern as shown in the following illustration. The flashing LEDs are represented by the dark circles with lines radiating from them.

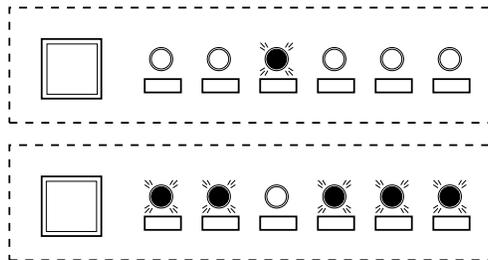
6. Quiesce the port again. Look for the following OCP indicators:

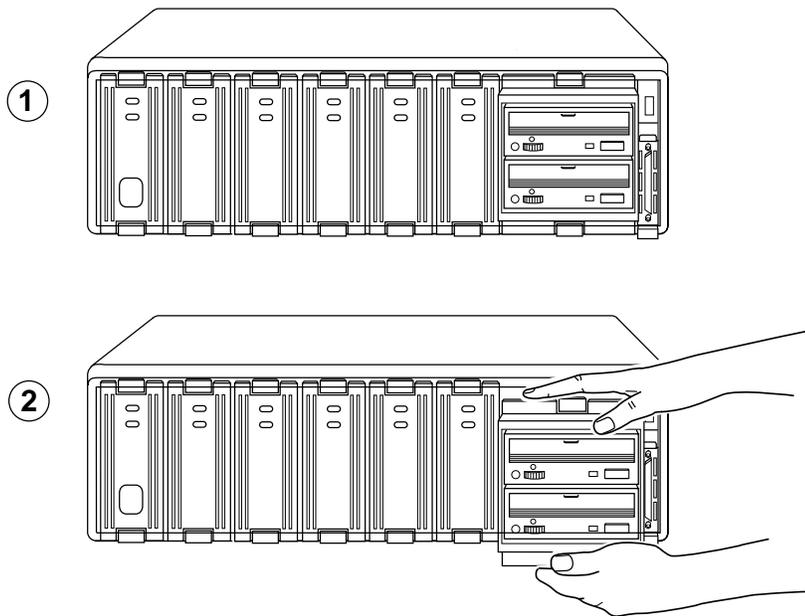
**Figure 2-30 Removing a CD-ROM drive**

```
HSJ50> SHUTDOWN OTHER_CONTROLLER
HSJ50> SHUTDOWN THIS_CONTROLLER
```
4. Remove the power cords from the device shelf that contains the failed solid-state disk drive, optical or CD-ROM.
5. Press the two mounting tabs together to remove the storage building block device from the shelf. See Figure 2-30.

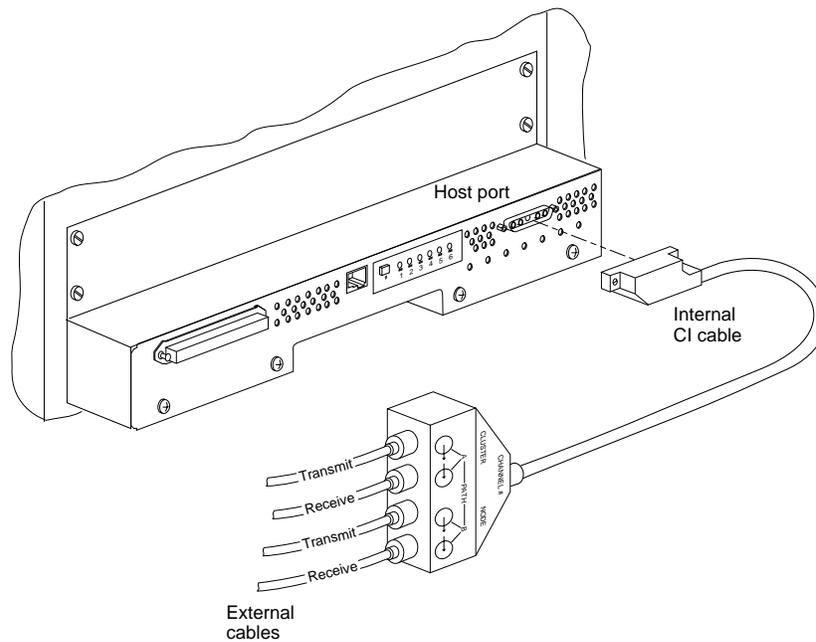
**Figure 2-31 Disconnecting the internal CI cable**

5. Disconnect the internal CI cable (17-03427-01) from the external CI cables. See Figure 2-31.
6. Remove the internal CI cable from the cabinet, cutting the tie wraps as necessary.
7. Position and route the new CI cable within the cabinet.
8. Connect the new CI cable to the controller.
9. Install new tie wraps as necessary to hold the new CI cable in place.
10. Connect the other end of the internal CI cable to the external CI cable.
11. Reconnect the external CI cable at the star coupler.

1. Halt all I/O activity using the appropriate procedures for your operating system.
2. Dismount all units using the procedures for your operating system.
3. Disconnect the external CI cable from the star coupler and terminate. See Figure 2-31.
4. Disconnect the CI cable from the controller host port.

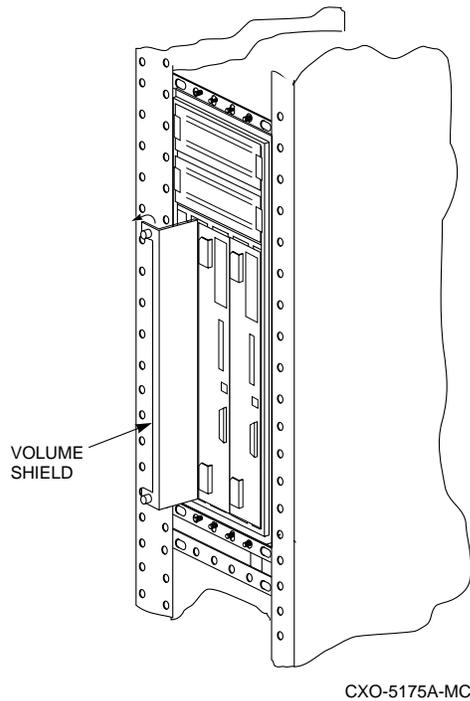
**Figure 2-32 Removing the volume shield**

1. Halt all I/O activity to the controller, using the appropriate procedure for your operating system.
2. Dismount all units using the appropriate procedures for your operating system.
3. Remove each controller and cache module using the Replacing Cache Module procedures.
4. Use a flat-head screwdriver to loosen the two captive screws on each side of the volume shield and remove the shield. See Figure 2-32.

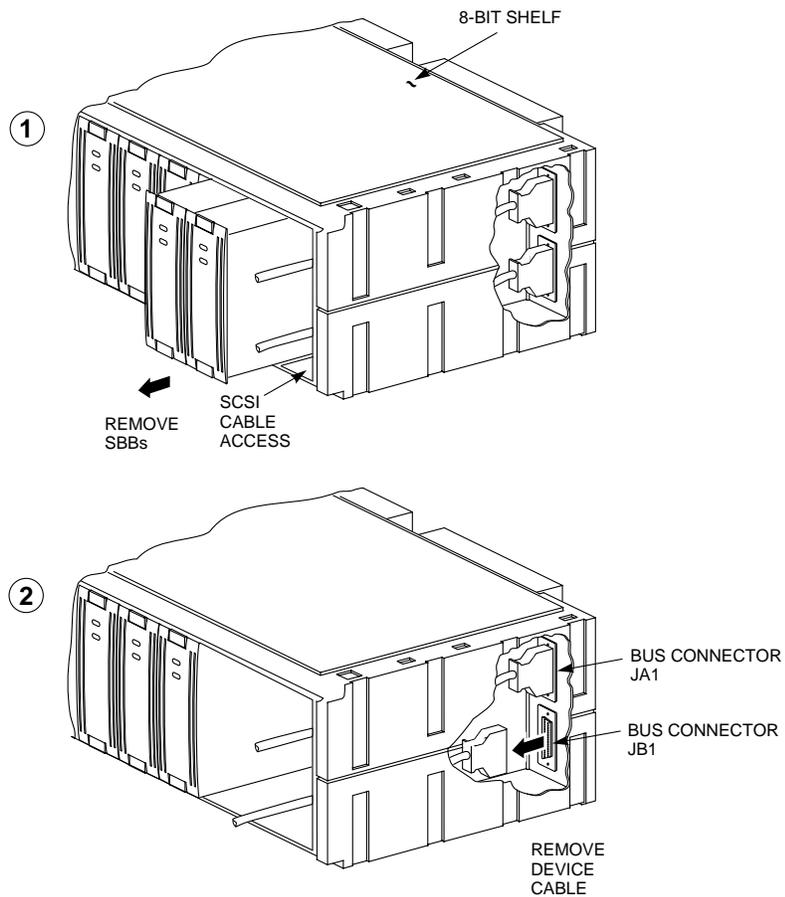
**Figure 2-33 Access to the SCSI cables**

6. Before removing the disk drives from the shelf, let the drive spin down for at least 30 seconds. Gyroscopic motion from a spinning disk may cause you to drop and damage the disk.
7. Remove any SBBs necessary to gain access the SCSI cable. See Figure 2-33.

8. Remove the failed cable from the device shelf backplane by pinching the cable connector side clips and disconnecting the cable. See Figure 2-33.
9. To install the new SCSI device port cable at the device shelf, gently slide the cable connector in from one side to the other, and rock the connector to help seat it. Listen for the connector to snap into the place. Take care not to bend any connector pins.

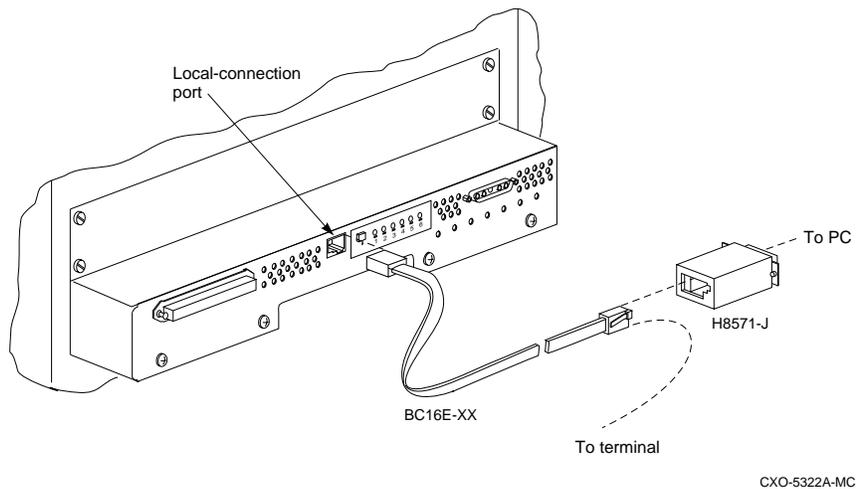
**Figure 3-1 Connecting a maintenance terminal to the controller**

1. Connect a maintenance terminal to the controller. See Figure 3-1.

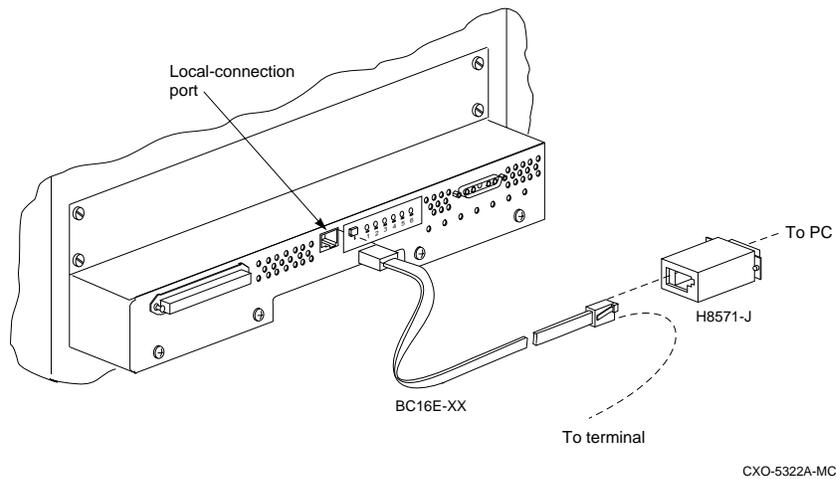
**Figure 3-2 Connecting a maintenance terminal to the controller**

1. Obtain the appropriate patch data for your controller's firmware version from your Digital Equipment Corporation representative.
2. Connect a maintenance terminal to the controller. See Figure 3-2.

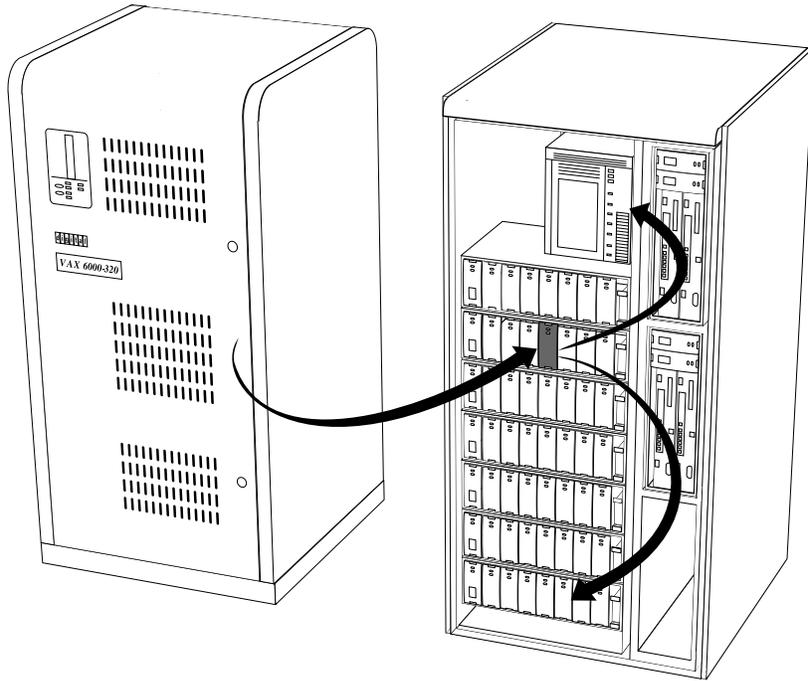
**Figure 3-3 Copy the firmware to a disk drive in your subsystem, then distribute it to the devices you want to upgrade.**

Installing new firmware on a disk or tape drive is a two-step process as shown in Figure 3-3. First, you copy the new firmware from your host to a disk drive in your subsystem, then use HSUTIL to distribute the firmware to devices in your subsystem).
