DIGITAL StorageWorks HSJ50 Array Controller

HSOF Version 5.1 Service Manual

Part Number: EK-HSJ50-SV.B01

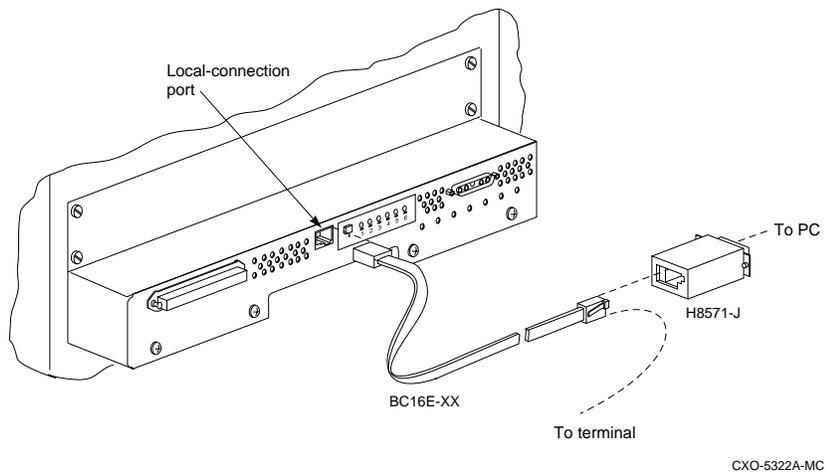
**Figure 3-4 Connecting a maintenance terminal to the controller**

2. Connect a maintenance terminal to the controller. See Figure 3-4.

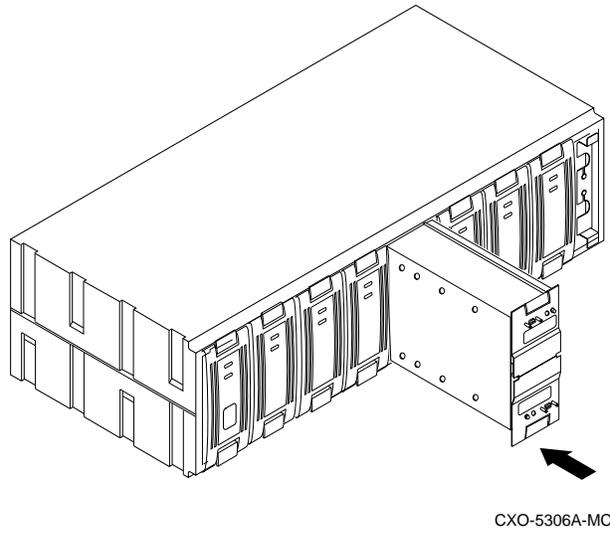
**Figure 3-5 Installing an ECB SBB**

5. Install an external cache battery (ECB) SBB into a convenient device slot. See Figure 3-5.

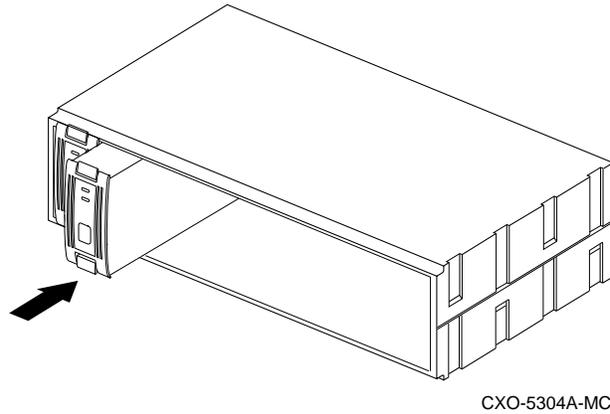
**Figure 3-6 Installing power supplies into the controller shelf**

6. Install the controller power supplies into the controller shelf. See Figure 3-6.

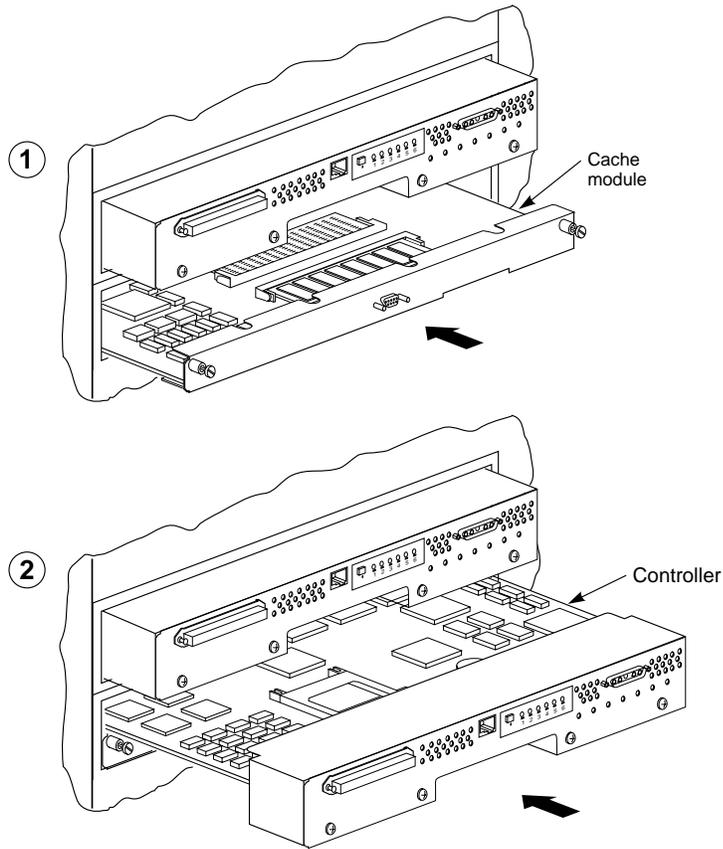
**Figure 3-7 Installing a single controller (SW500 cabinet)**

7. Slide the cache module into the controller shelf. Push the module firmly into the slot until it is seated. See Figure 3-7.

8. Install the controller module into the shelf slot that corresponds to SCSI ID7. See Figure 3-7 and Figure 3-8.

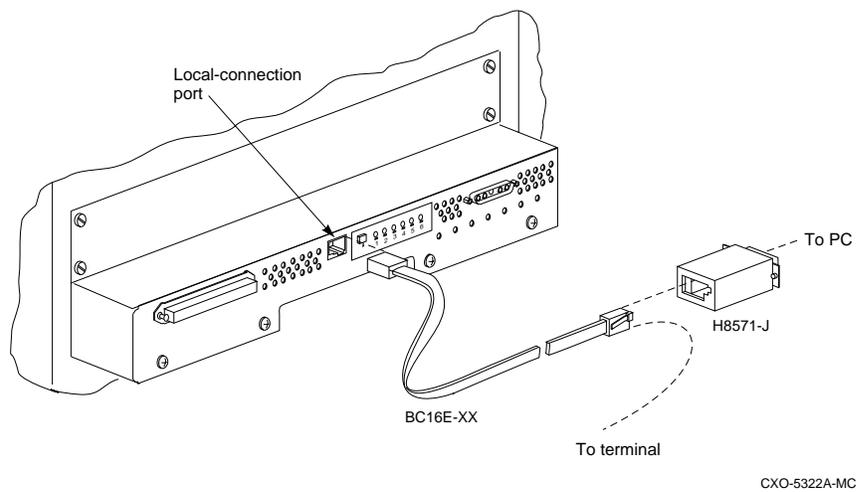
**Figure 3-9 Connecting a maintenance terminal to the controller**

1. Connect a maintenance terminal to the operating controller. See Figure 3-9.

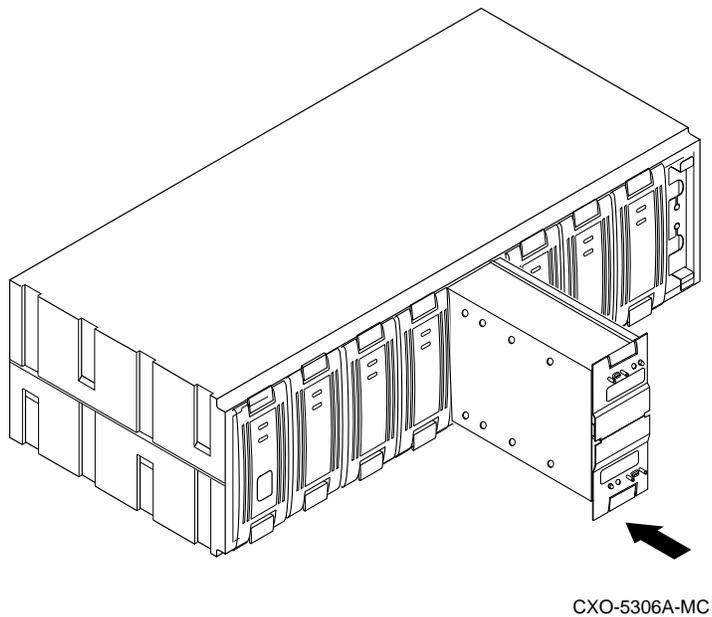
**Figure 3-10 Installing an SBB Battery module**

11. Install the SBB battery module into a convenient device slot. See Figure 3-10.

- a) Press the shutdown button on the single ECB until the LED stops flashing.
- b) Remove the ECB cable from the single ECB.
- c) Remove the single ECB from the device slot.
- d) Install the dual ECB into the device slot.

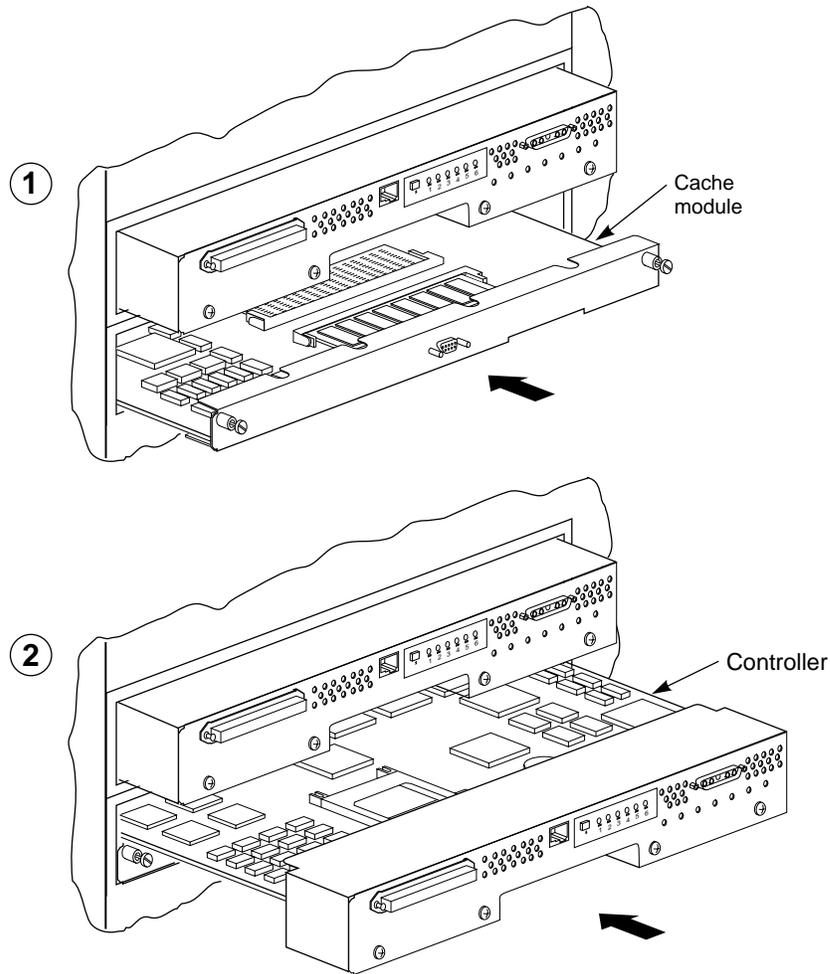
**Figure 3-11 Installing the second controller and cache module**

- Slide the cache module into the appropriate slot in the controller shelf. Push the module firmly into the slot until it is seated. See Figure 3-11.

- Slide the controller module into the appropriate slot. Push the module firmly into the slot until it is seated.

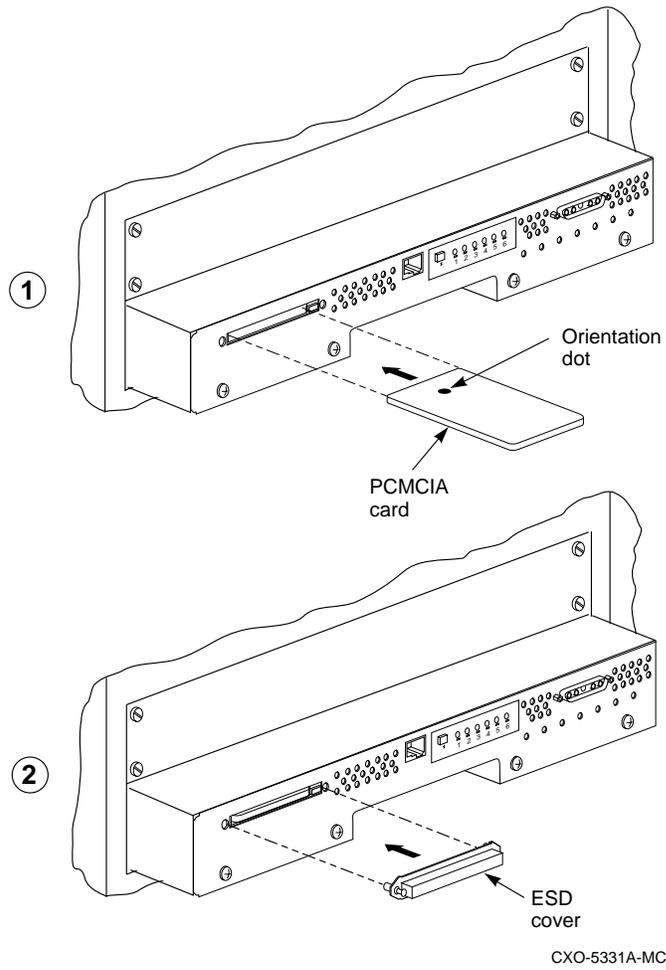
Figure 3-12 Inserting the program card

When the reset LED flashes at a rate of once every second, the initialization process is complete. If the controller fails to initialize, an OCP code will be displayed.

20. Snap the ESD cover into place over the program card. Push inward to lock the cover into place.

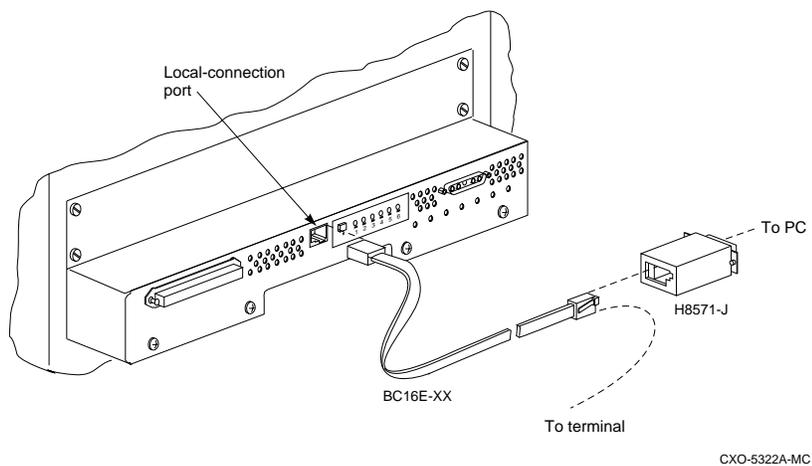
**Figure 3-13 Connecting a maintenance terminal to the controller**

1. Have the new module at hand. The module should be factory-fresh or should have been shut down cleanly (with the SHUTDOWN command) in its last application.
2. Connect a maintenance terminal to the existing controller. See Figure 3-13.

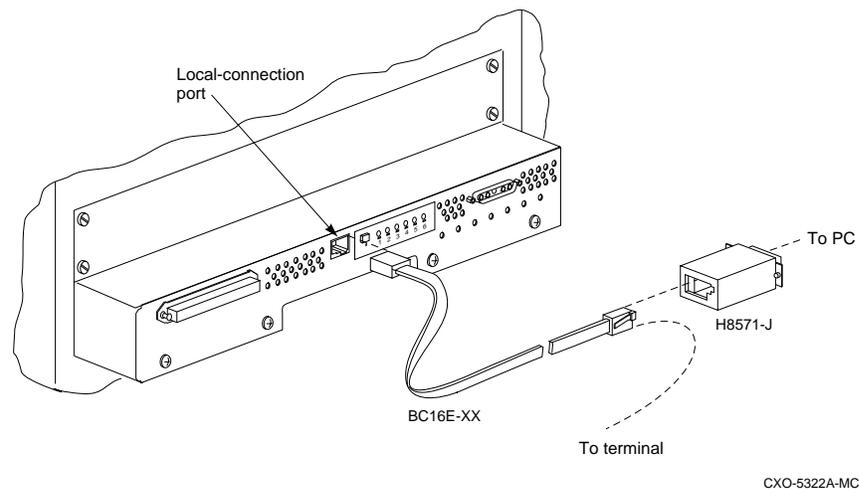
**Figure 3-14 Connecting a maintenance terminal to the controller**

1. Connect a maintenance terminal to the controller. See Figure 3-14.

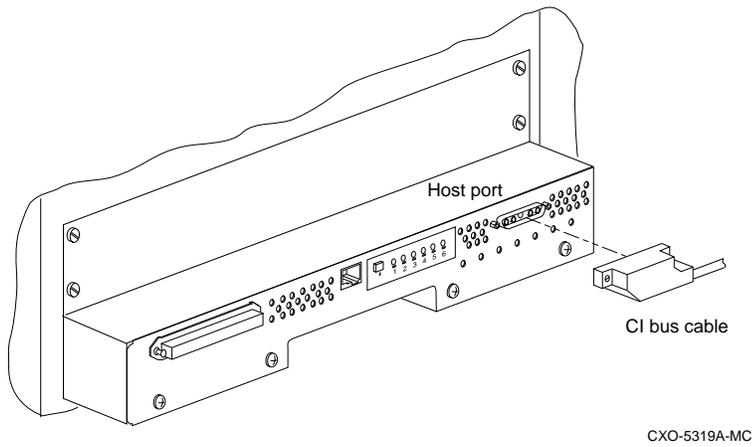
**Figure 3-15 Disconnecting the CI cable adapter**

```
CLI> SHUTDOWN THIS_CONTROLLER
```
4. After the controller has shut down, remove the maintenance terminal cable and remove power cables from the controller shelf.
5. Obtain and place an ESD wrist strap around your wrist. Ensure that the strap fits snugly around your wrist.
6. Attach or clip the other end of the ESD strap to the cabinet grounding stud or a convenient cabinet grounding point (nonpainted surface).
7. With a small flat-head screw driver, loosen the captive screws on the CI cable of the controller and remove the cable. See Figure 3-15.

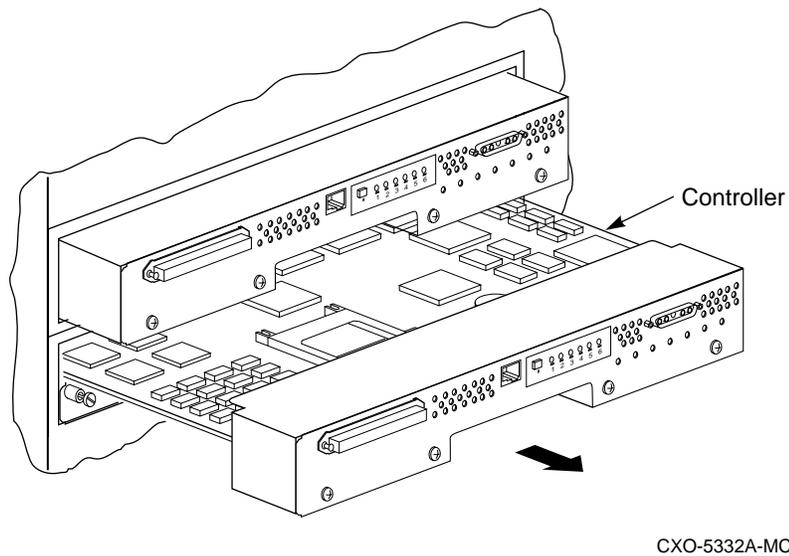
**Figure 3-16 Removing controller modules**

- 8. Use a gentle rocking motion to loosen the controller modules.
- 9. Slide the controller modules out of the shelf as shown in Figure 3-16 and place them on an ESD mat.

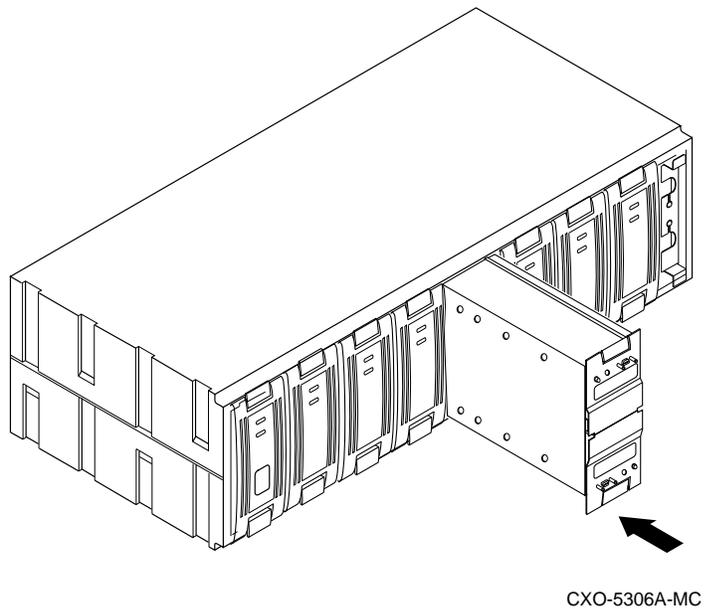
**Figure 3-17 Installing an SBB battery module**

1. Install the ECB SBB into a convenient device slot. See Figure 3-17.  
If you are replacing a single ECB with dual ECB, follow these steps:
  - a) Press the shutdown button on the single ECB until the LED stops flashing.
  - b) Remove the ECB cable from the single ECB.
  - c) Remove the single ECB from the device slot.
  - d) Install the dual ECB into the device slot.

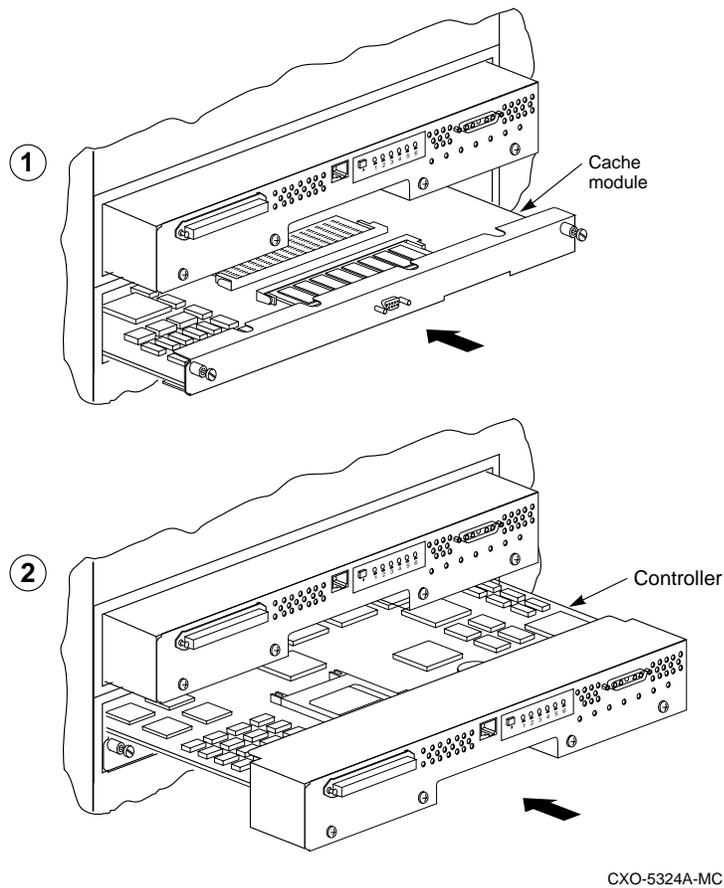
**Figure 3-18 Installing the cache and controller modules**

2. Slide the cache module into the appropriate slot. Push the module firmly into the slot until it is seated. See Figure 3-18.

3. Reinstall the controller module into the appropriate slot. Push the module firmly into the slot until it is seated. See Figure 3-18.

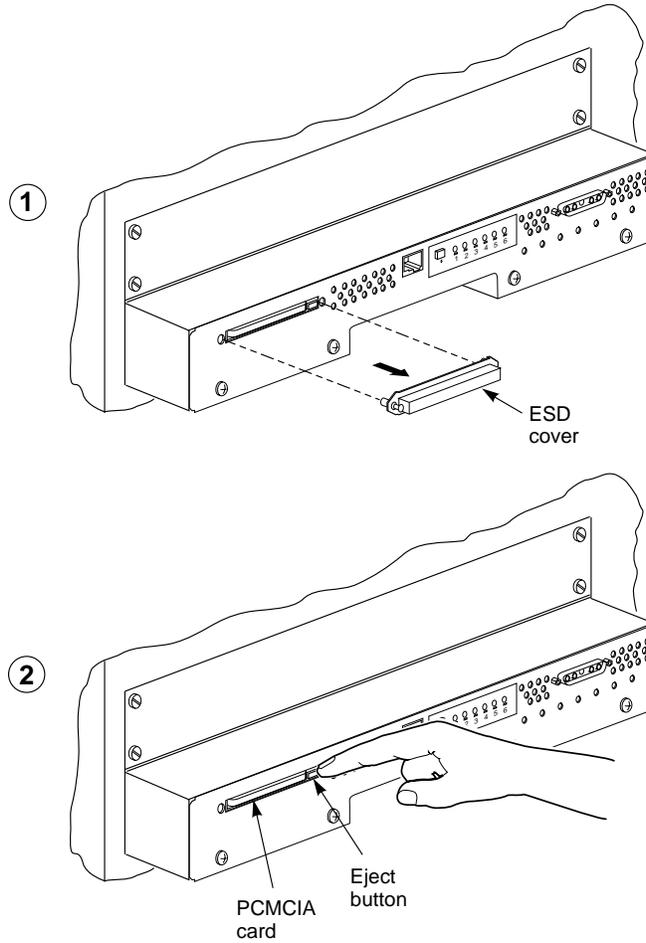
**Figure 3-19 Removing the program card**

1. Remove the program card from the controller by pressing and holding in the Reset button (//), then pressing the eject button next to the program card. See Figure 3-19.

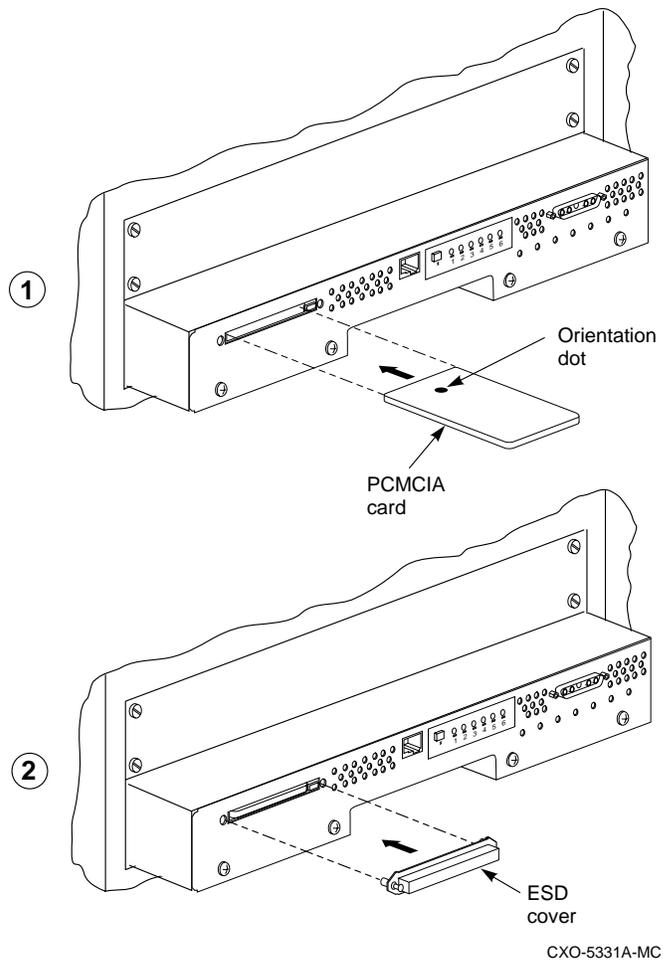
**Figure 3-20 Installing the program card**

3. Press and hold the Reset button (//) on the controller while pushing in the program cards. Release the Reset button. The controller will initialize. See Figure 3-20.

When the reset light on each controller flashes at a rate of once every second, the initialization process is complete.

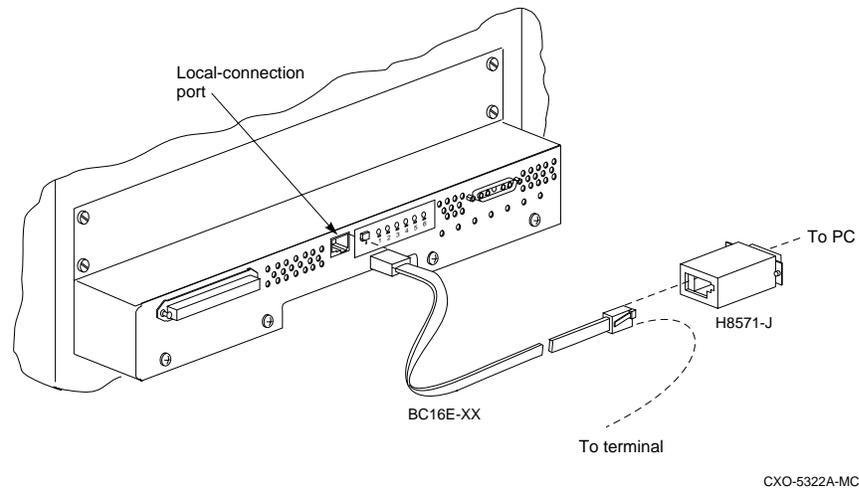
**Figure 3-21 Connecting a maintenance terminal to the controller**

1. Connect a maintenance terminal to the controller. See Figure 3-21.

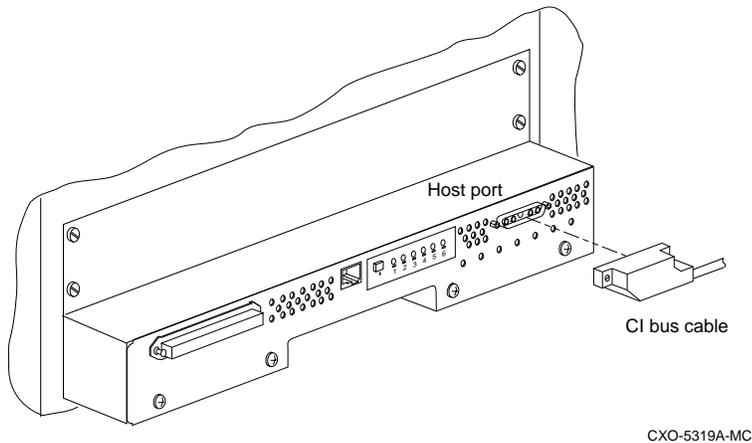
**Figure 3-22 Disconnecting the CI cable**

5. Obtain and place an ESD wrist strap around your wrist. Ensure that the strap fits snugly around your wrist.
6. Attach or clip the other end of the ESD strap to the cabinet grounding stud or a convenient cabinet grounding point (nonpainted surface).
7. Disable the ECB by pressing the battery disable switch on the battery module's front panel.
8. Loosen the captive screws on the controller's front bezel.
9. With a small flat-head screw driver, loosen the captive screws on the CI cable of each controller and remove the cable. See Figure 3-22.

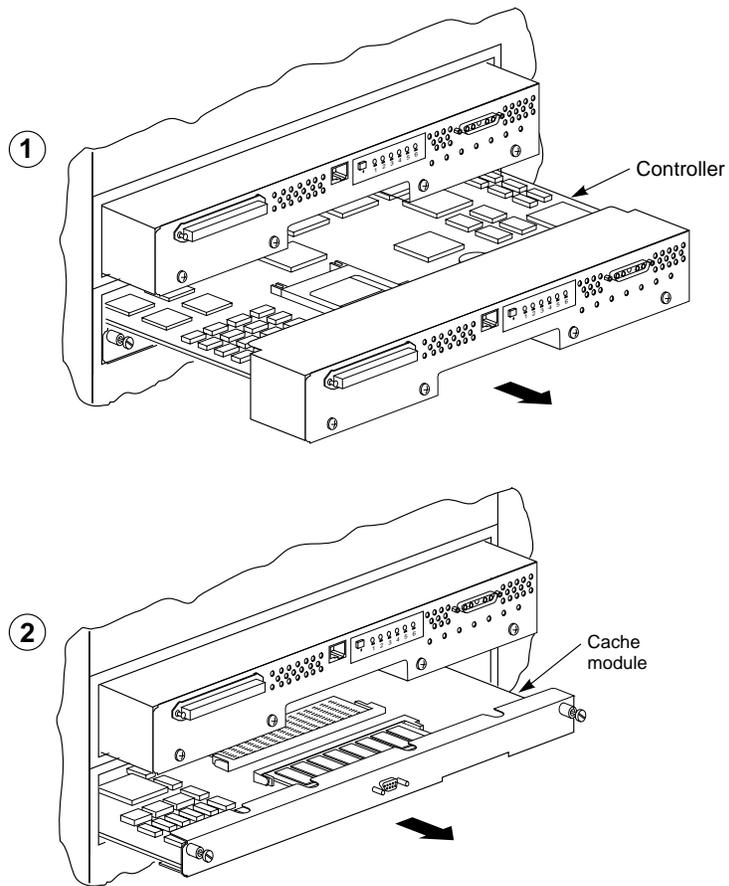
**Figure 3-23 Removing controller and cache modules**

12. Slide the controller modules out of the shelf and place them on an ESD mat. See Figure 3-23.

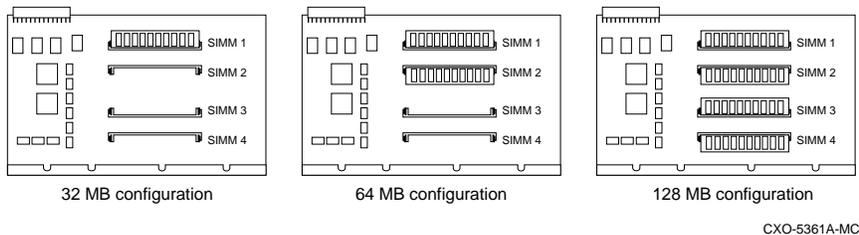
**Figure 3-24 Cache configurations for cache version 3**

Figure 3-24 shows all possible cache configurations.

- Refer to Table 3-11 and install as many SIMM cards into each cache modules as are required (up to 4x32MB maximum).

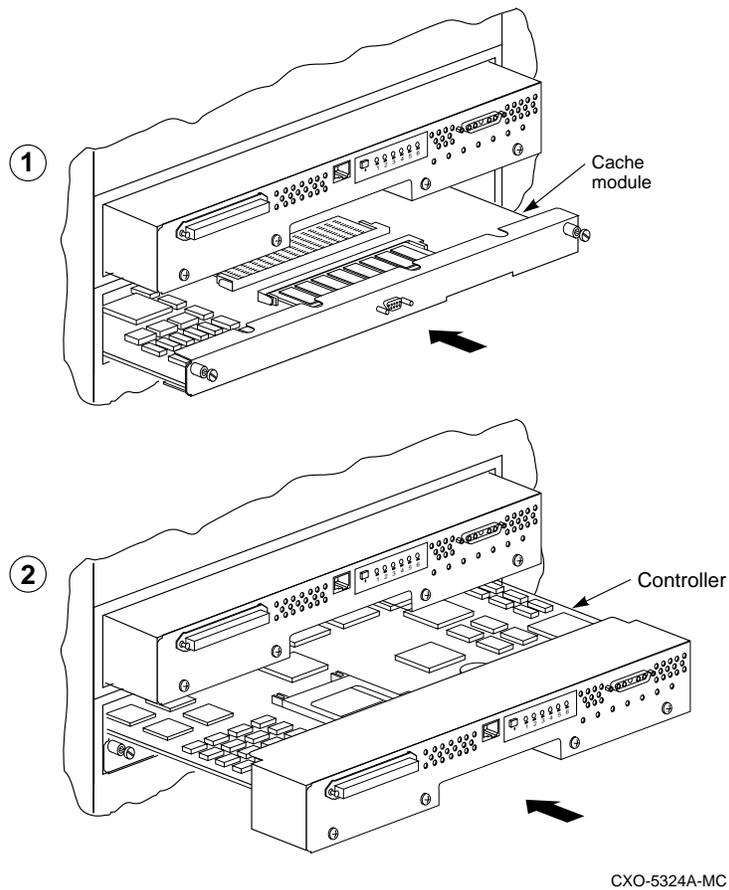
**Figure 3-25 Installing the controller and cache module**

- Reinstall the cache modules into the controller shelf.
- Reinstall the controller modules into their original slots. See Figure 3-25. Use a gentle rocking motion to help seat the module. If you are using a single controller configuration, use the slot that is designated SCSI ID 7.

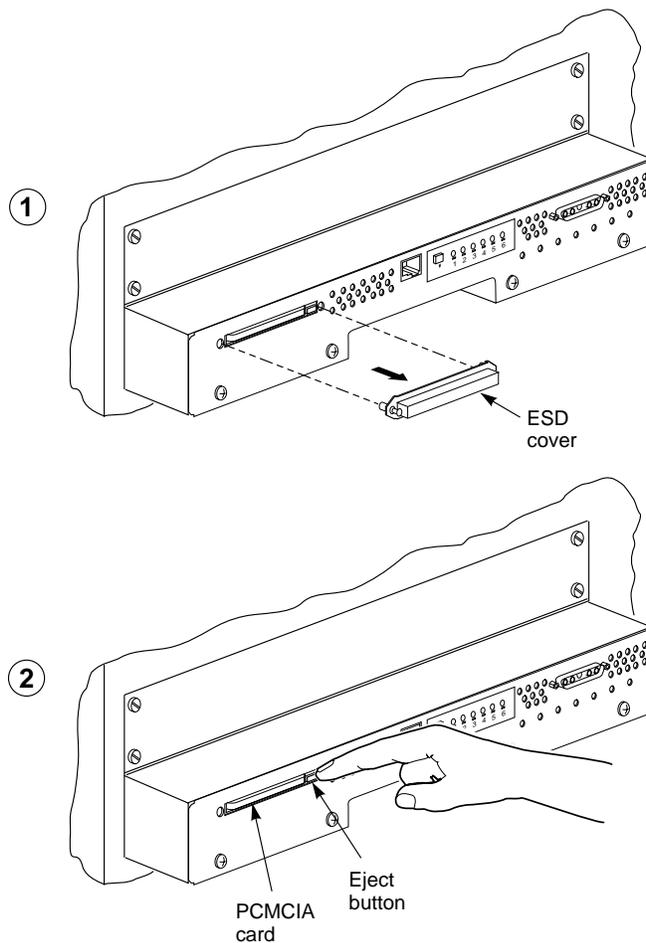
**Figure 3-26 Removing the program card**

20. Remove the program card from each controller by pressing and holding in the Reset button (//), then pressing the eject button next to the program card. See Figure 3-26.

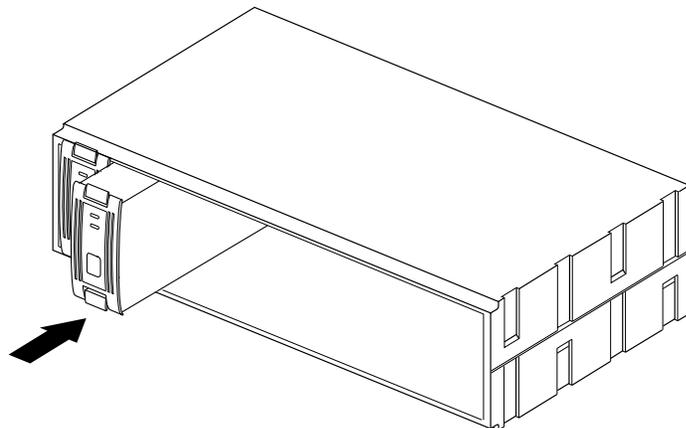
**Figure 3-27 Installing a power supply SBB**

1. Firmly push the power supply into the shelf until the mounting tabs snap into place. See Figure 3-27.

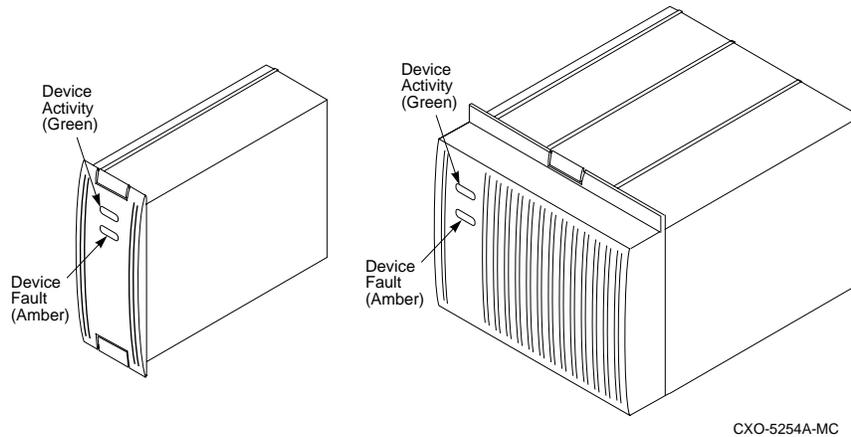
**Figure 3-28** Typical 3.5-inch and 5.25-inch disk drive or optical disk SBBs

- 3.5-inch and 5.25-inch disk drives

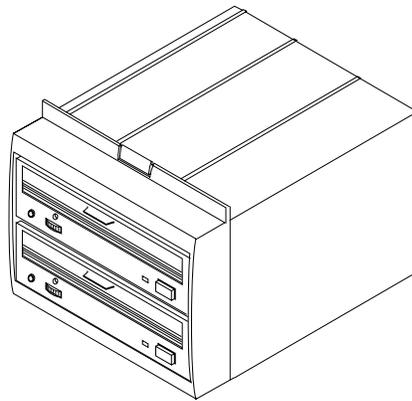
**Figure 3-29 Typical 5.25-inch CD ROM SBB**

- CD ROM drives in 5 1/4 inch Storage Works building blocks

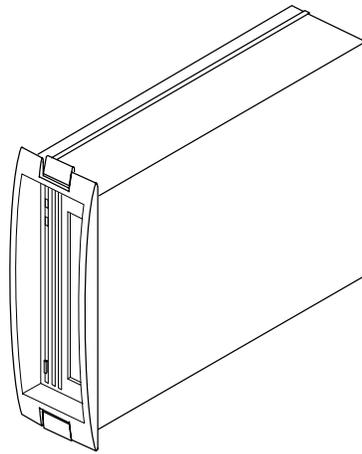
**Figure 3-30 Typical 3.5-inch tape drive SBB**

- Solid state disks and tape drives

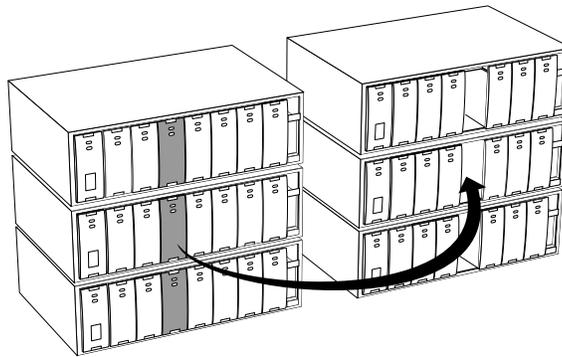
**Figure 4—1 Moving a stageset from one subsystem to another**

You can move a stageset from one subsystem to another without destroying its data. You can also follow these steps to move a stageset to a new location within the same subsystem.

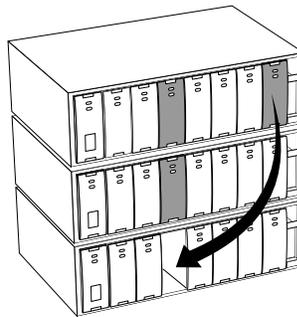
**Figure 4—2 Maintaining symmetry in your subsystem makes it easier to keep track of your storage sets and their members**

You may want to move a storage set member—and its data—from one PTL location to another to maintain the symmetry in your subsystem. For example, if a RAID set member fails and is replaced by a disk drive in the spareset, you could move the replacement member into the column that contains the RAID set.

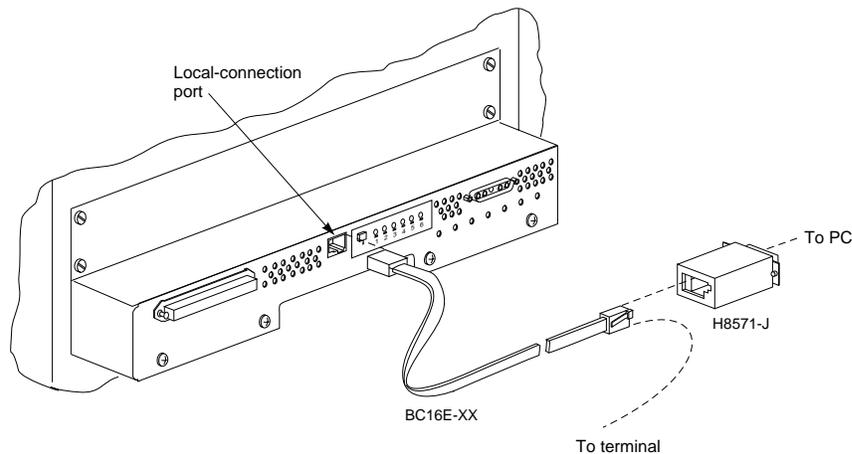
**Figure 5-1 Connecting a maintenance terminal to the controller**

1. Connect a maintenance terminal to one of the controllers. See Figure 5-1.

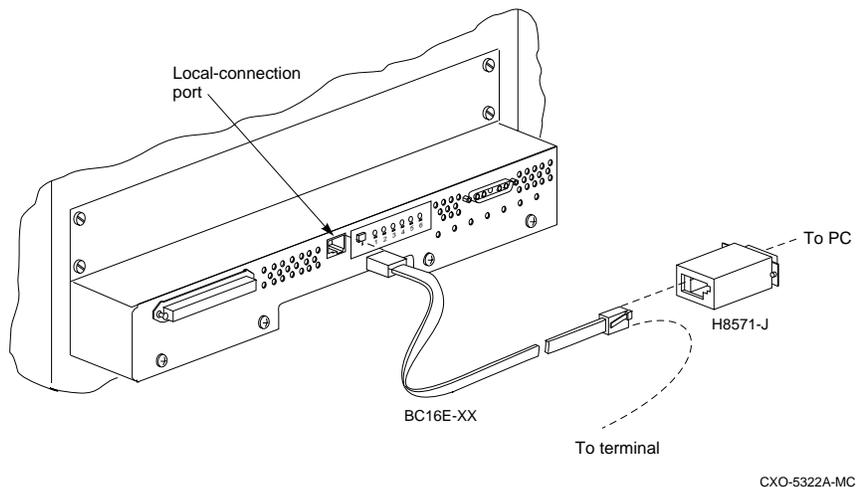
**Figure 5-2 Connecting a maintenance terminal to the controller**

1. Connect a maintenance terminal to the controller to be removed. See Figure 5-2.

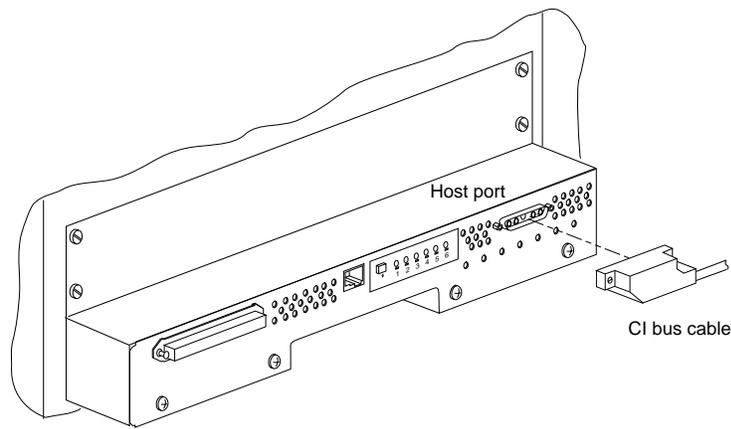
**Figure 5-3 Disconnecting the CI cable connector**

3. Ensure that the controller has shutdown cleanly. Check for the following indications on the controller's OCP (operator control panel).
  - The Reset (//) light is on.
  - Port lights 1, 2, 3 are continuously lit.
4. With a small flat-head screwdriver, loosen the captive screws that secure the CI cable to the controller. See Figure 5-3.

5. Remove the CI cable from the controller's front bezel.
6. Disable the ECB by pressing the battery disable switch on the battery module's front panel.

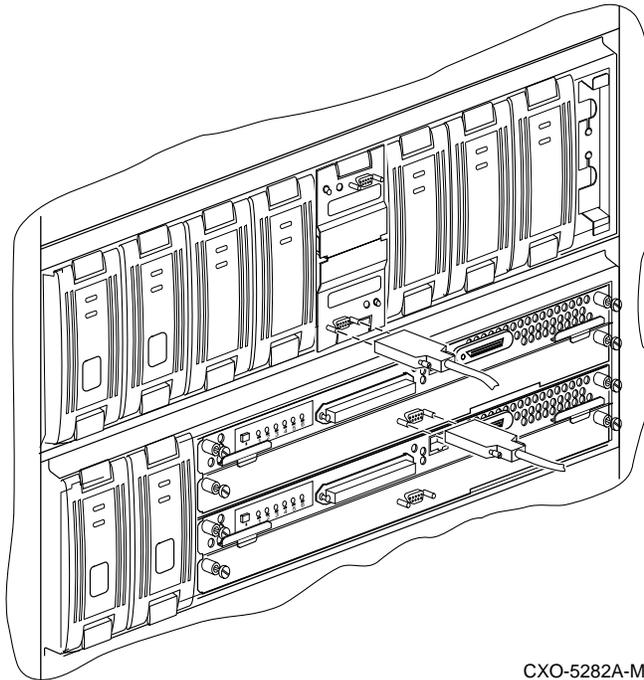
**Figure 5-4 Removing the ECB cables**

7. Disconnect the ECB cables. See Figure 5-4.

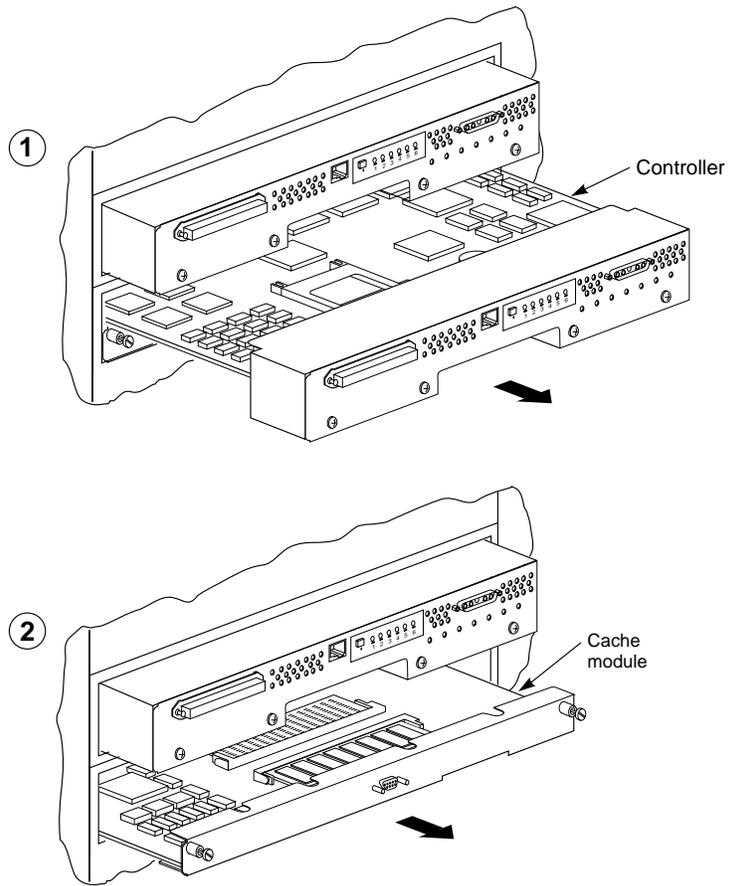
**Figure 5-5 Removing the controller and cache module**

8. Loosen the captive screws on the controller and cache module's front bezel.
9. Obtain and place an ESD wrist strap around your wrist. Ensure that the strap fits snugly around your wrist.
10. Attach the other end of the ESD strap to the cabinet grounding stud or a convenient cabinet grounding point (non-painted surface).
11. Slide the controller out of the shelf (see Figure 5-5) and place it in an ESD bag.

12. If required, slide the cache module out of the shelf and place it in an ESD bag. See Figure 5-5.
13. Remove the ECB and store it with the cache module.

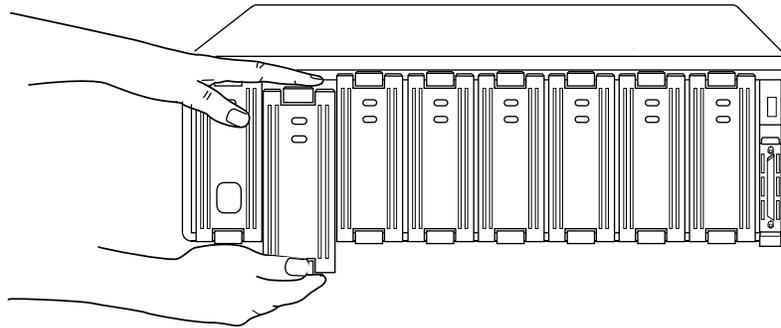
**Figure 5-6 Removing a 3.5-inch disk drive**

1. Determine the disk drive you wish to remove.
2. Press the two mounting tabs together to release the disk drive from the shelf and partially pull the disk drive out of the shelf. Allow the disk drive to spin down.

- Using both hands, slide the disk drive out of the shelf and place it on flat surface (see Figure 5-6).

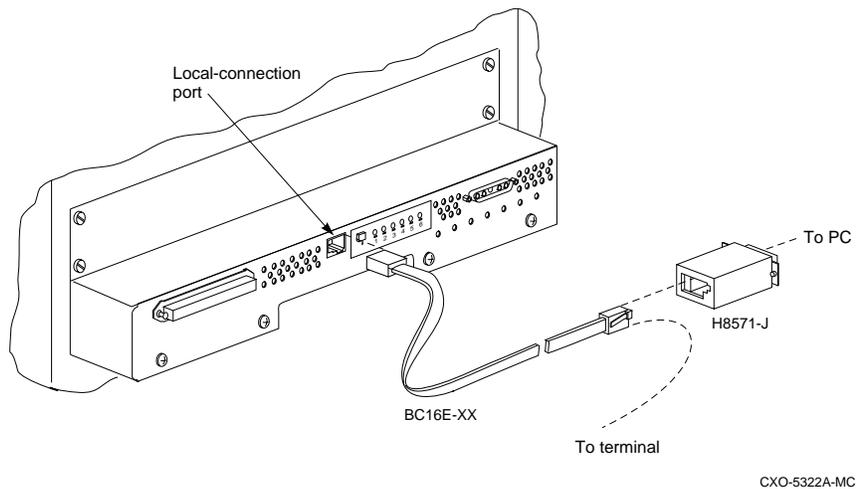
**Figure 5-7 Connecting a maintenance terminal to the controller**

- Connect a maintenance terminal to the controller (see Figure 5-7).

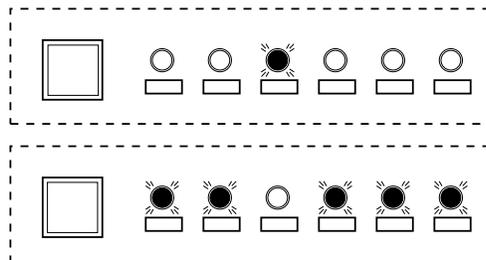
1. Halt all I/O activity to the tape drive using the appropriate procedures for your operating system.
2. Quiesce the appropriate device port by pushing the device port button on the controller's OCP (operator control panel).
3. When the OCP LEDs flash in an alternating pattern the device port is quiesced. For example when you quiesce device port 3 and I/O has halted, the OCP LEDs are flashing in an alternating pattern as shown below. The flashing LEDs are represented by the dark circles with lines radiating from them.
