DIGITAL StorageWorks HSZ40 Array Controller

HSOF Version 3.1 Service Manual

Part Number: EK-HSZ40-SV.B01

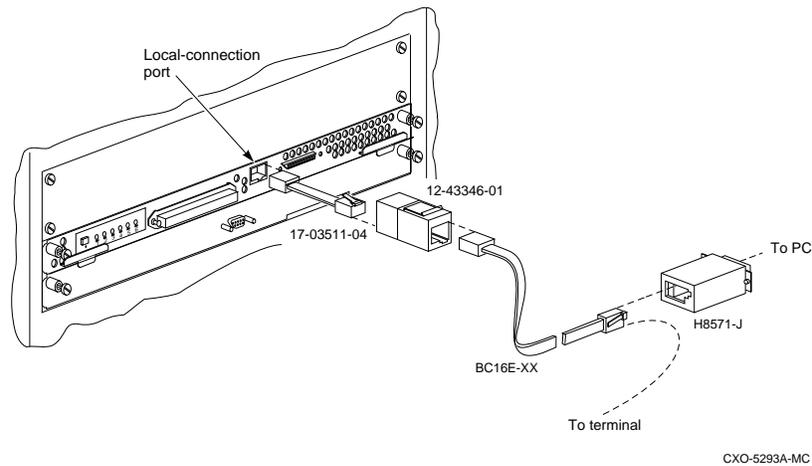
Figure 2-1 Connecting a maintenance terminal

1. Connect a maintenance terminal to the controller that does NOT require service. See Figure 2-1.

1. Connect the maintenance terminal to the newly installed controller. See Figure 2-1.
2. Press and hold the Reset (/) button on the new controller while inserting the program card from the replaced controller.
3. Release the Reset button to initialize the controller. Wait for the CLI prompt to appear at the terminal. You will see a "Controllers misconfigured" message, which you can ignore.
4. Enter the following command at the CLI:

1. If the controller is fully or partially functioning, connect a maintenance terminal to the controller. See Figure 2-1. If the controller is not functioning, try to restart the controller. If it reboots, proceed with Step 2. If it does not reboot, go to Step 6.

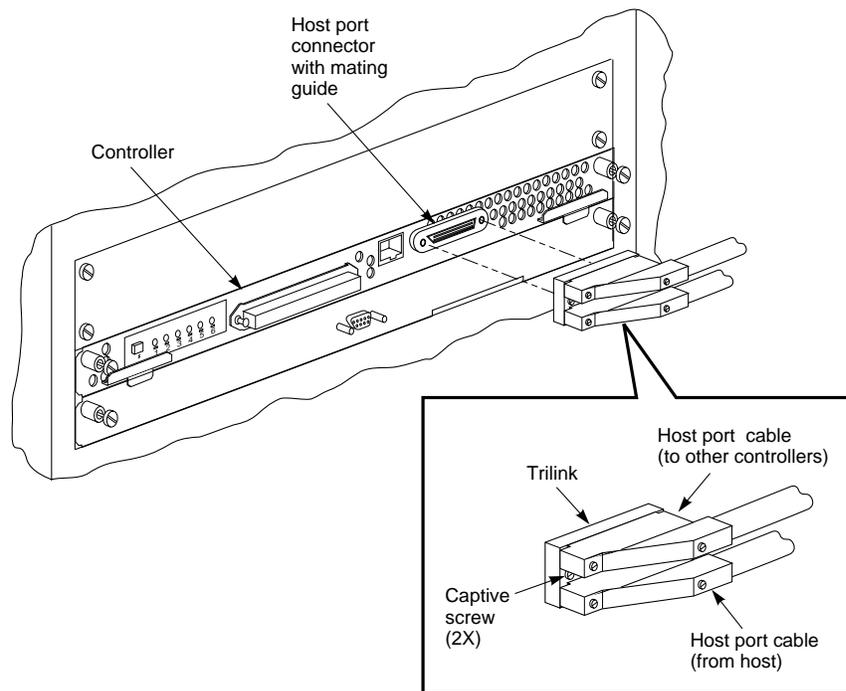
Figure 2-2 Disconnecting the trilink connector

12. Loosen the captive screws that secure the trilink connector to the controller requiring service. Do not remove the connector. See Figure 2-2.

6. Remove the power cords from the controller power supplies.
7. Unsnap and remove the program card ESD shield. See Figure 2-3.
8. Eject the program card by pressing and holding the Reset button (//), then pressing the Eject button next to the program card. Remove the program card and save it for the replacement controller. See Figure 2-3.
9. Loosen the captive screws on the trilink connector and remove the trilink. See Figure 2-2.

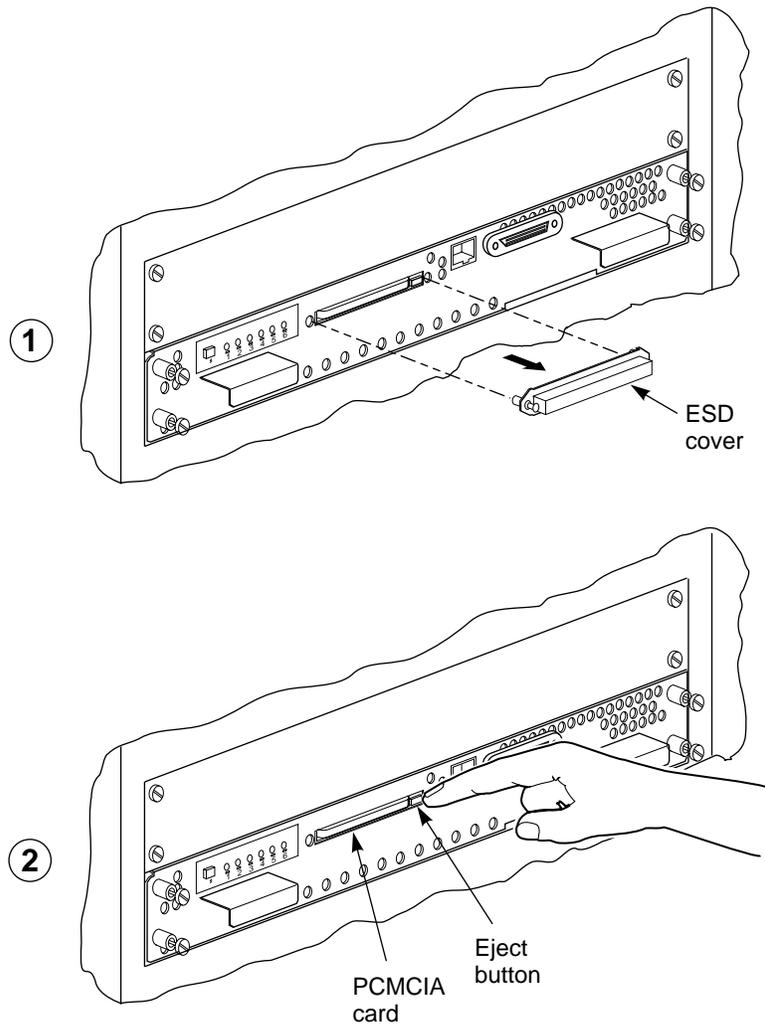
Figure 2-3 Removing the program card

5. Eject the program card by pressing and holding the Reset button (//), then pressing the Eject button next to the program card.
 - If you are not replacing the controller module, leave the program card in the ejected position.
 - If you are replacing the controller, remove the program card. Save it for use in the replacement controller. See Figure 2-3.

where *n,n,n,n* are equal to all host port SCSI target IDs noted in Step 3.
5. Loosen the captive screws on the trilink connector and remove the trilink.
6. Unsnap and remove the program card ESD shield. See Figure 2-3.
7. Eject the program card by pressing and holding the Reset button (//), then pressing the Eject button next to the program card. Remove the program card and save it for the replacement controller. See Figure 2-3.
8. Loosen the controller from the shelf backplane with a gently rocking motion. Slide the controller module out of the shelf, noting in which rails it was seated. See Figure 2-4.
9. Loosen the cache module from the shelf backplane with a gentle rocking motion and slide the module out of the shelf. See Figure 2-4.

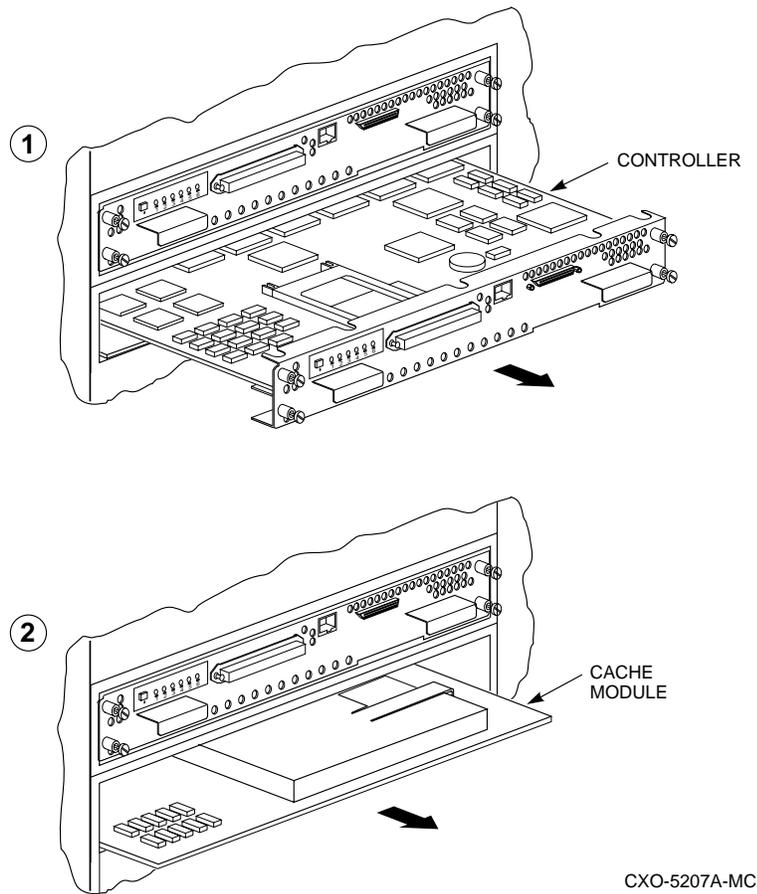
Figure 2-4 Removing the controller and cache modules

6. Remove the trilink connector from the controller. Do not disconnect the host cables from the trilink.
7. Slide the failed controller out of the shelf and note the location. See Figure 2-4. If you are replacing the cache module or cache batteries, remove the cache module as well.

10. Loosen the captive retaining screws on the controller's front bezel.
11. Loosen the controller from the shelf backplane with a gently rocking motion. Slide the controller module out of the shelf, noting in which rails it was seated. See Figure 2-4.
12. If you are replacing the cache module, loosen the cache module from the shelf backplane with a gentle rocking motion and slide the module out of the shelf. See Figure 2-4.
13. Install the battery jumper over both battery enable pins. Leave in place for five minutes, then remove the jumper and store it. Store it by installing it over only one pin.

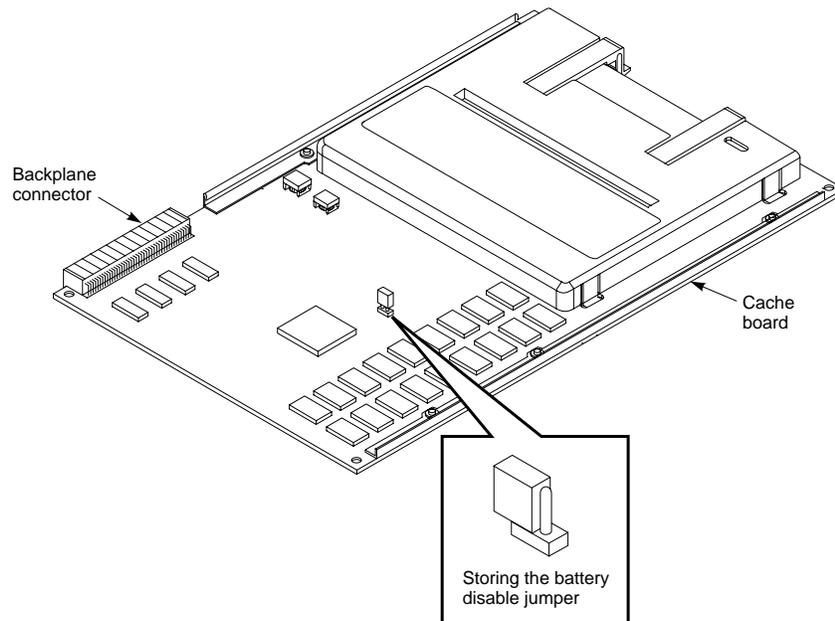
Figure 2-5 Removing and storing the battery jumper

1. If you removed either the cache module or the cache battery, install the over both battery enable pins. Leave in place for about five minutes, then remove the jumper and store it. Store the battery jumper by installing it over only one pin. See Figure 2-5.

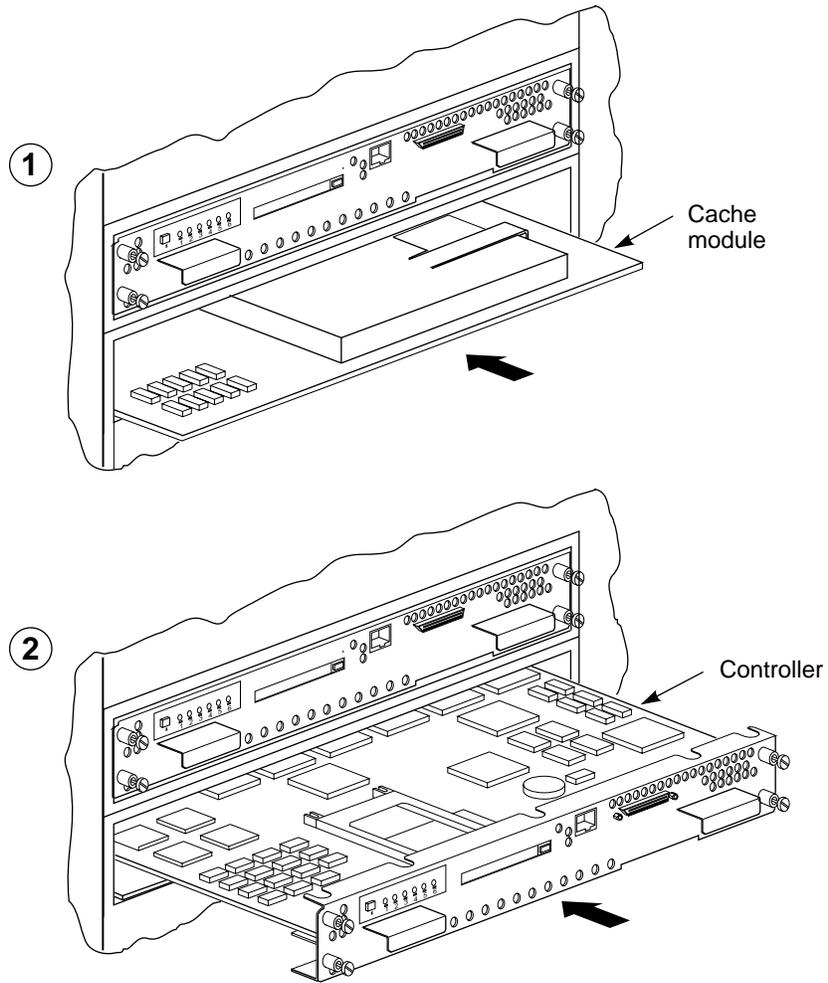
Figure 2-6 Installing the controller and cache modules

5. Insert the cache module by sliding it straight in along the rails and then push firmly to seat it in the backplane. See Figure 2-6.
6. Insert the controller module by sliding it straight in along the rails and then push firmly to seat it in the backplane. See Figure 2-6.

1. If you removed the cache module, install the replacement cache module into the shelf. See Figure 2-6.
2. Slide the new controller module into the shelf using the same rails from which you removed the module. See Figure 2-6.

1. If you removed the cache module in the previous procedure, slide the new cache module into the shelf. Make sure you use the correct slot.
2. Slide the new controller module into the shelf using the same rails from which you removed the module. See Figure 2-6.

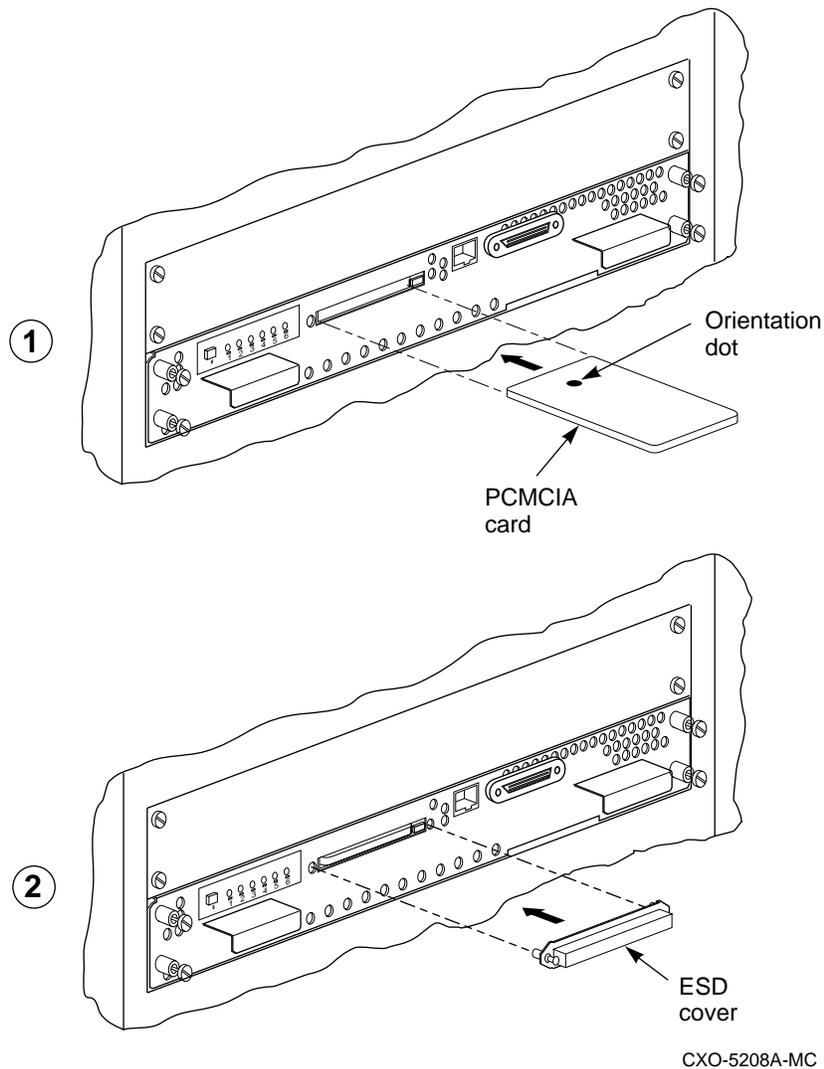
Figure 2-7 Installing the program card

3. Tighten the captive screws on the front bezel of the controller.
4. Reconnect the power cords to the controller power supplies.
5. Attach a maintenance terminal to the new controller.
6. Press and hold the controller's green reset (//) button, while inserting the program card. The program card eject button will extend when the card is fully inserted. See Figure 2-7.

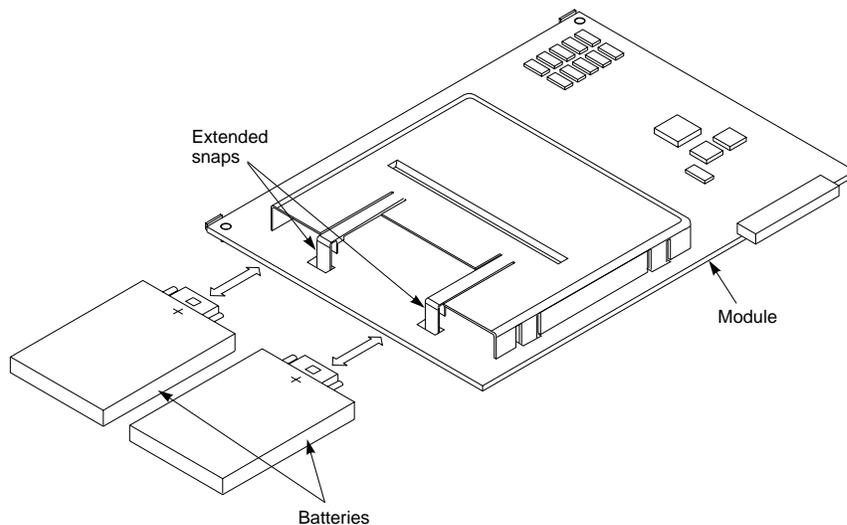
Figure 2-8 Removing and replacing cache batteries

1. Remove the cache modules using the procedure described in the section “Replacing a Controller and Cache Module in a Single Controller Configuration.”
2. Disengage the snaps by pressing them slightly toward the center of the module. Gently lift the extended snaps on the plastic battery bracket. See Figure 2-8.

3. Pull the battery cells straight out of the bracket.
4. Slide the new battery cells straight into the bracket. Make sure to orient the cells with the “+” polarity symbol up.
5. Press the cells firmly into the bracket so that the extended snaps close easily around them. If a cell is installed upside-down, you will not be able to fully close the snaps.

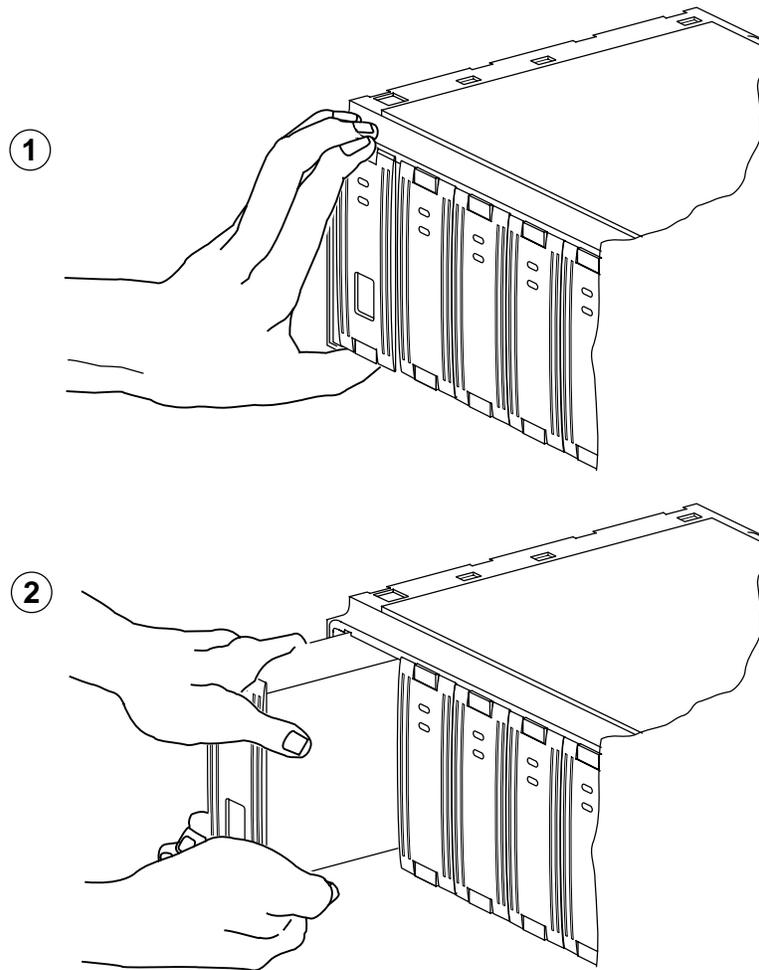
Figure 2-9 Removing the power supply

4. Disconnect the power cords from the power supply.
5. Press the two mounting tabs together to release the power supply from the shelf and partially pull it out of the shelf. See Figure 2-9.
6. Use both hands to pull the power supply out of the shelf. See Figure 2-9.

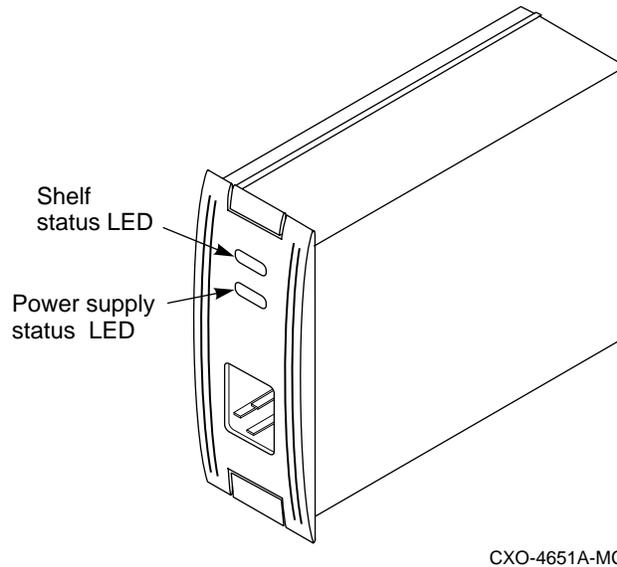
Figure 2-10 Power supply fault indicators

1. Firmly push the power supply into the shelf until the mounting tabs snap into place.
2. Reconnect the power cord to the power supply.
3. Observe the power and shelf fault indicators to make sure they are on. See Figure 2-10.

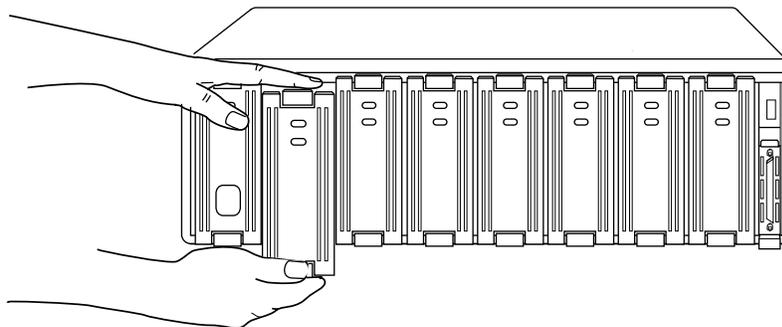
Figure 2-11 Removing a disk drive

```
HSZ40>SHOW DISK_NAME
```
5. If the failed device is part of a failedset, delete it from the failedset. If the failed device is part of a spareset, delete it from the spareset.
6. If the device is part of a storageset or unit, follow the procedure described in the *SBB User's Guide* to remove the device from a storageset.
7. Once the device is no longer part of a storageset or unit, delete the disk name you determined in Step 3.
8. Determine which disk drive has failed using the procedures in Chapter 1, "Troubleshooting", of this manual.
9. Press the two mounting tabs together to release the disk drive from the shelf and partially pull it out of the shelf. See Figure 2-11.

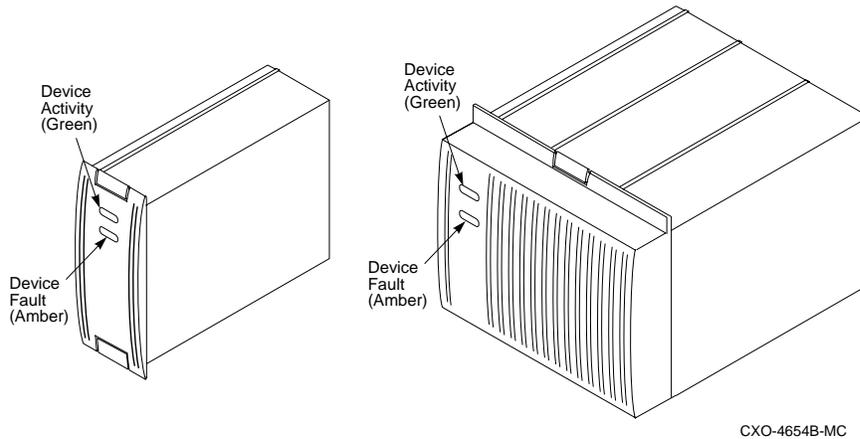
Figure 2-12 Default indicators for 3.5- and 5.25-inch SBBs

12. Push the disk drive all the way into the shelf until the locking tabs snap into place.
13. Observe the status LED for the following indications. See Figure 2-12.
 - The device activity (green) LED is either on, flashing, or off.
 - The device fault (amber) LED is off.

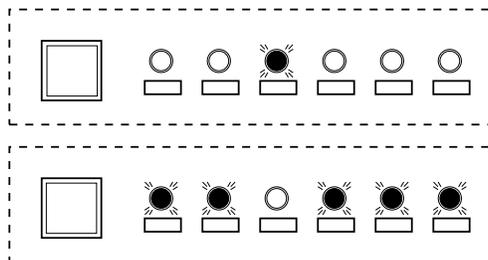
Figure 2-13 OCP LED patterns

1. Determine the failed device using the procedures in Chapter 1, “Troubleshooting”, of this manual.
2. Quiesce the port by pressing the OCP button for that port. When the OCP LED flashes the port is quiesced.
3. When the OCP LEDs flash in an alternating pattern the device port is quiesced. For example, when you quiesce device port three and I/O has halted, the OCP LEDs are flashing in an alternating pattern as shown in Figure 2-13. The flashing LEDs are represented by the dark circles with lines radiating from them.

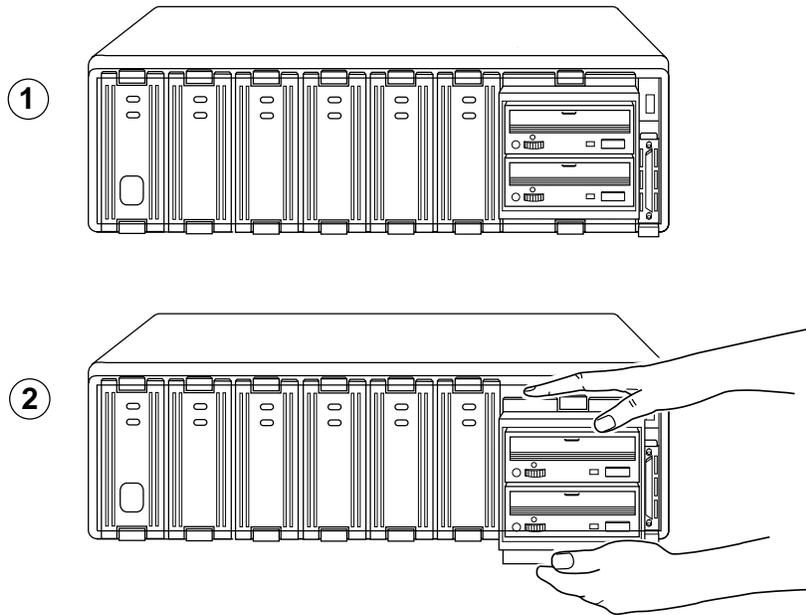
Figure 2-14 Removing the CD-ROM drive

```
HSZ40> SHUTDOWN OTHER_CONTROLLER  
HSZ40> SHUTDOWN THIS_CONTROLLER
```
4. Remove the power cords from the shelf that contains the failed solid-state disk drive. If the device is in an SW300 cabinet, you must power down the whole cabinet.
5. Press the two mounting tabs together to remove the SBB from the shelf. See Figure 2-14.

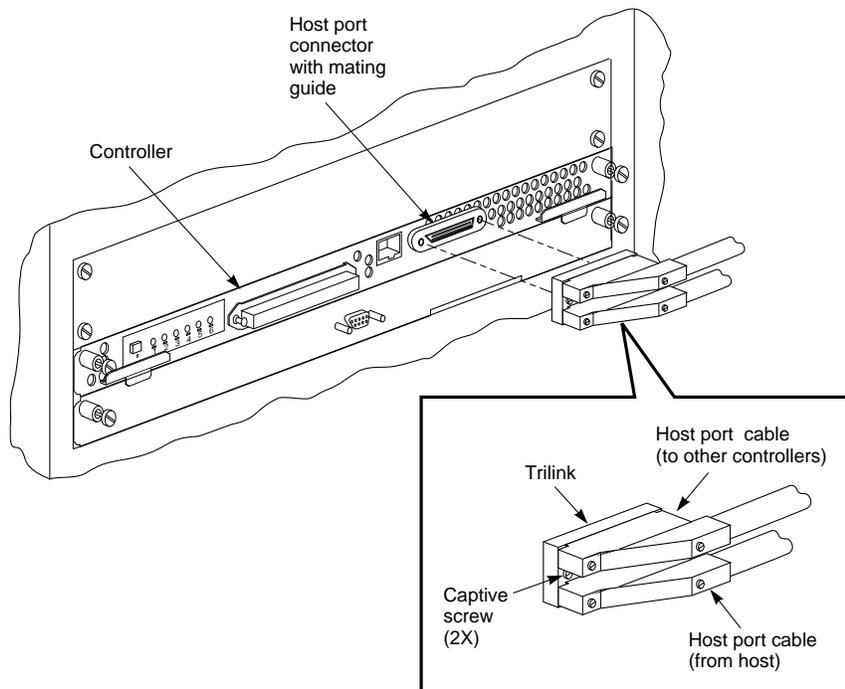
Figure 2-15 Disconnecting the SCSI host cable

1. Halt all I/O activity using the appropriate procedures for your operating system.
2. Dismount all units using the procedures for your operating system.
3. Disconnect the failed SCSI host cable from the host or other device.
4. Shut down the controller/controllers.
5. Loosen the captive screws on the trilink connector at the controller's front bezel. Disconnect the cable from the trilink connector. See Figure 2-15.

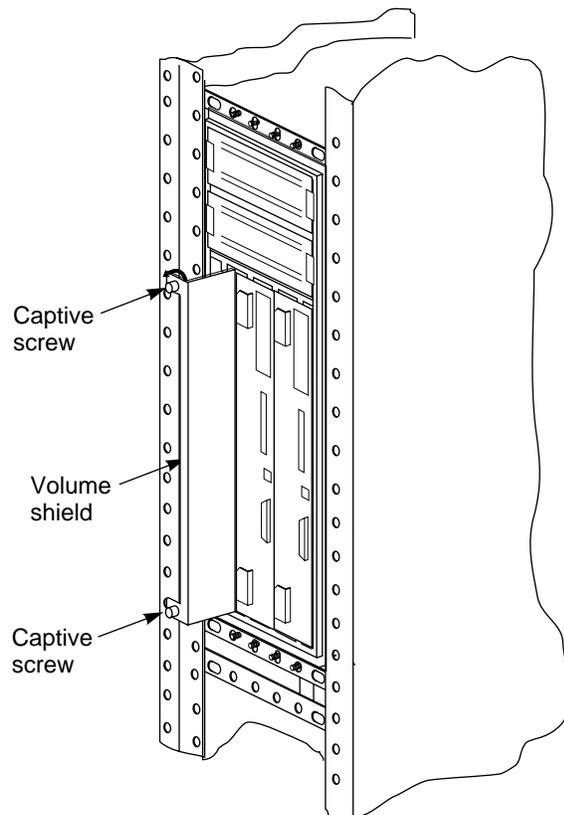
Figure 2-16 Removing the volume shield

1. Make sure the controller/controllers have been properly shut down.
2. Remove each controller and cache module using the procedure described in “Replacing a Controller and Cache Module in a Single Controller Configuration.”
3. Loosen the two captive screws on each side of the volume shield and remove the shield. See Figure 2-16.

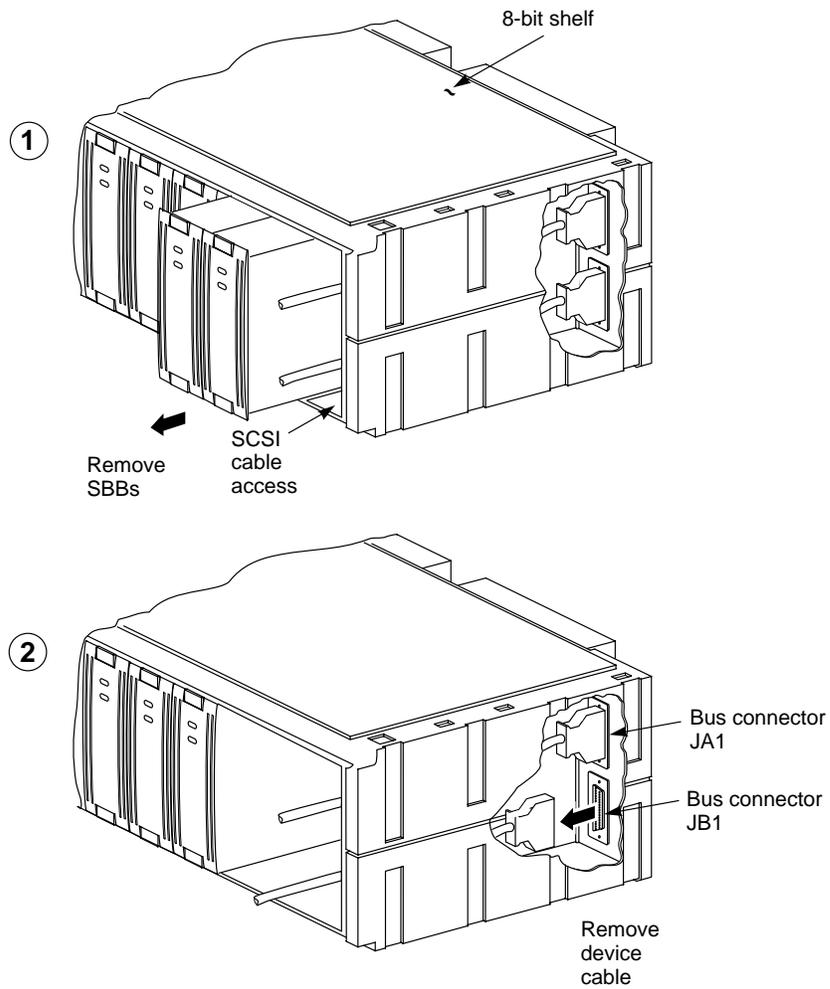
Figure 2-17 Access to the SCSI cables

6. Remove any SBBs necessary to gain access the SCSI cable. See Figure 2-17.

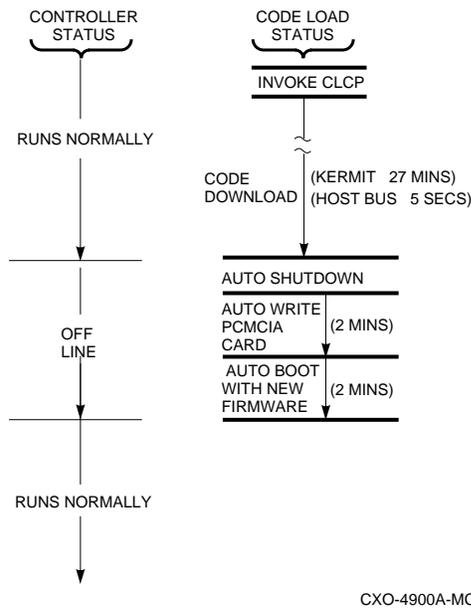
Figure 3—1 Single controller code load method

After the CLCP utility is invoked, the controller continues to run normally while the code is downloaded from host console or PC terminal program. This process may take from several seconds (for a host bus download) to 35 to 45 minutes (for a download performed via the maintenance terminal port). The only time the code load process interrupts device service is for a period of about 4 minutes, while the program card is written and the controller initializes with the new software.

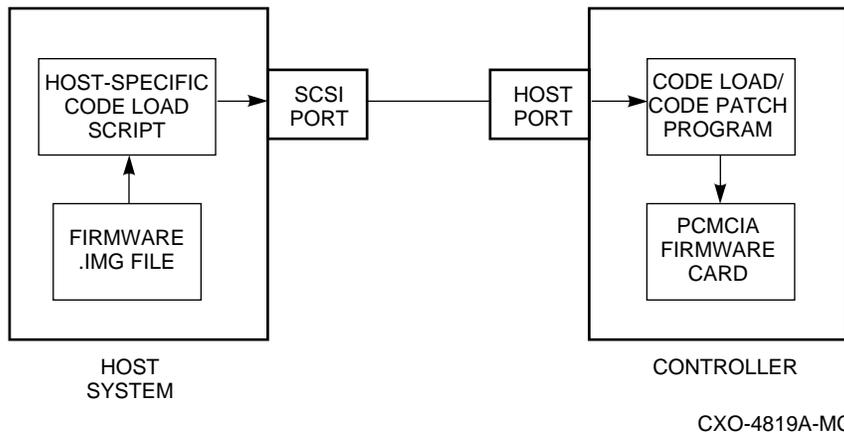
Figure 3—2 Host port code load operation

The user invokes the CLCP utility via the CLI, and when prompted, instructs the host to download the binary software image to the controller using the download script. The controller rewrites the software in its program card using the downloaded software image.

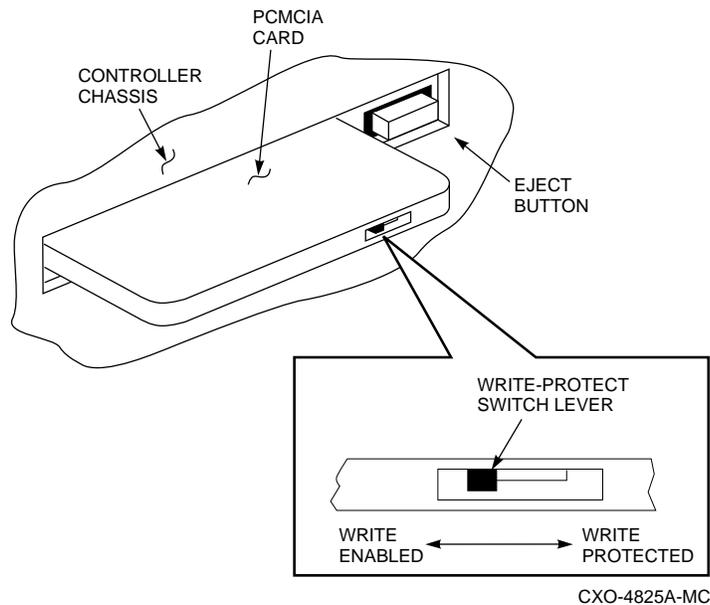
Figure 3—3 Write enable the program card

1. Locate the program card on the controller module.
2. Locate the write-protect switch on the outer edge of the card.
3. With a small pointed object, carefully slide the switch lever away from the eject button (see Figure 3-3).

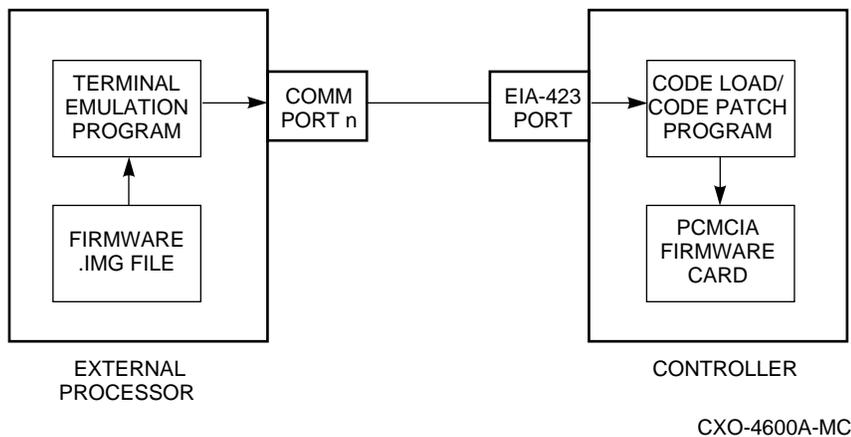
Figure 3—4 Terminal port code load operation

When prompted by the CLCP utility, the user instructs the terminal emulator program to download the binary software image to the controller using the KERMIT line protocol. The controller rewrites the software in its program card using the downloaded software image.

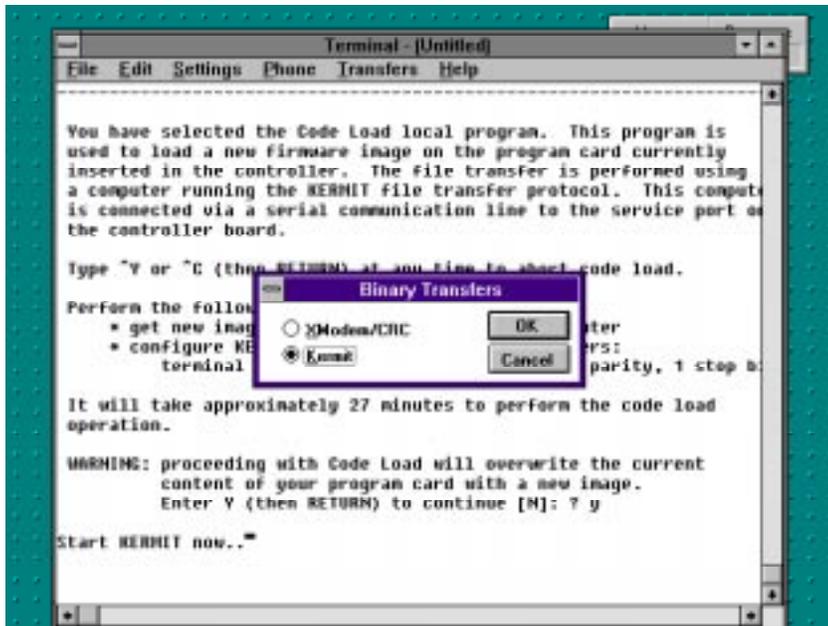
Figure 3—5 Binary transfer protocol selection

12. Select the KERMIT transfer protocol and click on the OK button (see Figure 3—5).
13. Your external processor and the serial link to the controller are now ready to download the new software image to the controller.
14. Remove the program card ESD cover.
15. Check the program card in your controller and see if it has a write protect switch.

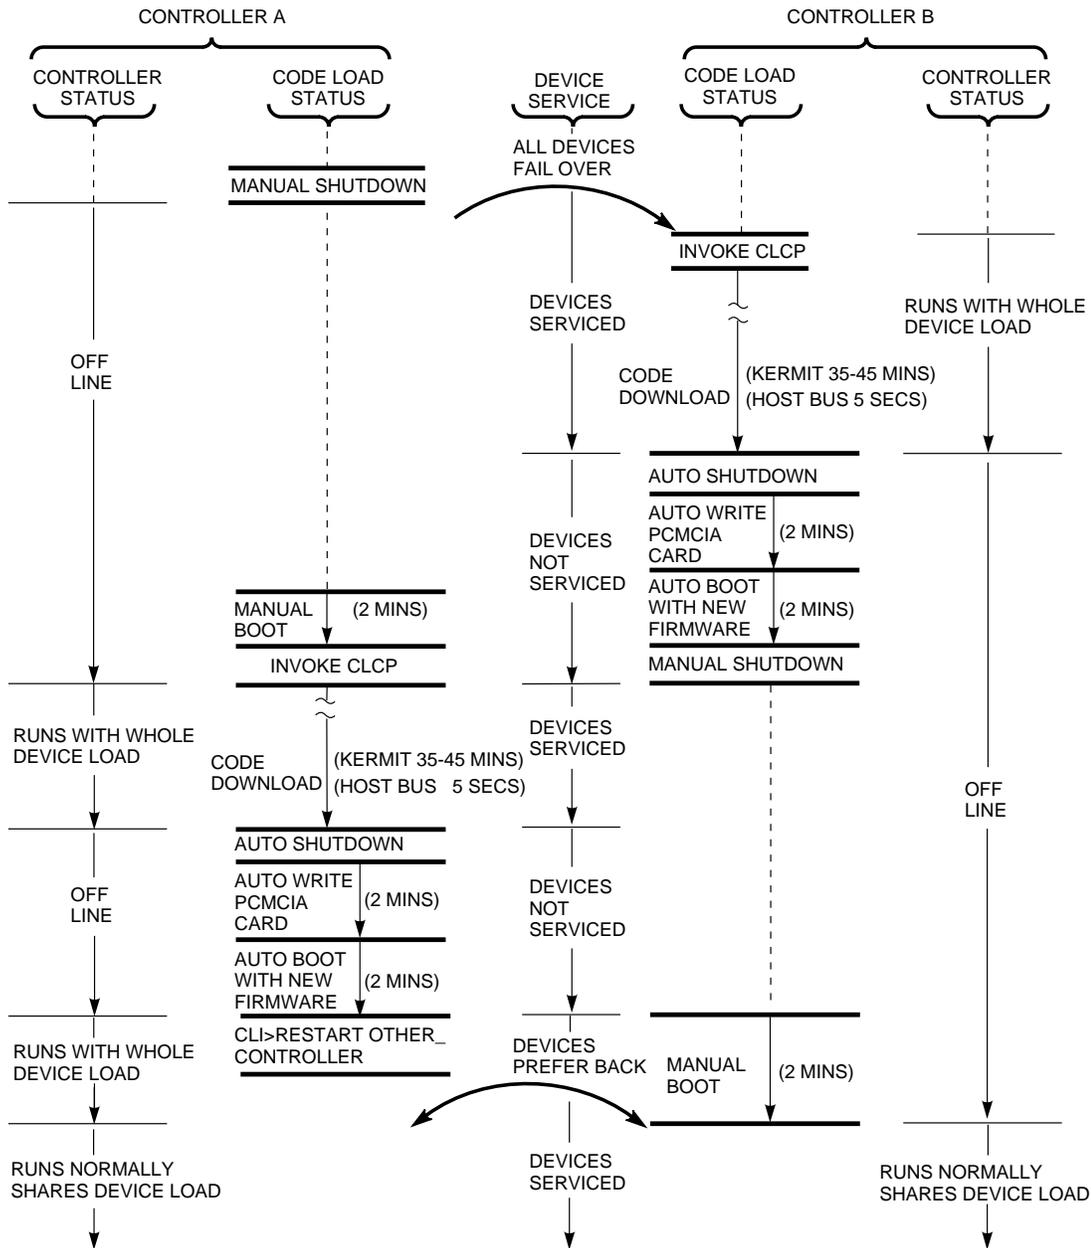
Figure 3-6 The sequential upgrade method

- You must invoke CLCP separately for each controller in a dual-redundant configuration. CLCP does not automatically load both controllers.
- To avoid extended downtime, always upgrade both controllers when you perform a software upgrade.

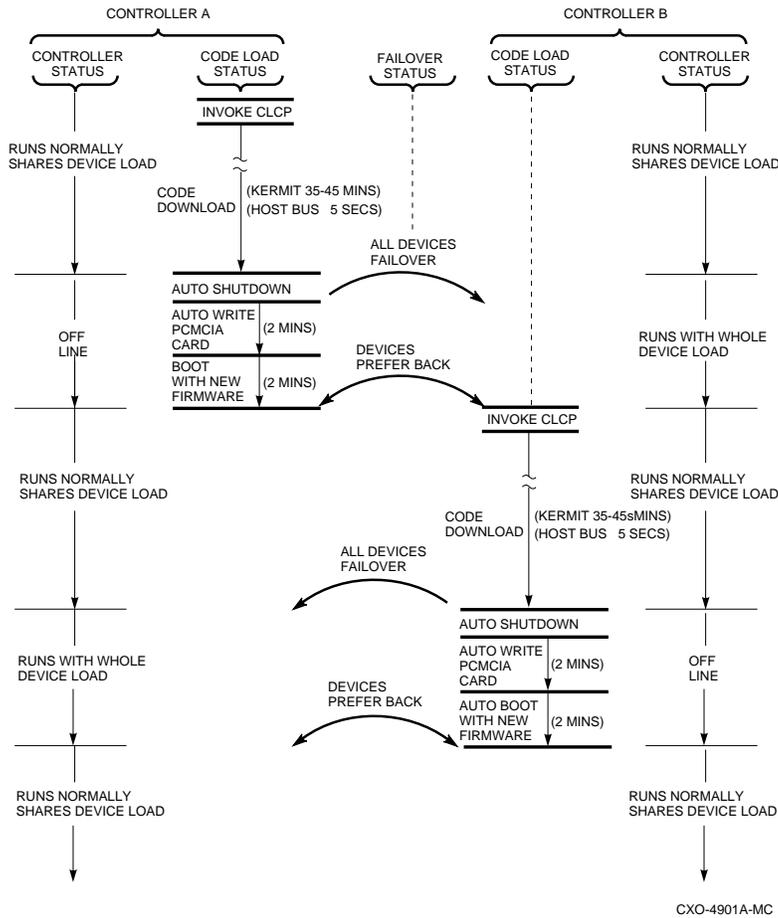
Figure 3—7 The concurrent upgrade method

1. For the purpose of this procedure, mark one controller "A" and the other controller "B."
2. If you wish to use the maintenance terminal to upgrade the software, use the Single Controller Maintenance Port Upgrade procedure.
3. After you have upgraded software in one controller repeat the same procedure for the other controller.
4. If you wish to use the host port to upgrade the software, proceed with Step 5 of this procedure.

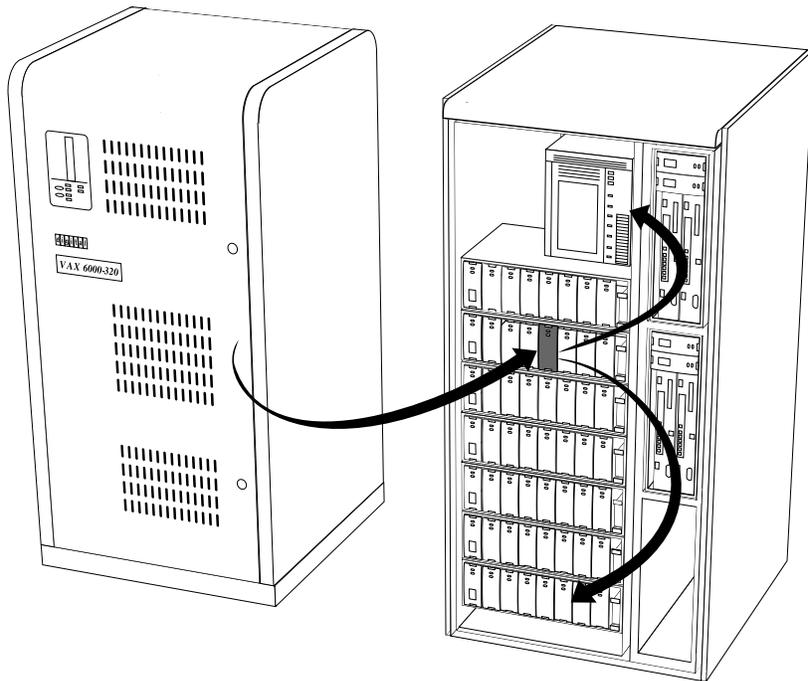
Installing new firmware on a disk or tape drive is a two-step process as shown in Figure 3—8. First, copy the new firmware from your host to a disk drive in your subsystem, then use HSUTIL to distribute the *firmware* devices in your subsystem.

Figure 3—8 Copy the *firmware* to a disk drive in your subsystem, then distribute it to the devices you want to upgrade.

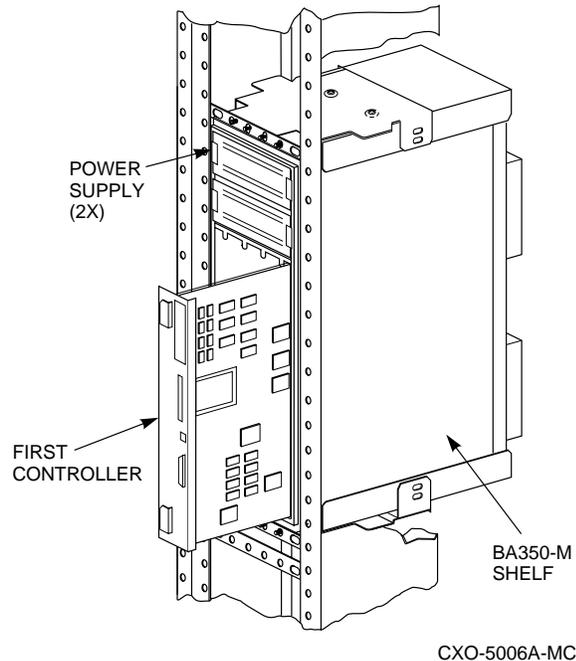
Figure 3-9 Installing a single controller (SW800 cabinet)

5. Slide the cache module into the controller shelf with a gentle rocking motion to help seat the module.
6. Slide the controller module into the shelf slot that corresponds to SCSI ID 7 (see Figure 3-9).

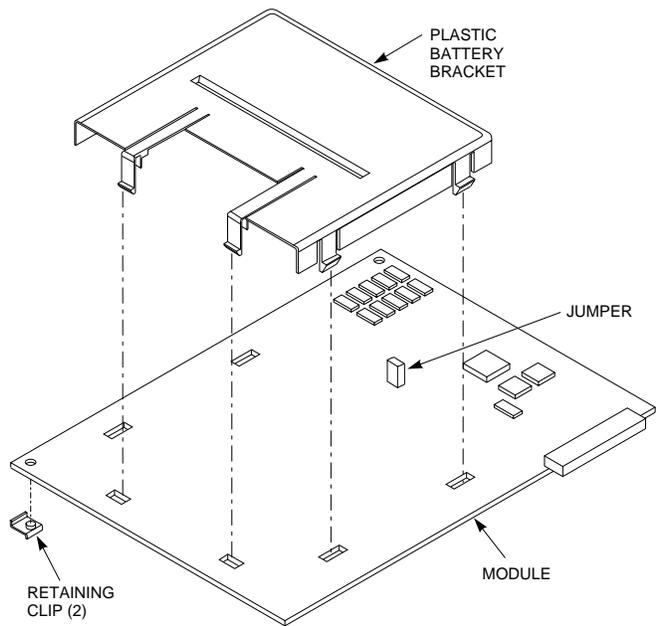
CXO-4121A-MC

Figure 3—10 Installing the battery bracket

1. Install the battery bracket on to the cache module (see Figure 3—10).

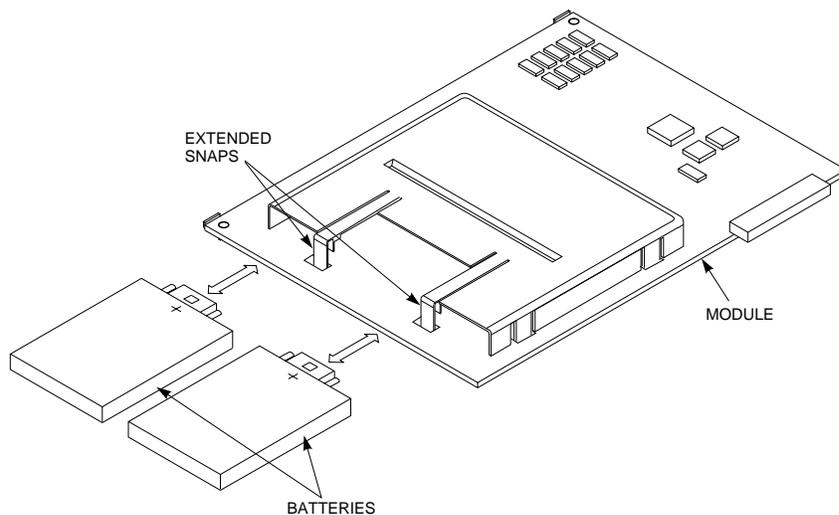
CXO-4122B-MC

Figure 3—11 Installing write back cache batteries

3. Slide the battery cells straight into the bracket. Make sure to orient the cells with the “+” polarity symbol facing up.
4. Press the cells firmly into the bracket so that the extended snaps close easily around them. If a cell is installed upside-down, you will not be able to fully close the snaps.
5. Enable the write-back cache batteries by removing the jumper. Store the battery disable jumper by installing it over only one pin.
6. Slide the write-back cache and controller modules back into their appropriate slots in the controller shelf.
7. Tighten the four captive screws on the controller’s front bezel.
8. Eject the program card by pressing and holding in the Reset button (//), then pressing the Eject button next to the program card. Remove the program card from the controller.
9. Reconnect the power cords to the controller shelf power supply.

2. Disengage the extended snaps by pressing them slightly toward the center of the module. Gently lift the extended snaps on the plastic battery bracket (see Figure 3—11).

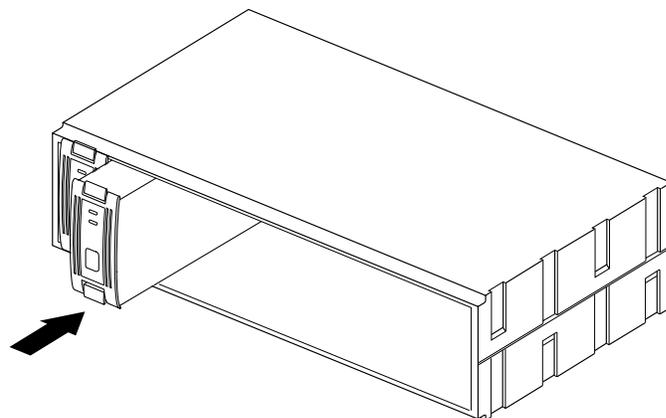
CXO-5304A-MC

Figure 3—12 Installing a power supply

1. Orient the power supply so that the status indicators are at the top. Firmly push the power supply into the shelf until the mounting tabs snap into place (see Figure 3—12).

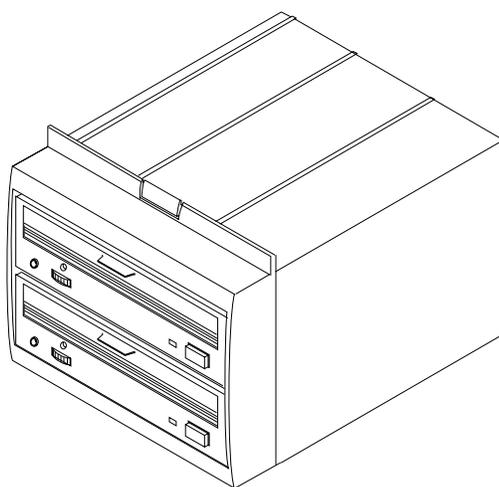
CXO-5167A-MC

Figure 3—14 Typical 5.25-inch CD-ROM SBB

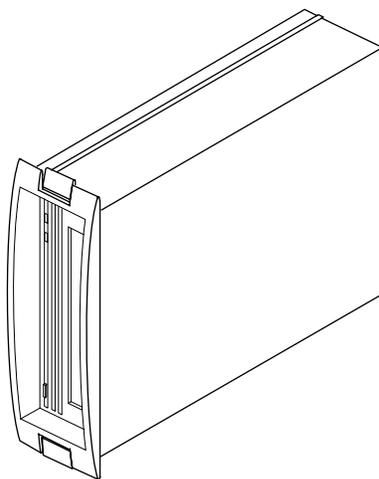
CXO-5168A-MC

Figure 3—15 Typical 3.5-inch tape drive SBB

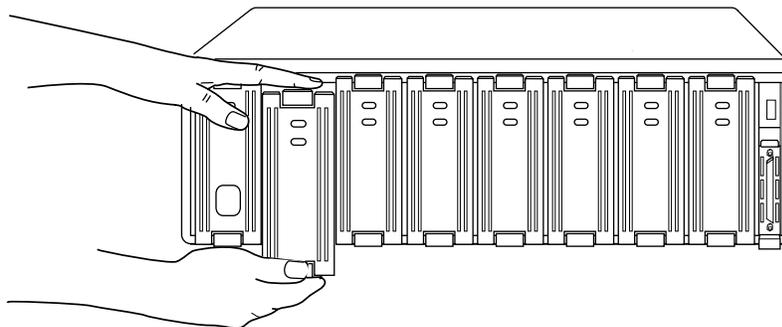
CXO-4439A-MC

Figure 5—1 Removing a 3.5-inch disk drive

1. Determine the disk drive you wish to remove.
2. Press the two mounting tabs together to release the disk drive from the shelf and partially pull the disk drive out of the shelf. Allow the disk drive to spin down.

3. Using both hands, slide the disk drive out of the shelf and place it on flat surface (see Figure 5—1).

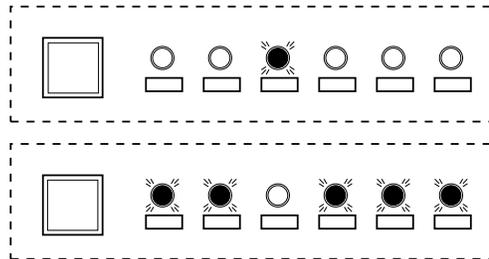
CXO-4824A-MC

Figure 5—2 OCP LED patterns

1. Halt all I/O activity to the tape drive using the appropriate procedures for your operating system.
2. Quiesce the appropriate device port by pushing the device port button on the controller's OCP (operator control panel).
3. When the OCP LEDs flash in an alternating pattern the device port is quiesced. For example when you quiesce device port 3 and I/O has halted, the OCP LEDs are flashing in an alternating pattern as shown in Figure 5—2. The flashing LEDs are represented by the dark circles with lines radiating from them.
